# Commercial GI Retrofits: Construction, Performance, and Maintenance

Ohio Stormwater Conference – Sharonville, OH

May 10, 2019

# Reynoldsburg Meijer

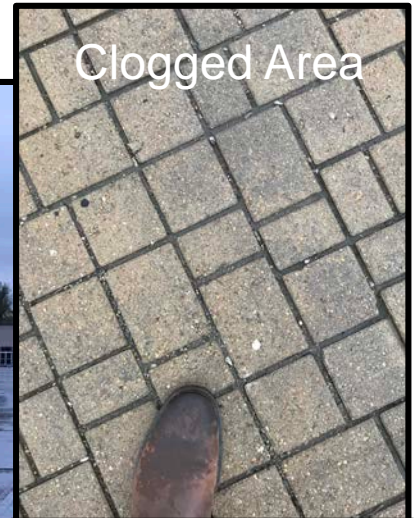
Clogged Area

- Site was 17 months old at time of maintenance
  - No previous maintenance
  - Moderately clogged (5-150 in/hr)
  - Maintenance performed April 25, 2019
  - 5-15 passes with regenerative air street sweeper
  - Maintenance took 45 mins + 15 mins to add new chip stone

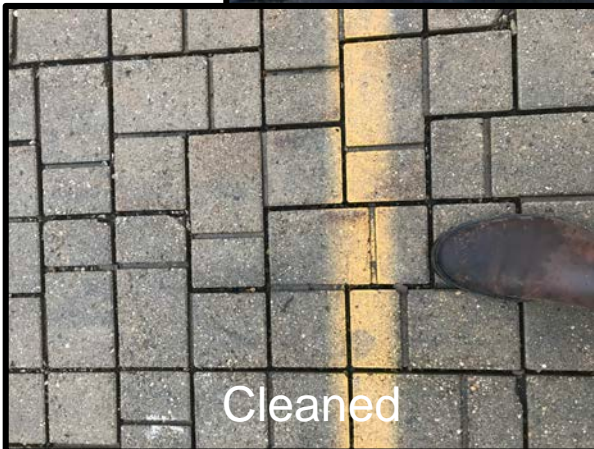
Cleaned

- Decline in infiltration rate following maintenance at 5/6 testing locations
  - Have not observed this in ~5 rounds of pre/post infiltration testing since 2014 when using a regenerative air sweeper
  - Perhaps related to rain during maintenance?
