CASE STUDIES FOCUSED ON LONG TERM INSPECTION AND MAINTENANCE OF POST-CONSTRUCTION BMP'S IN HAMILTON COUNTY

Hamilton County Planning + Development
Stormwater + Infrastructure Division

Mohammad M Islam PE
Ben Poole EIT

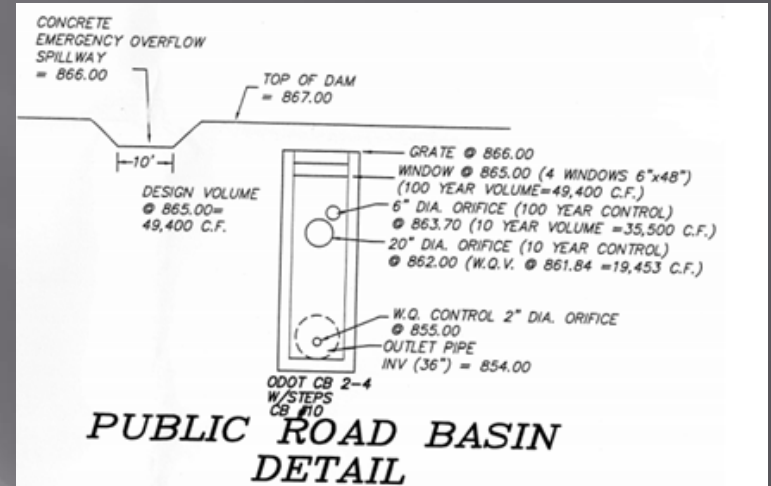
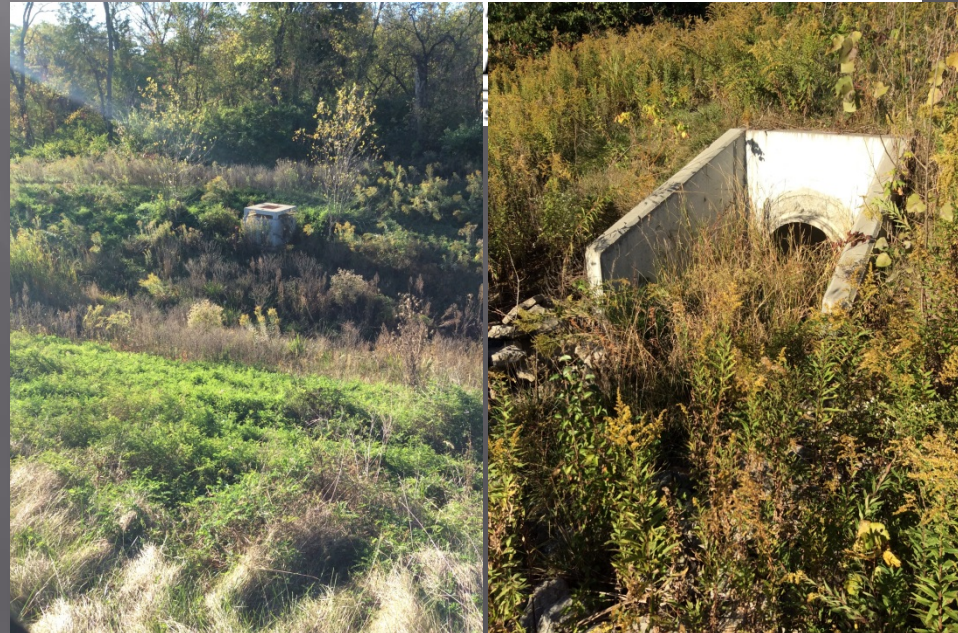
- ▣ Total Volume = 49,400 cf
- ▣ $WQ_v = 19,453$ cf
- ▣ Inspection Scores:
 - 2015 – 6
 - 2017 – 6
 - 2018 – 12
- ▣ Inlet/Outlet clogging and sediment issues ongoing.
- ▣ Trash, erosion, and ground cover issues in 2017 & 2018.
- ▣ 2" orifice in face of Outlet Control Structure (OCS).

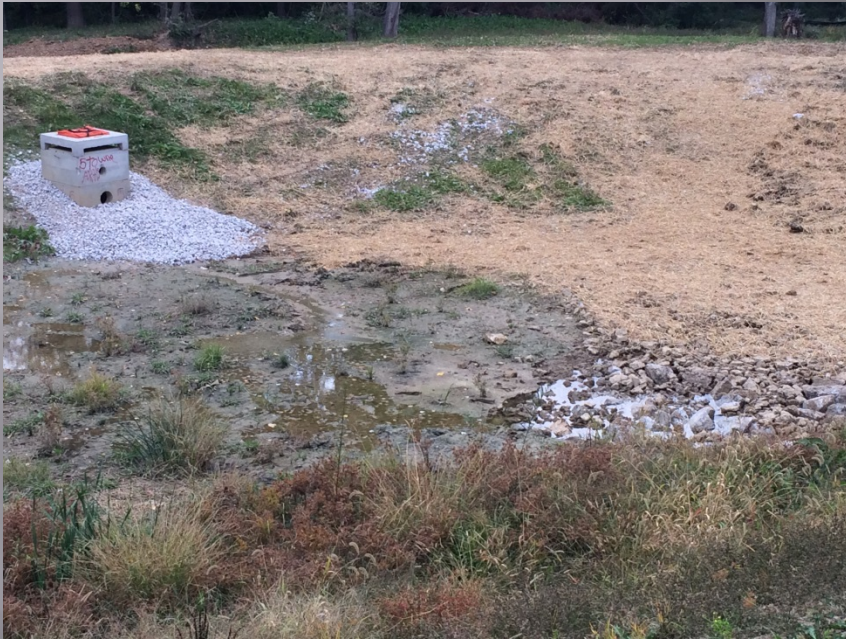
October 2016

- ❑ Dry detention basin installed in 2015.
- ❑ Total Volume = 24,113 cf
- ❑ $WQ_v = 8,471$ cf
- ❑ Inspection Scores:
 - 2017 – 12
 - 2018 – 6
- ❑ Erosion, overgrown vegetation, sedimentation, inlets & outlets clogged.
- ❑ Control structure condition improved 2017-2018.
- ❑ 4" perforated pipe under washed gravel WQ control.

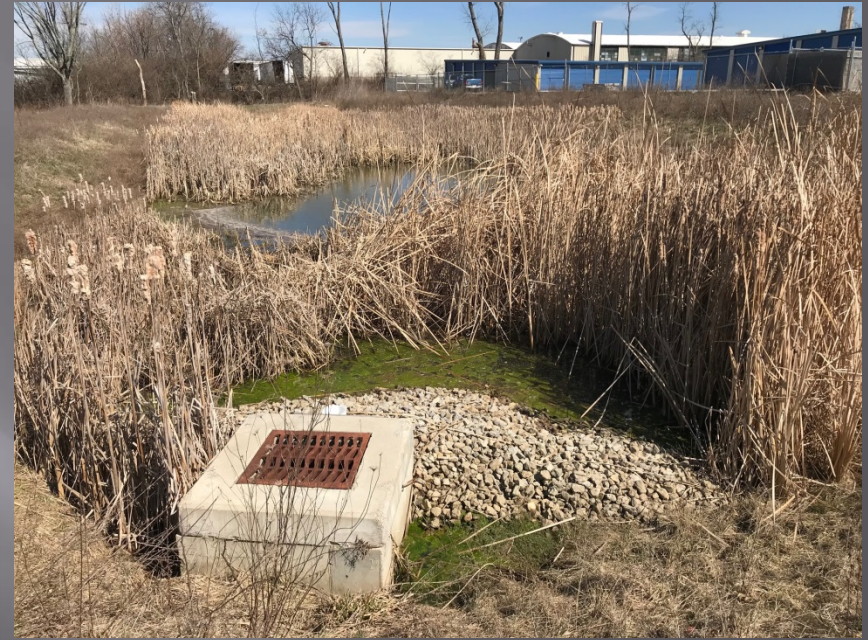
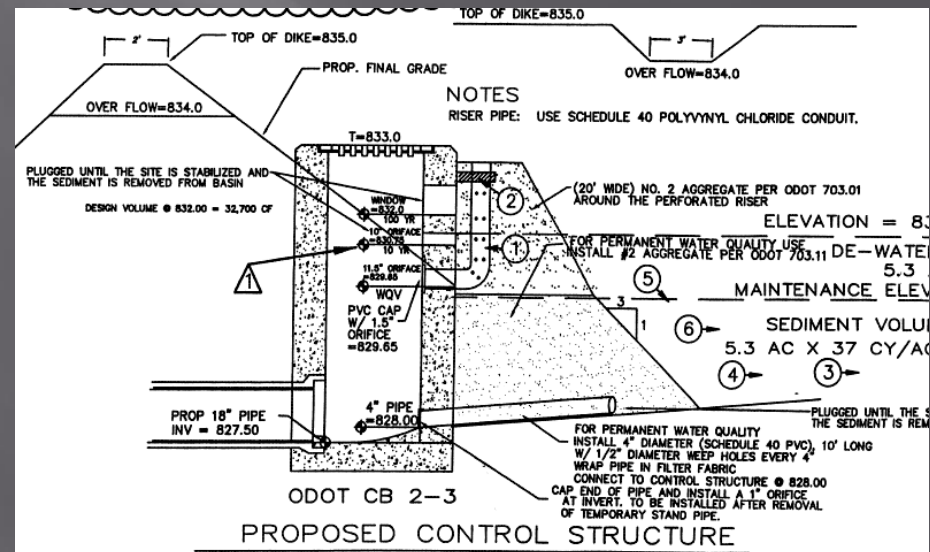
- ❑ Total Volume = 25,591 cf
- ❑ $WQ_v = 6,400$ cf
- ❑ Inspection Scores:
 - 2015 – 8
 - 2017 – 25
 - 2019 – 23
- ❑ Sediment Basin standpipe was never switched to Post Construction Water Quality Control.
 - Prevented the basin from functioning as a dry basin
 - Oversight/miscommunication between agencies/inspectors.
- ❑ Inlets clogged, trash, and overgrown vegetation are ongoing issues.

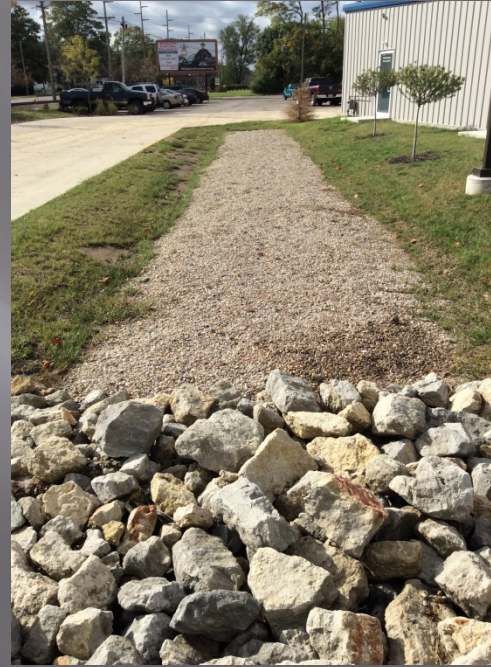
*October
2015*

- ▣ Redeveloped WQv treated = 288 cf
- ▣ 6" underdrain outlet
- ▣ Inspection Scores:
 - 2015 – 0
 - 2018 – 1
- ▣ 2018 - Minor sediment deposits in gravel

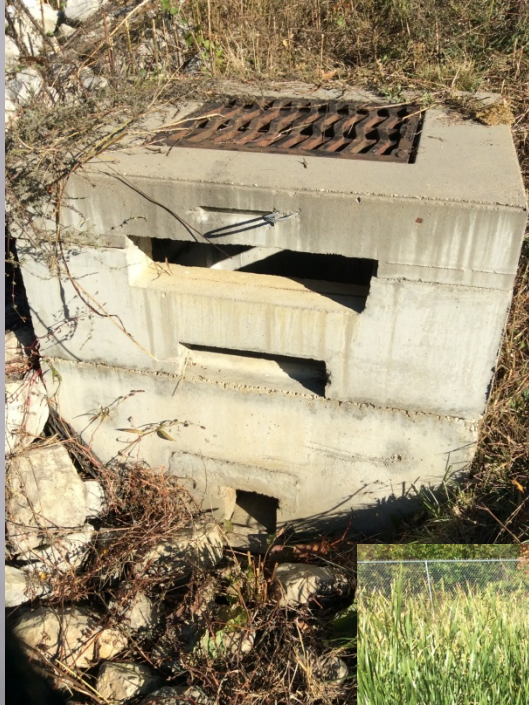
*October
2015*

- ❑ 1 Dry Detention Basin installed in 2010.
- ❑ 8.11 ac drainage area
- ❑ Total Volume = 15,390
- ❑ $WQ_v = 4,792$
- ❑ Inspection Scores:
 - 2015 - 12
 - 2017 - 13
 - 2018 - 19
- ❑ Erosion, ground cover, WQ control and standing water are ongoing issues.

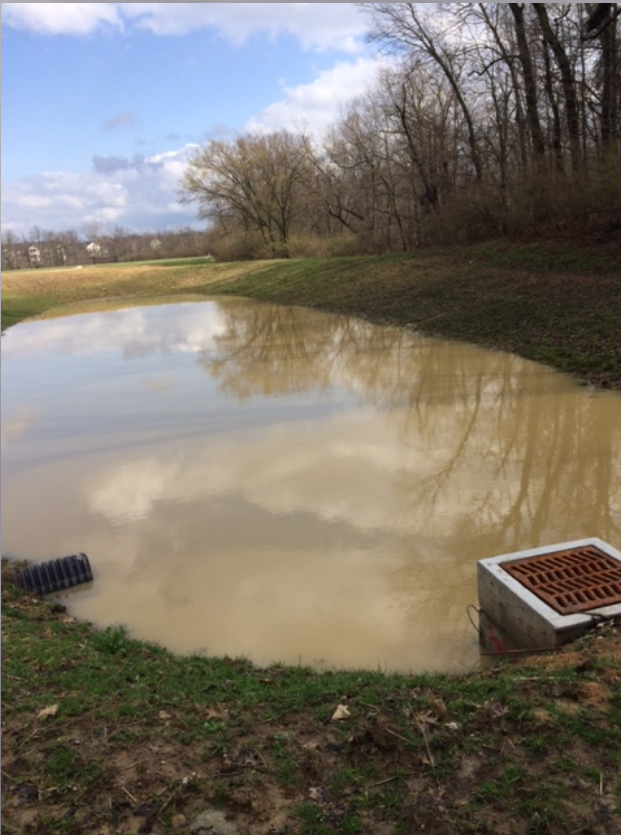
*March 2017
(after heavy
rain)*

- ▣ Erosion and overgrown vegetation issues in 2017.
- ▣ Vegetation only issue in 2018.

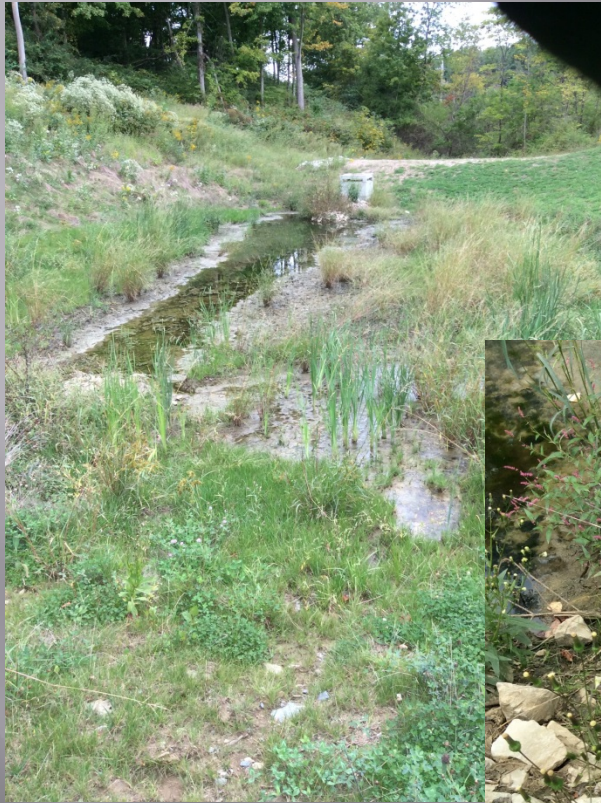
October 2015

- Dry Detention Basin installed in 2014
- 6.5 ac drainage area
- Total Volume = 15,000 cf
- $WQ_v = 5,875$ cf
- 4" perforated pipe under washed gravel
- Inlet/Outlet/WQ Control clogged, erosion, vegetation, sediment, and standing water issues all 3 years.
