Streambank Failure Mechanisms and Streambank Stabilization on Pistol Creek at McCammon Drive

Patrick McMahon, S&ME Senior Engineer

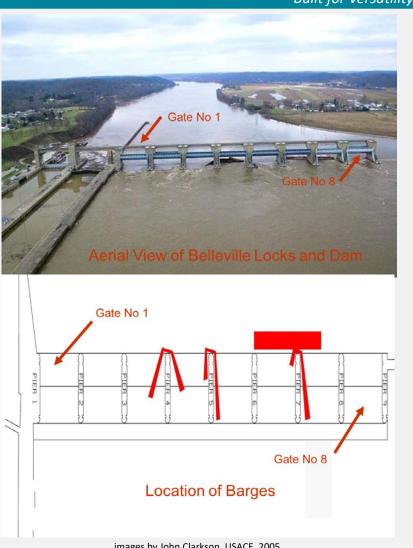
- Belleville Locks and Dam, 2005
- Geotechnical Failure **Due to Rapid Draw** Down, Due to...
- 42 miles upstream to the next dam, plus tributaries
- Rapid draw down up to 14 feet
- Widespread bank failures...

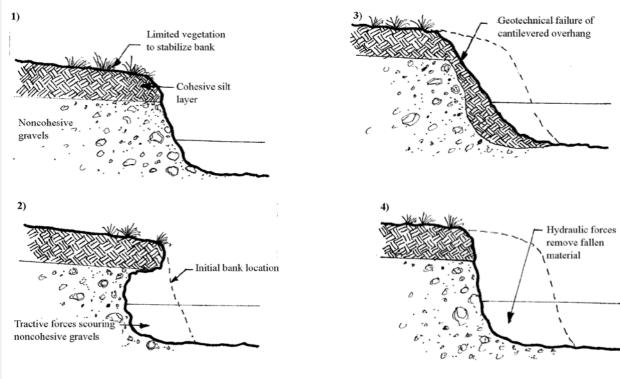
Figure 3: Stratified Streambanks and Combination Failures (Adapted from Johnson and Stypula 1993)

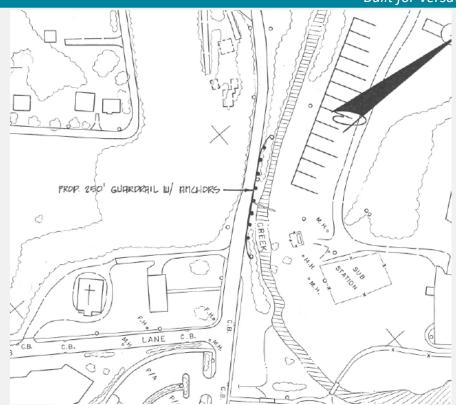
LOCATION

West bank Pistol Creek too eroding Eastern edge Louisville Rd.

Install guardrail on Eastern edge Louisville Rd.
