Alleviating CSOs in St. Louis

HARLEM BADEN TRUNK SEWER REHABILITATION

Harlem Baden (Hebert) Trunk Sewer Rehabilitation – Package 8

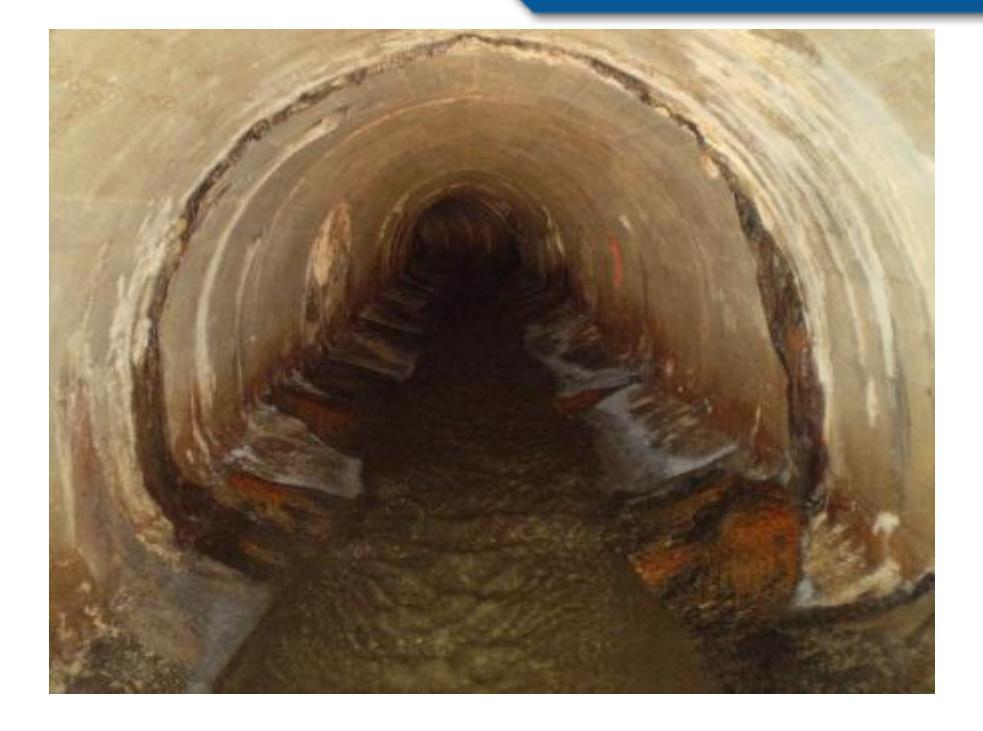
Significant Evidence of Leakage

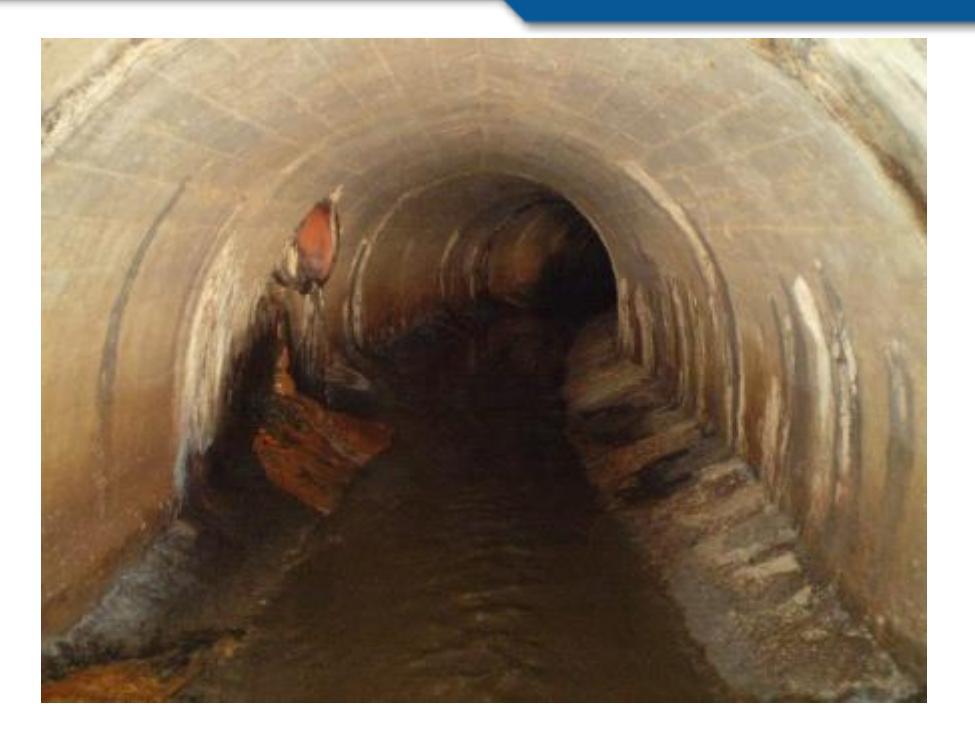
- Typical Connection
- Mineral deposits
- Infiltration stains

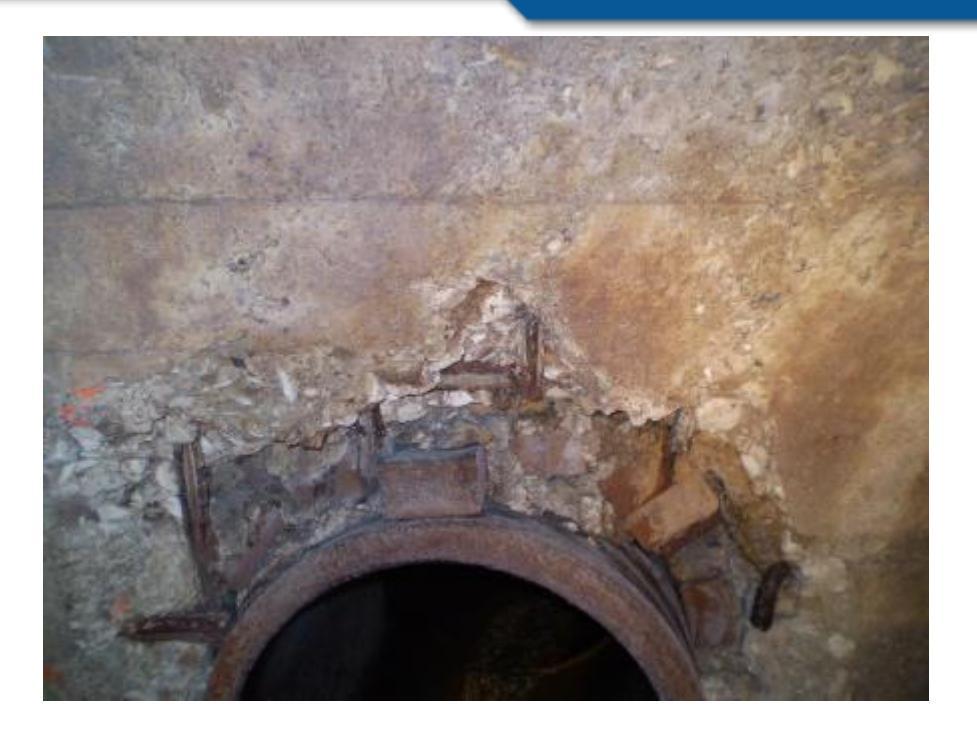
- Needs patch around service connection
- Exposed reinforcing steel at connection

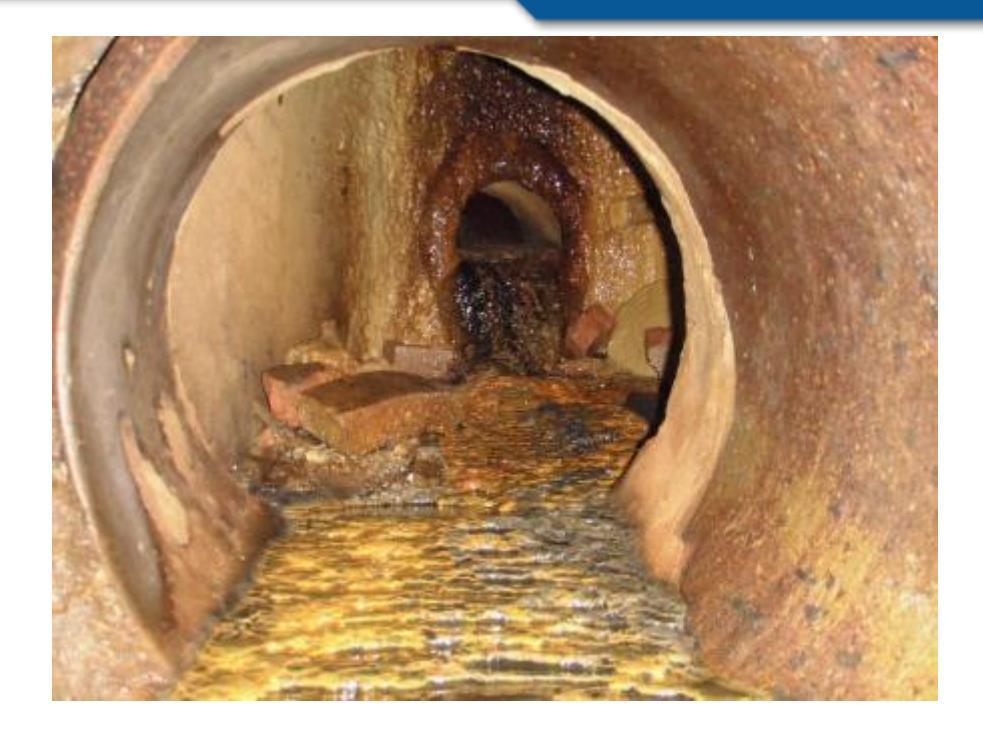
- Tap break-in
- Fair to good condition
- No protrusion
- 41-inch VCP
- Manhole in view

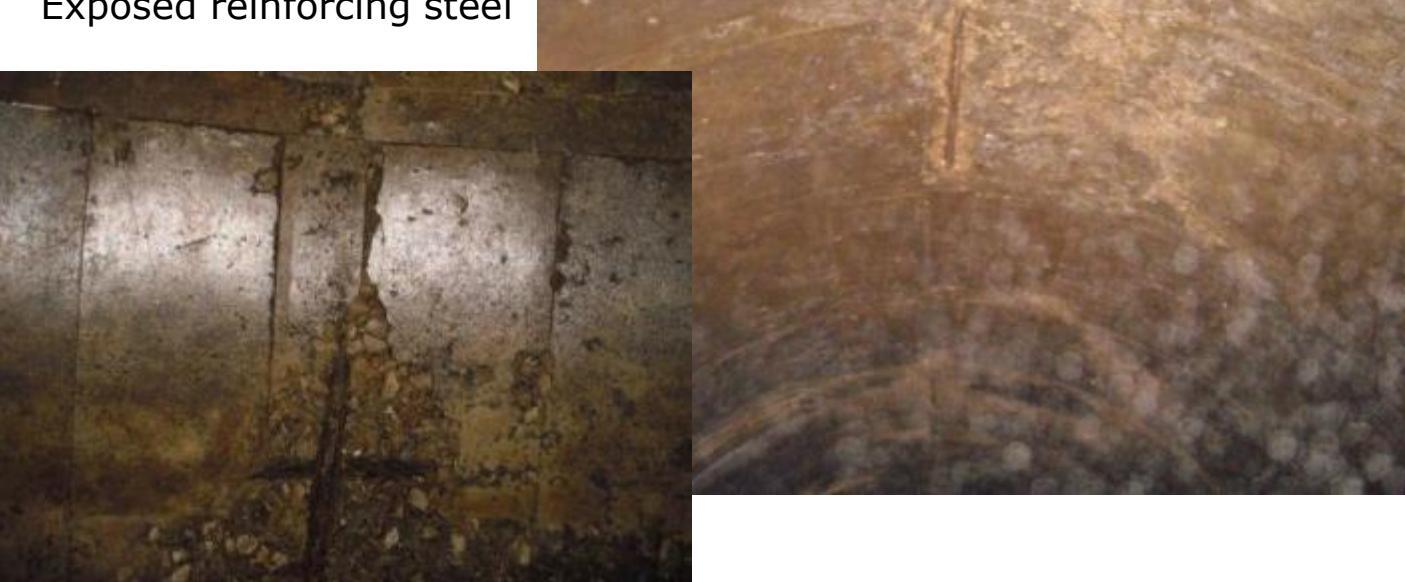
- Moderate corrosion
- Exposed reinforcing steel

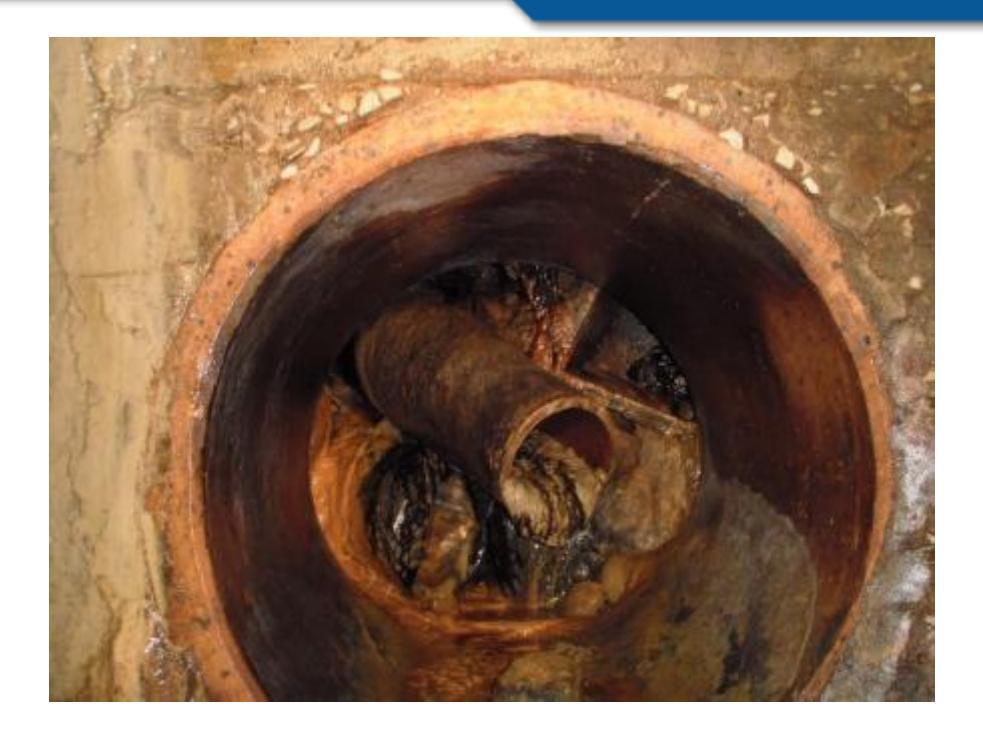
- Tap Break-in
- Structural damage (moderate-severe)
- 31-inch VCP
- Full of debris

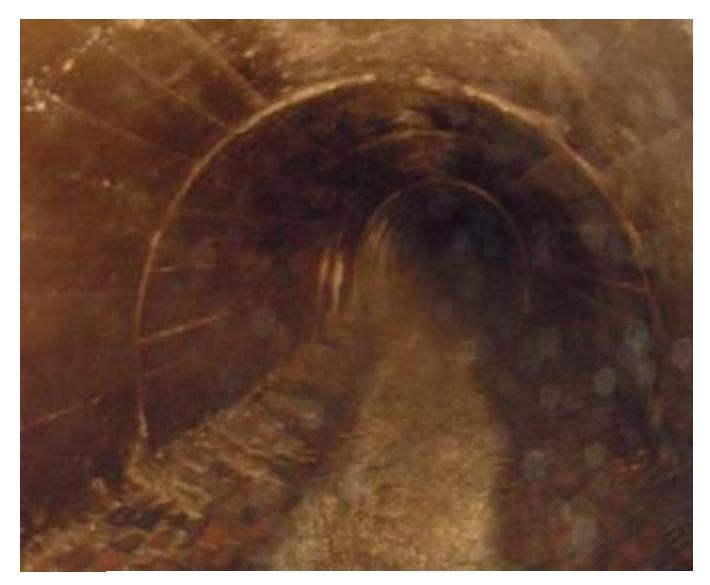
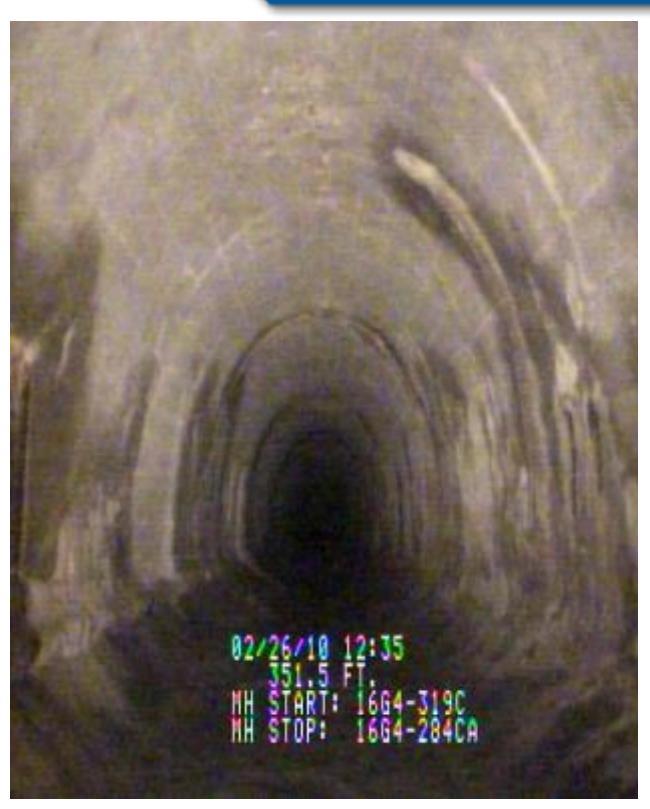
- Cast-in-place horseshoeshaped sewer
- Inlaid brick invert

Sewer is in need of repairs to extend useful service life and have it function within the overall intent of the Harlem Baden project.
