### Strand Associates, Inc.® (SA)

Leveraging Clean Water Act Compliance to Maximize Community Benefits

John T. Lyons, P.E. – Strand Associates, Inc.

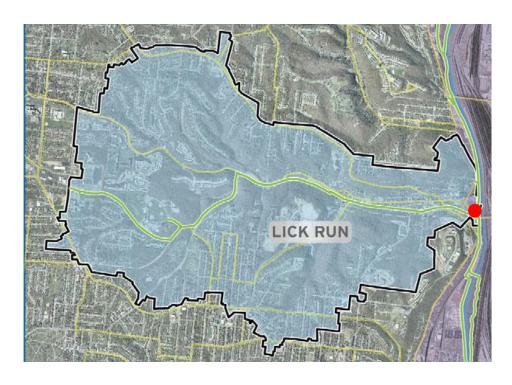
CSO #5, in the Lick Run Watershed, is MSDGC's largest CSO within the system.

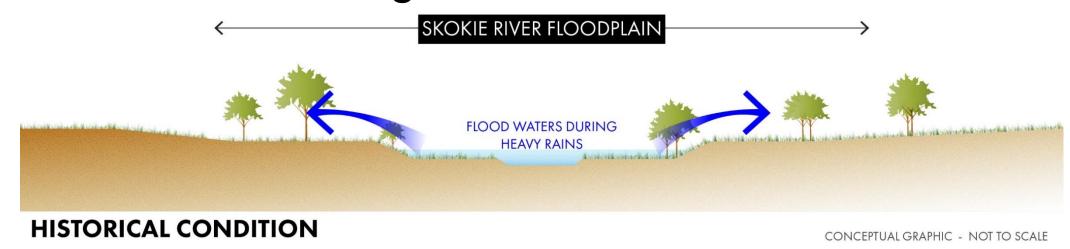
### Skokie River Drainage

#### $\leftarrow$ SKOKIE RIVER FLOODPLAIN $\rightarrow$

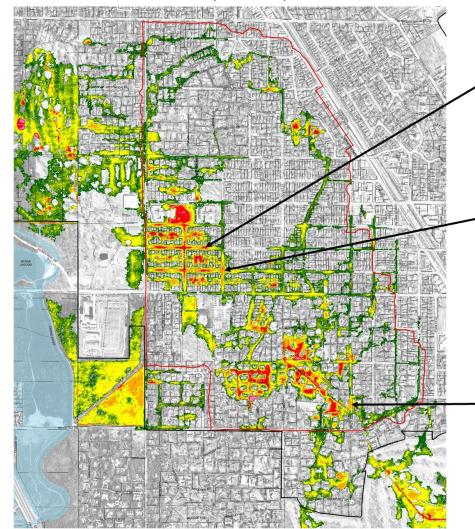
#### **EXISTING CONDITIONS, 100-YR, 3-HR EVENT**

# **Existing Conditions**

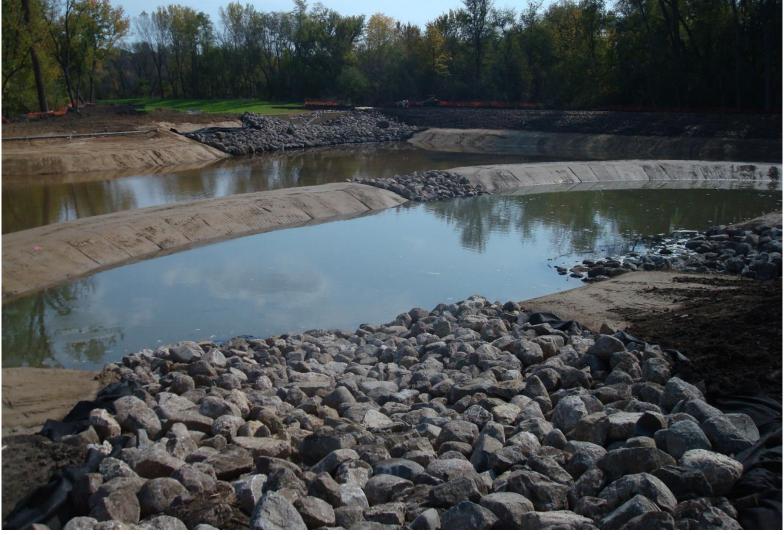
Pond partially filled with water prior to a large rain event that filled the pond completely.

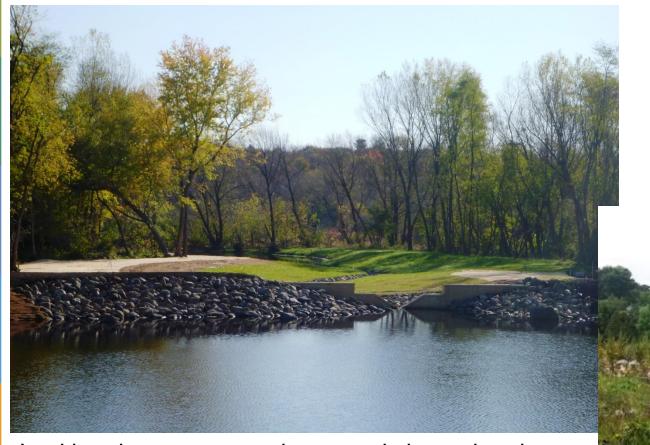
Looking downstream at the natural channel and stilling pool/wetland restoration.
