Stabilization Along the Cuyahoga River: Avoiding a “Tow Away Zone”

*Kristen Buccier, NEORSD
Shannon Conway, Stantec*

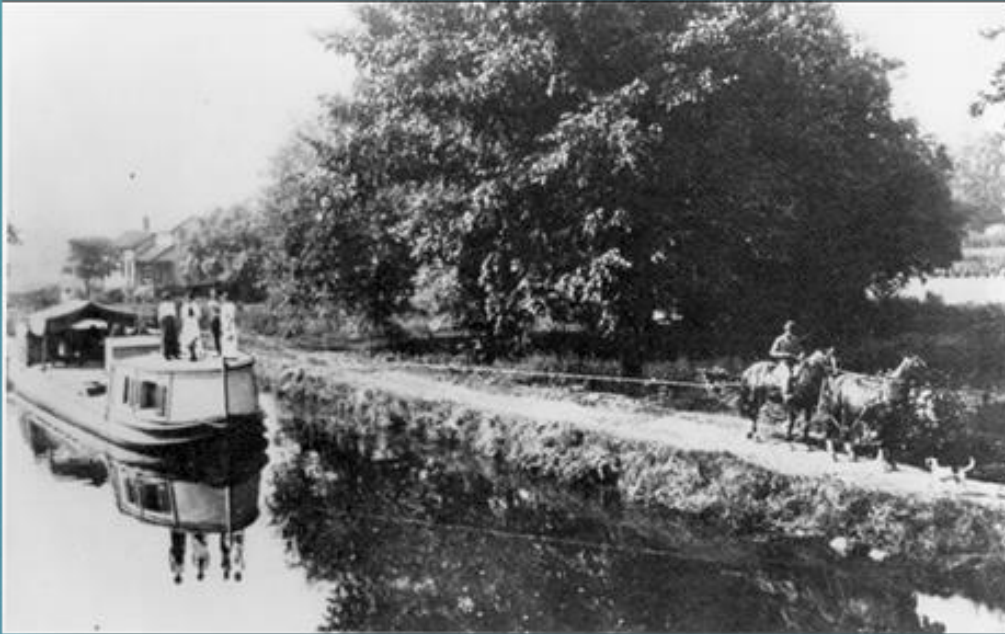
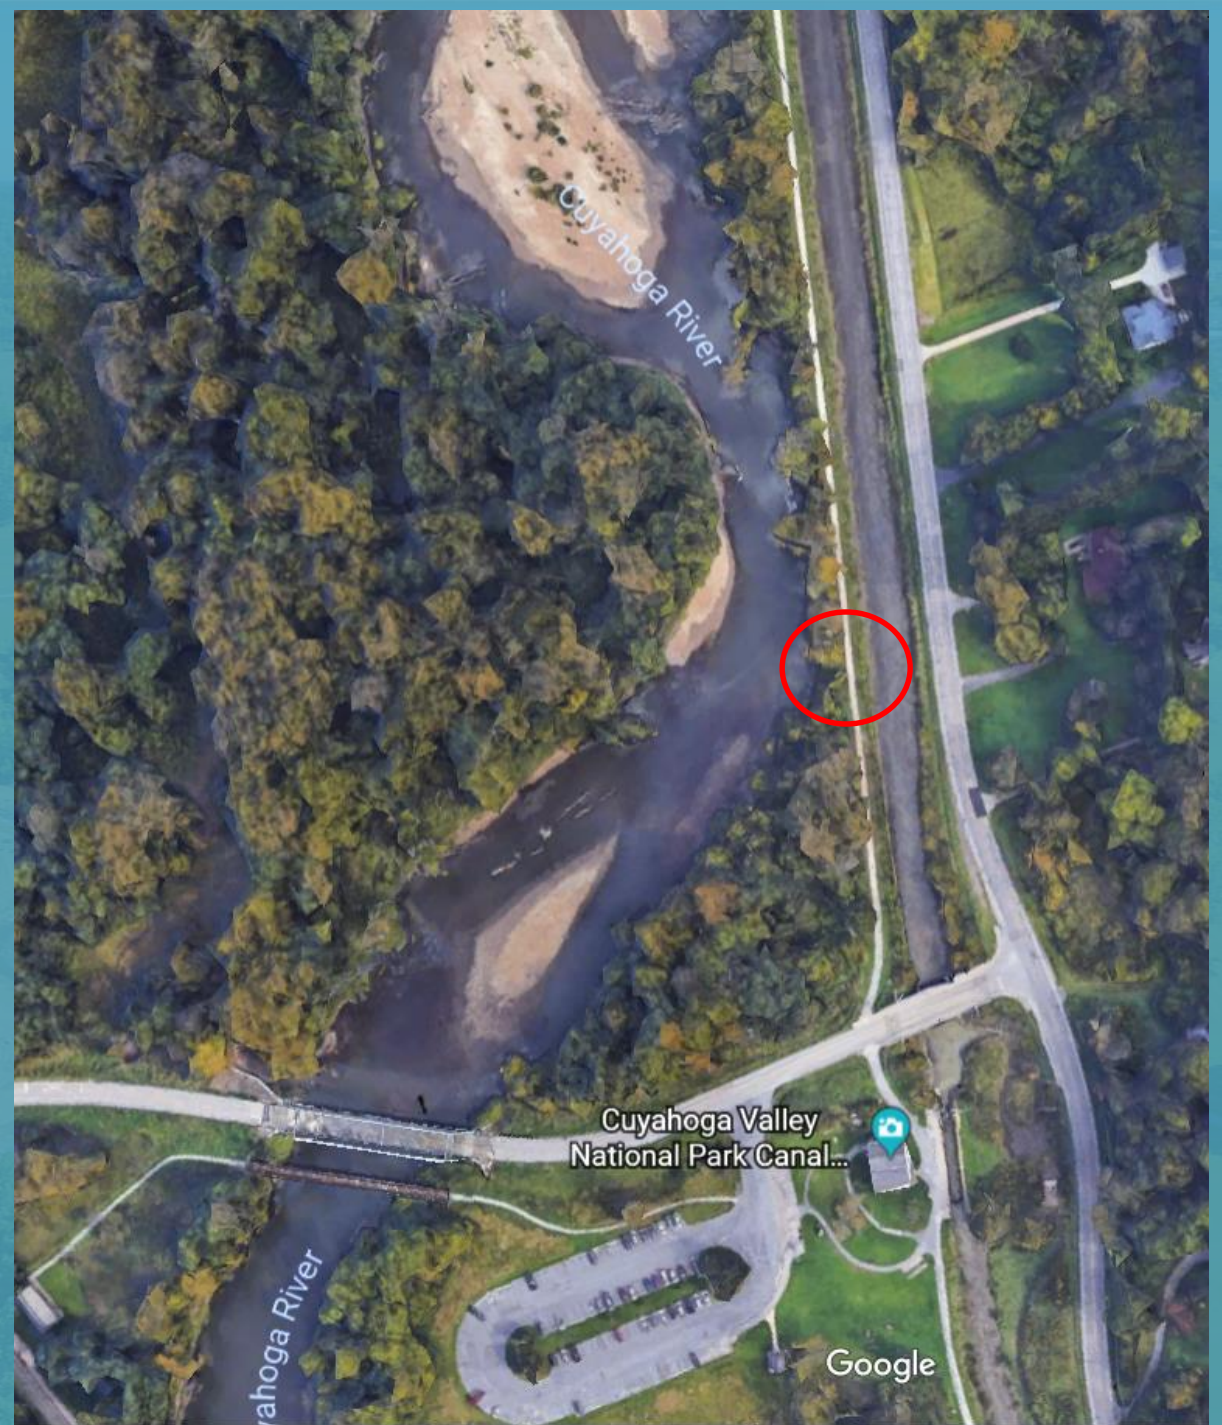
Project is located in the Cuyahoga Valley National Park

Cuyahoga River was eroding the right bank to the point of undermining the Ohio and Erie Canal Towpath Trail

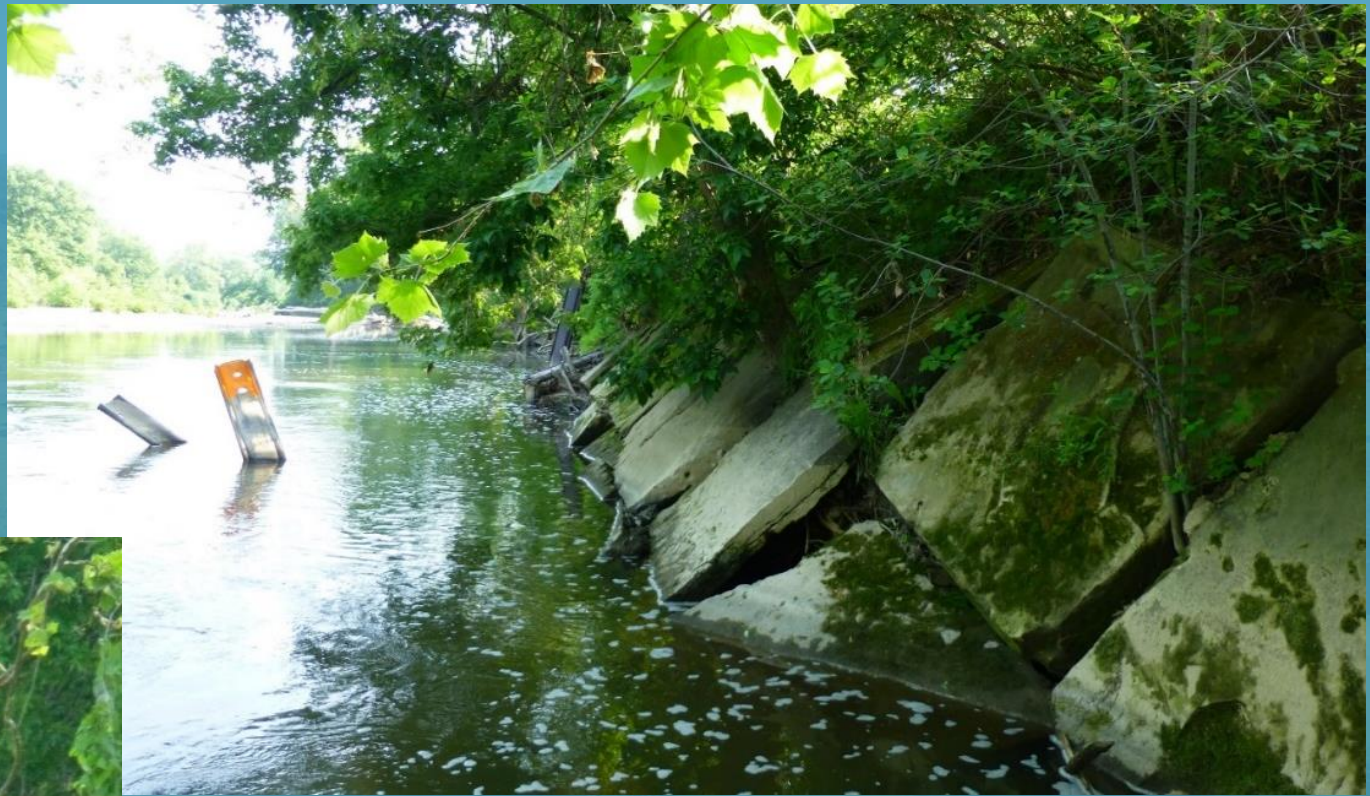
Previous Stabilization Efforts

Sandstone Sheeting

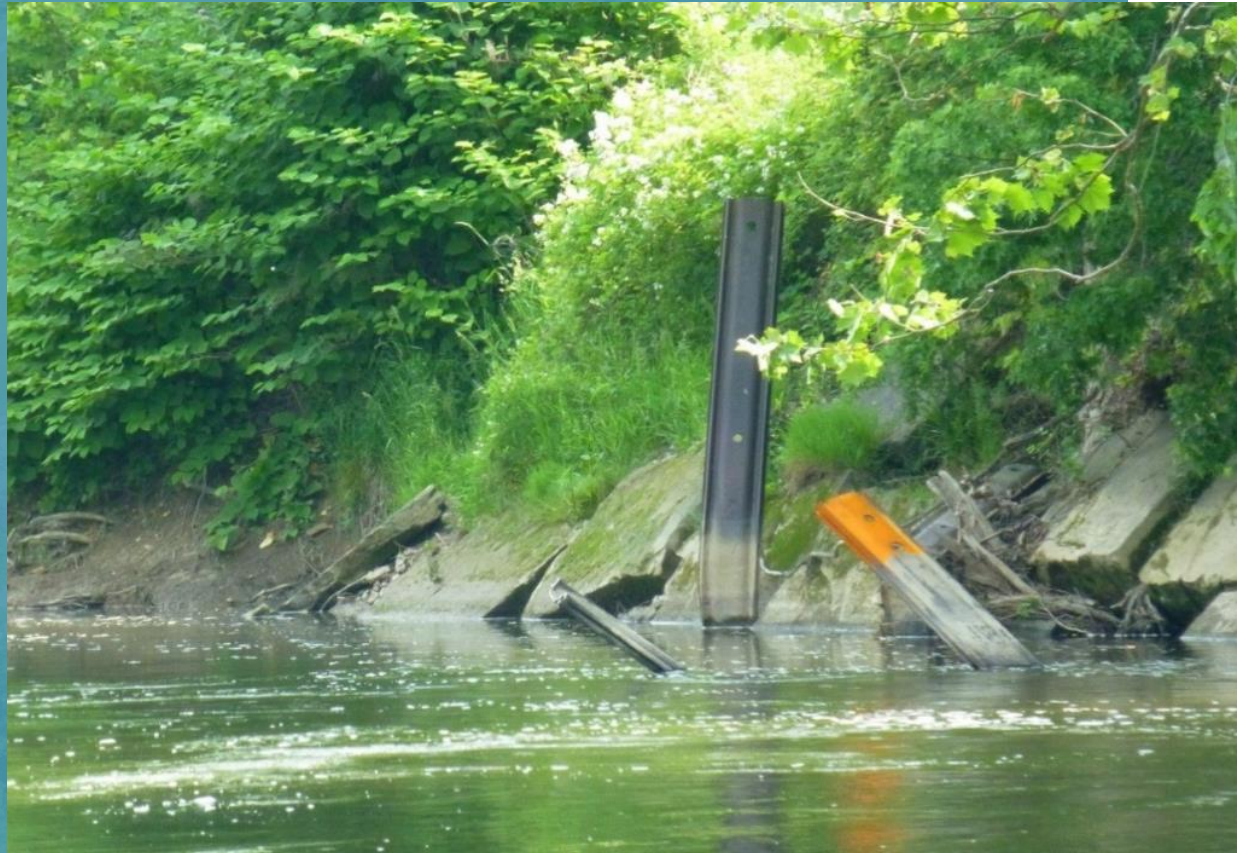
Piles

Removal of Sandstone Sheets and Piles

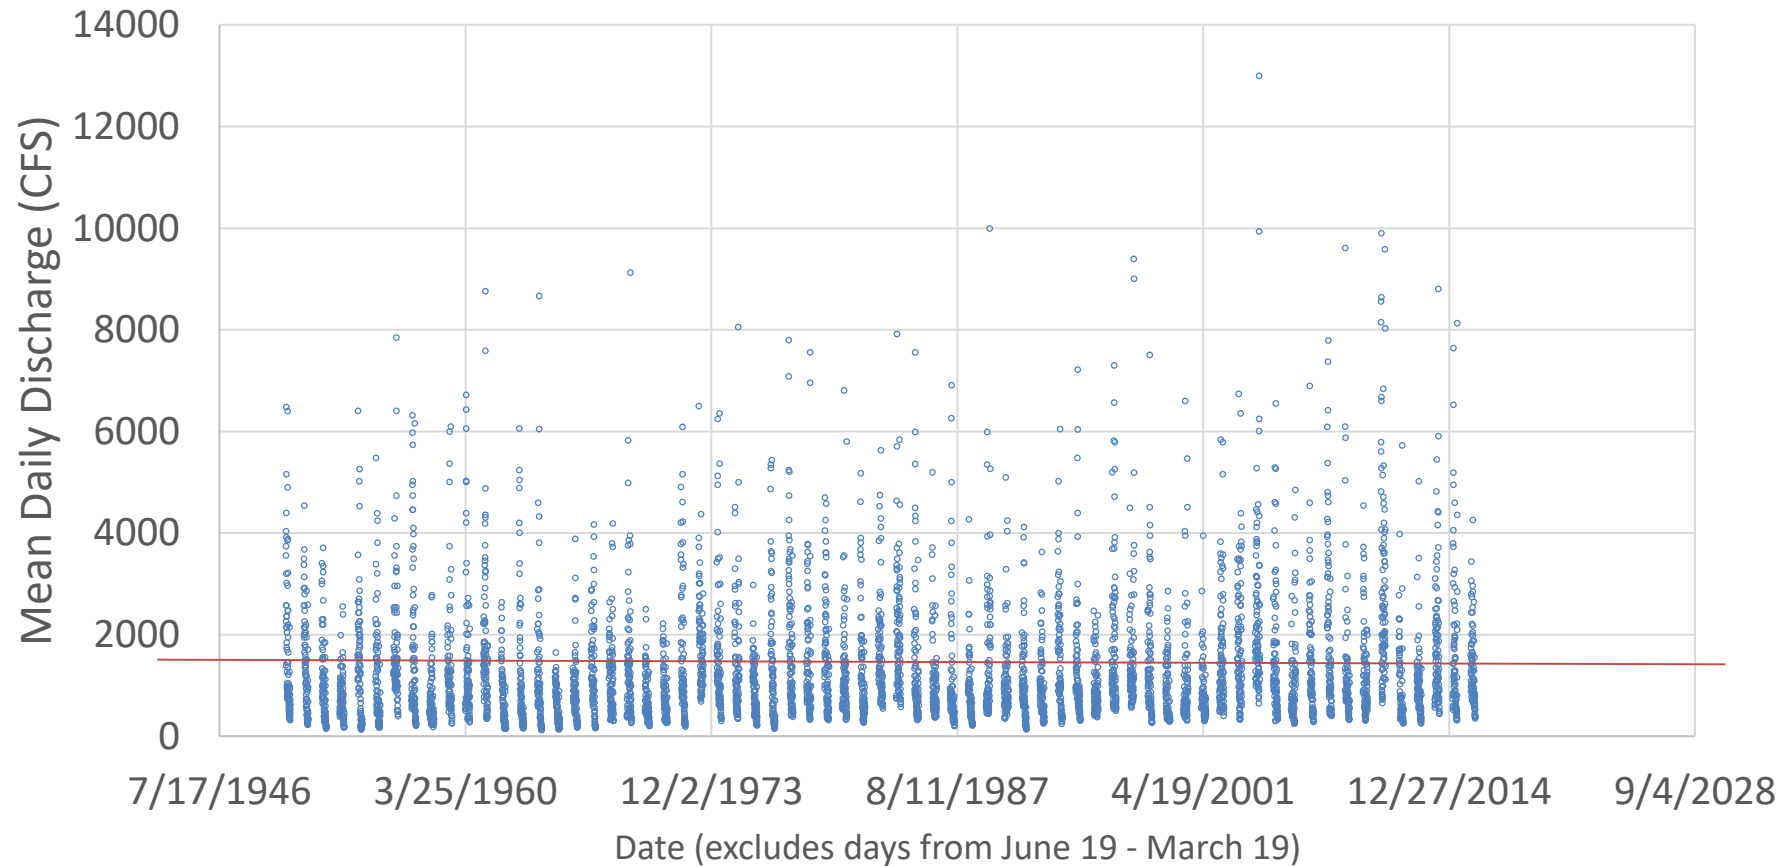
Working in the Cuyahoga River

Mean Daily Discharge by Date - Springtime Only 1950-2016

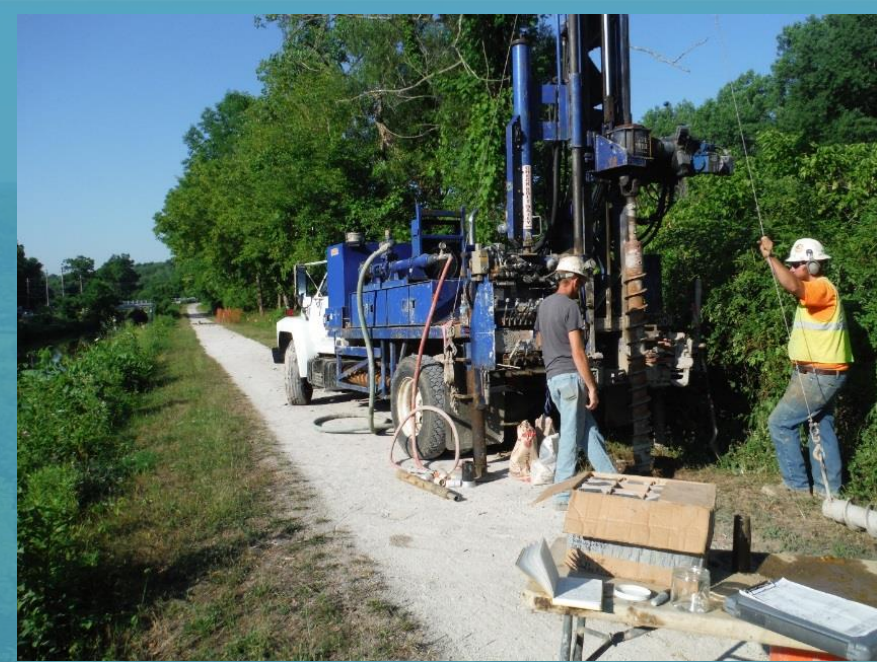
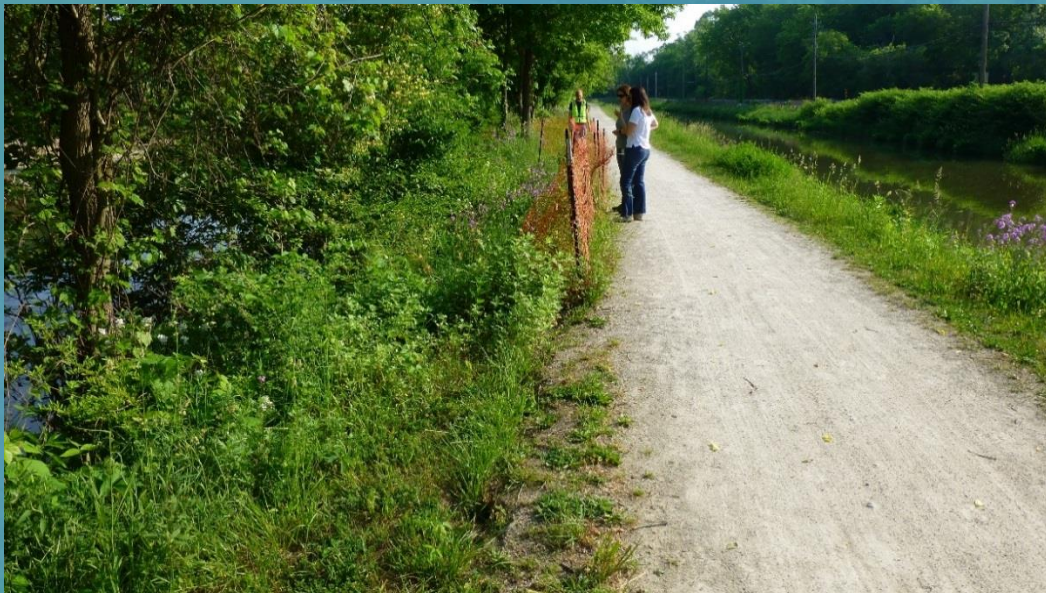
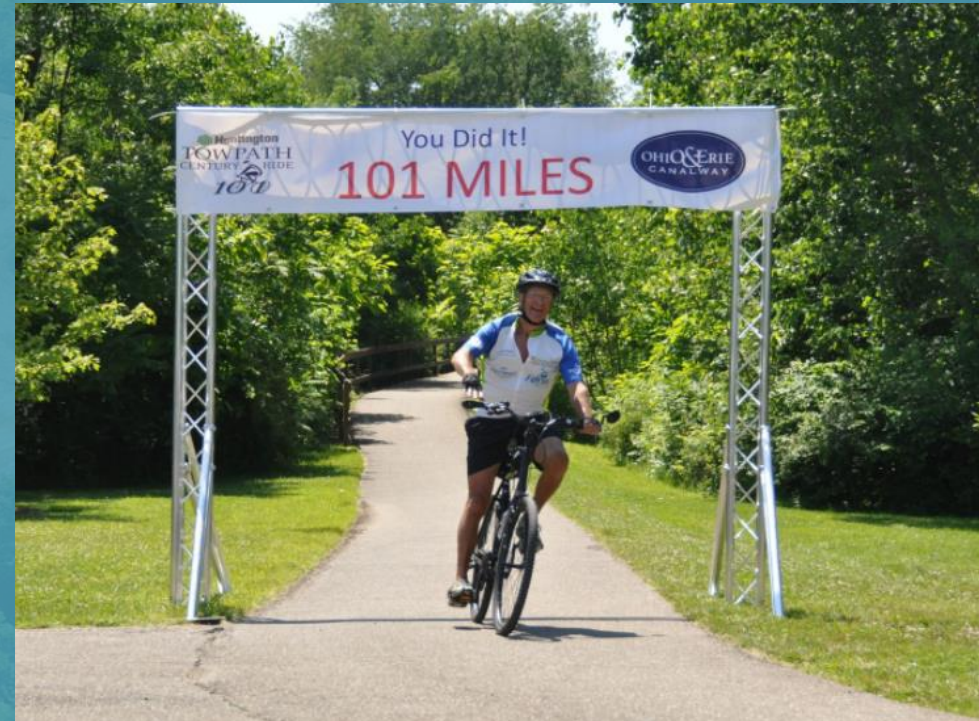
Towpath Trail Constraints

- Limited Space for equipment
- Heavily utilized recreational trail, important to minimize closures

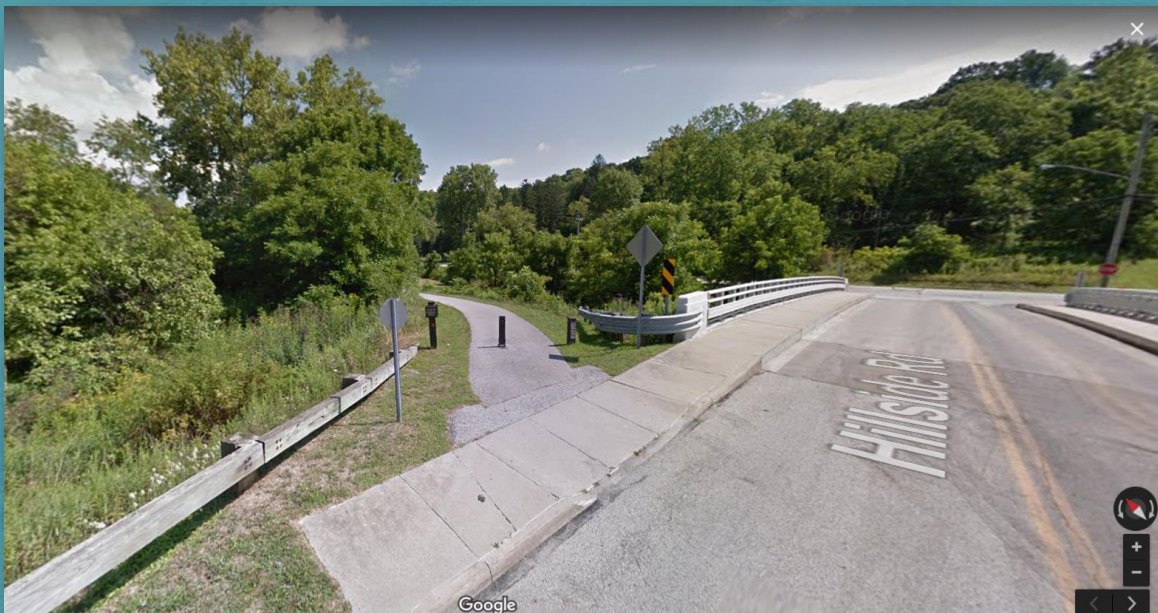
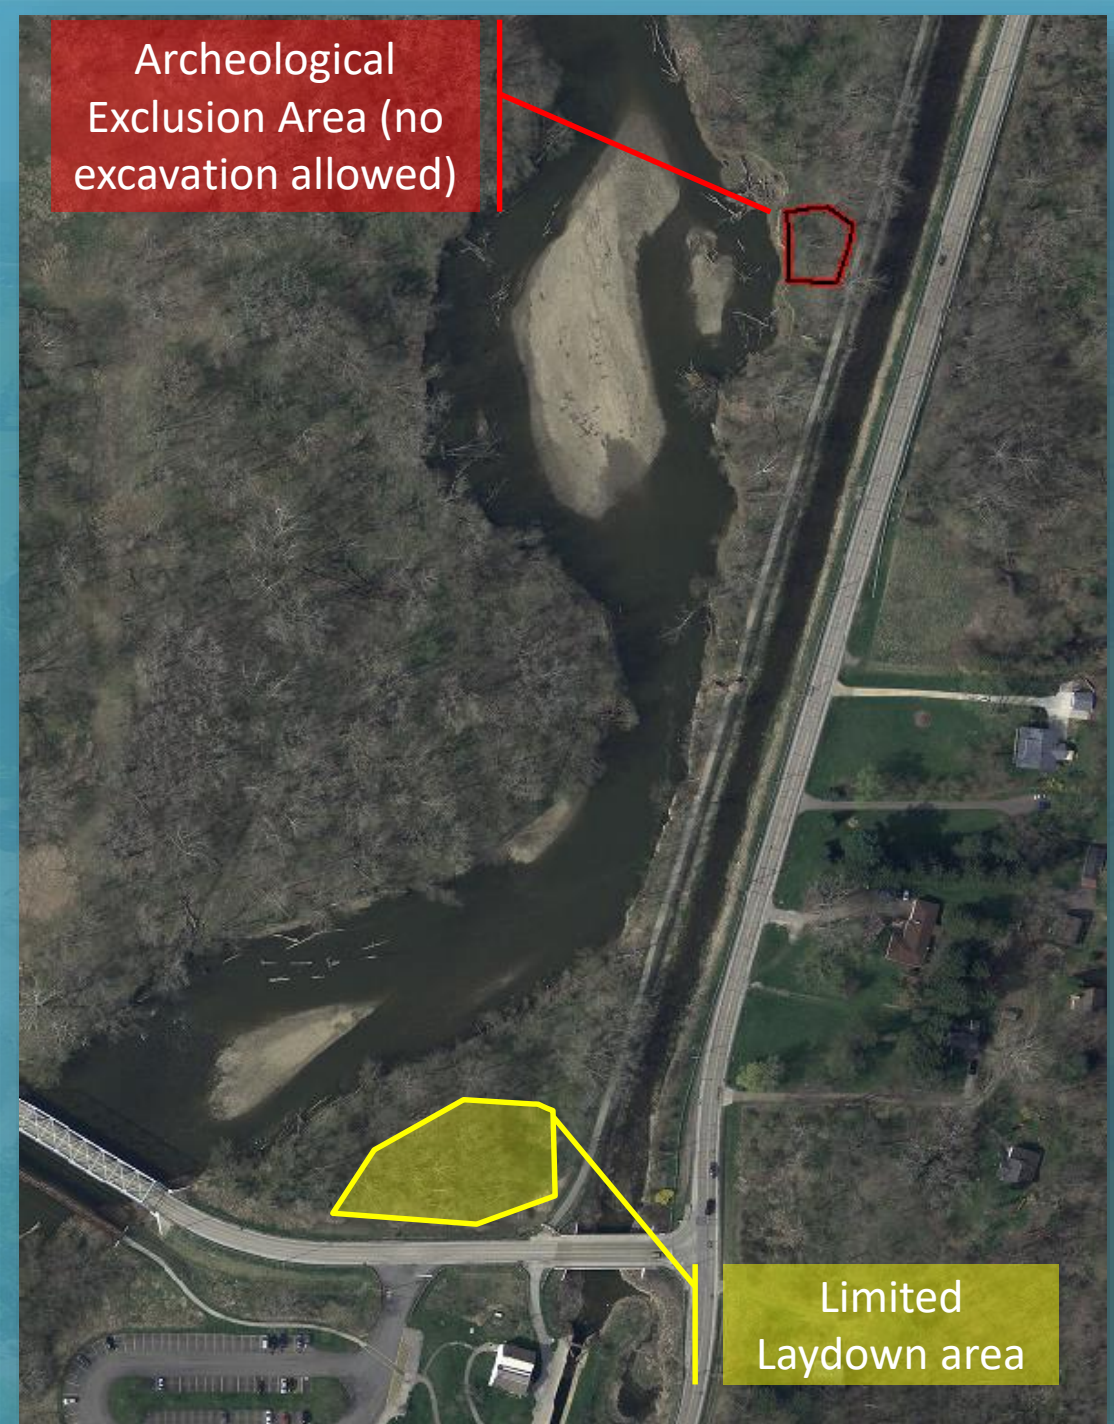
Site is Physically Constrained

- Narrow Towpath between Canal and Cuyahoga River
- Trail is heavily utilized
- Limited laydown area
- Archeological Exclusion Area
- Load limits on Hillside, Canal Road, Towpath

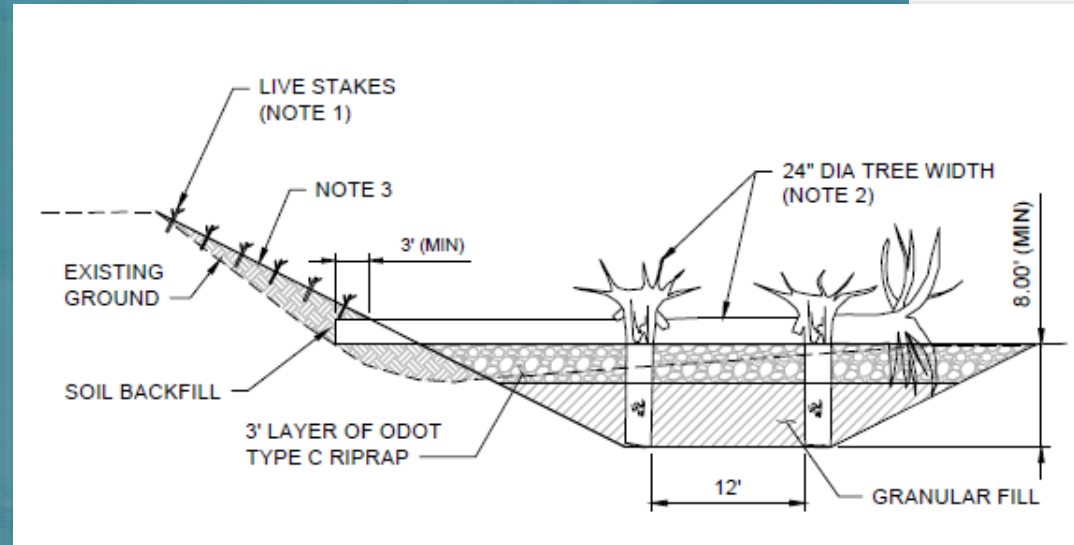
Pilot natural stabilization method selected in downstream, less critical area:

Large, woody debris structures:

H: 24" dia., 36'-40' long with root wad intact

V: 24" dia., 12'-14' long

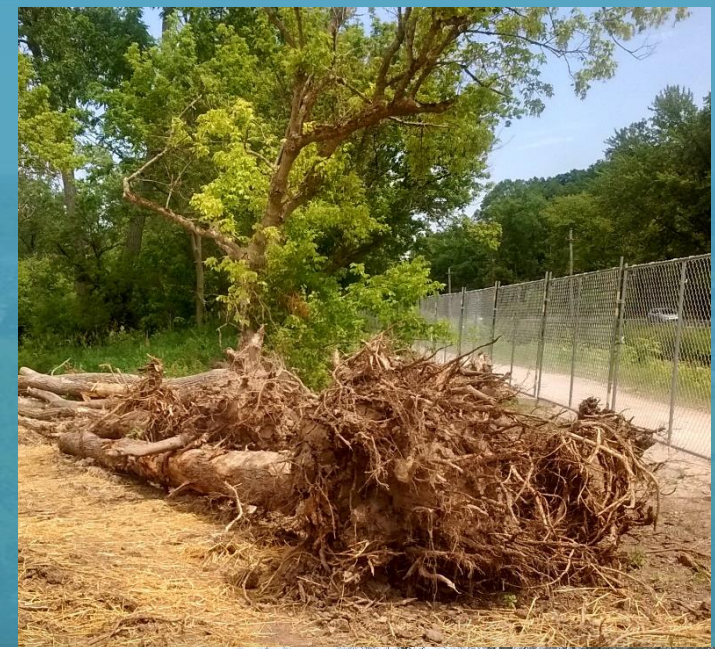
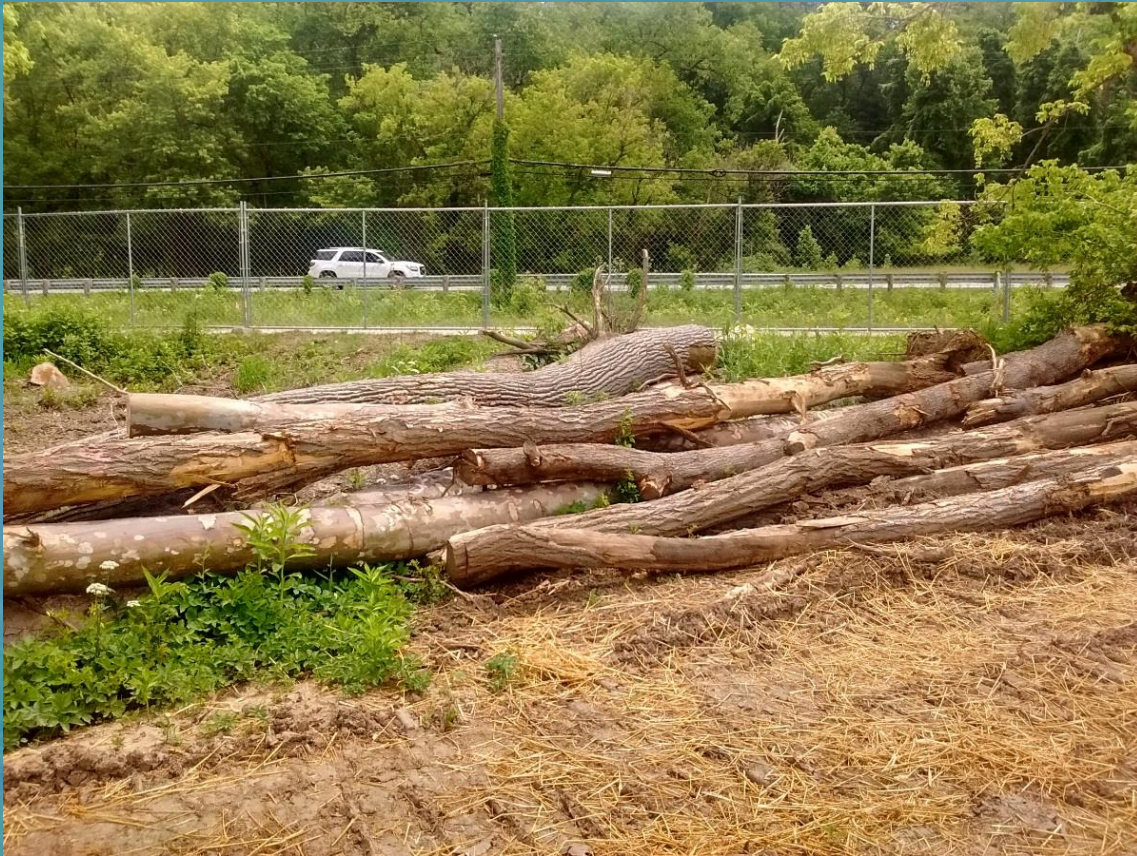
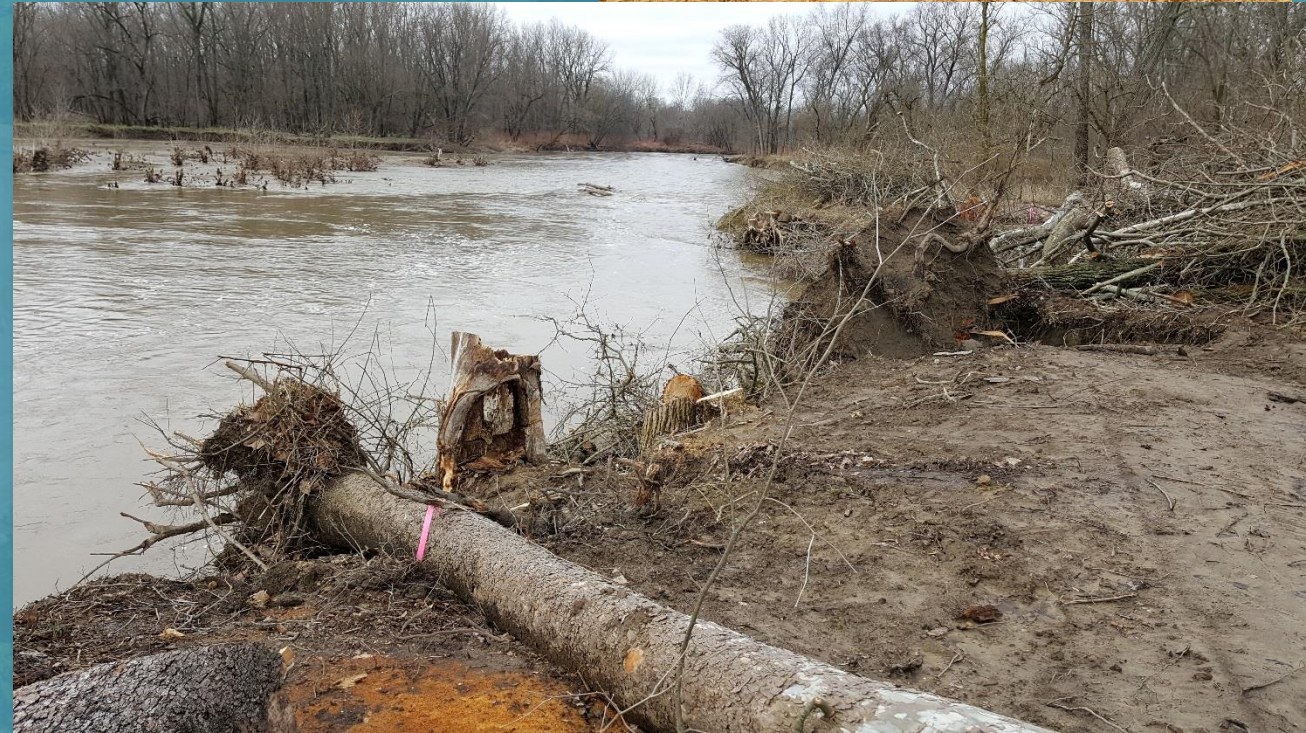
On-Site Trees used for LWD Structures

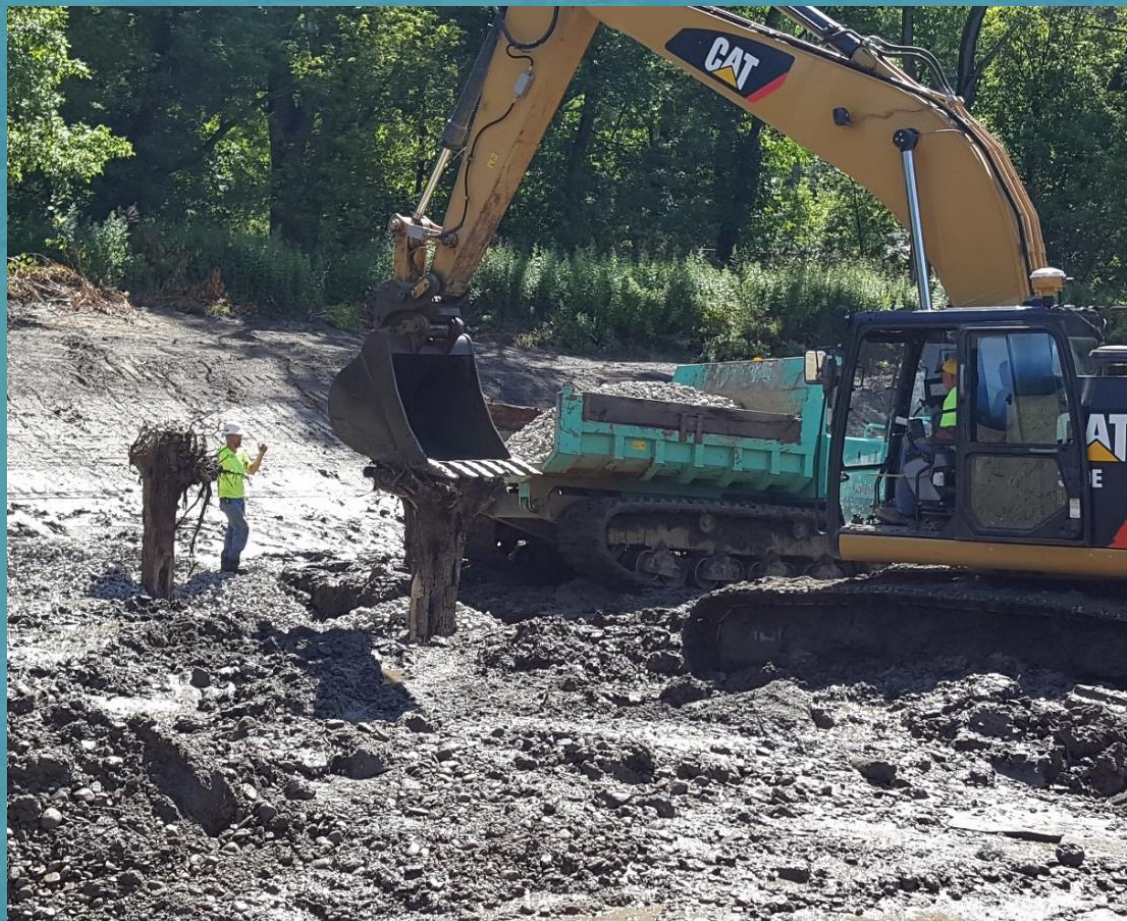
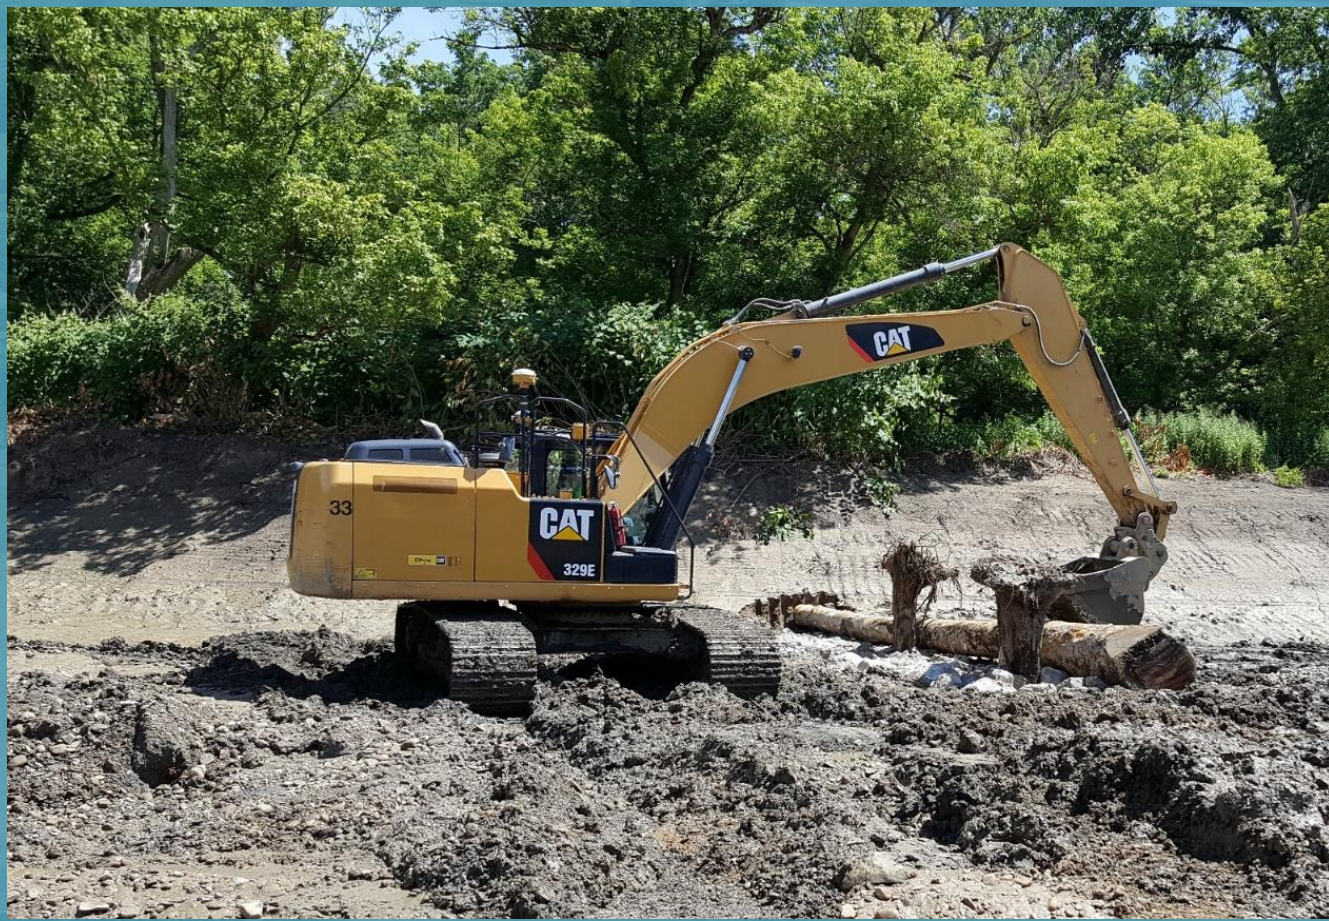
LWD Structures Installation

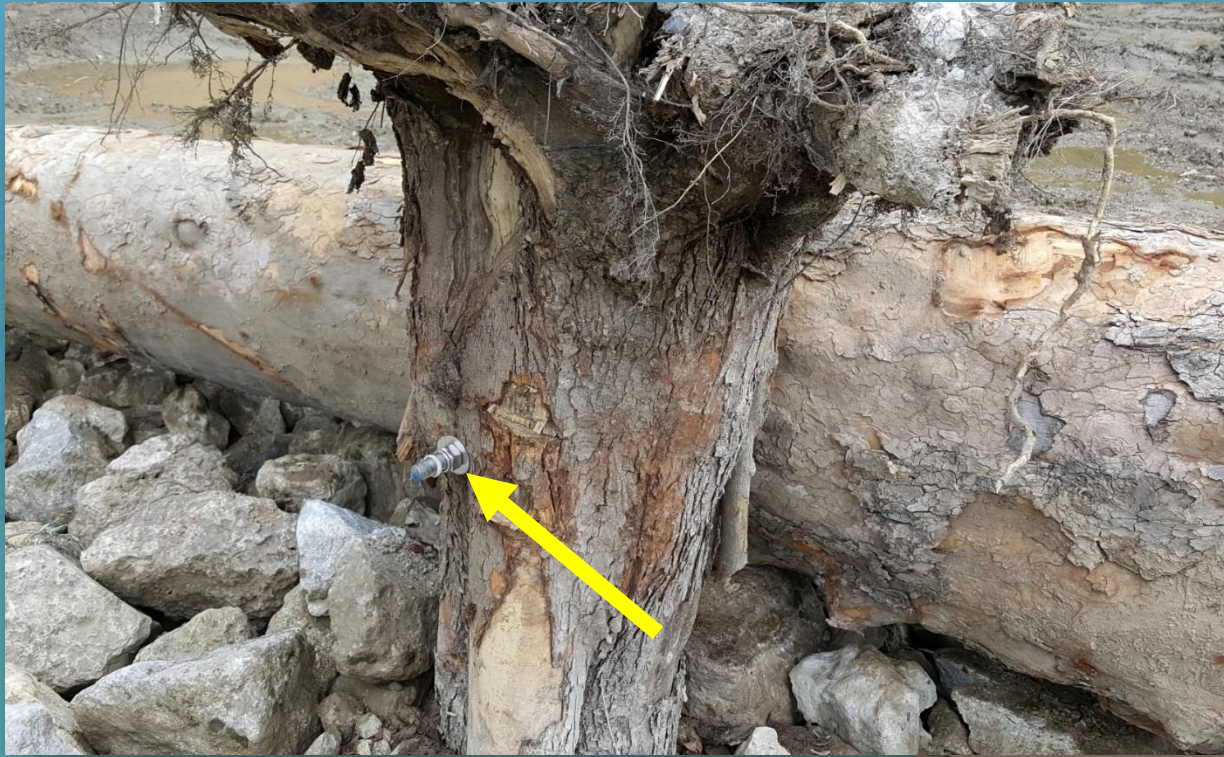
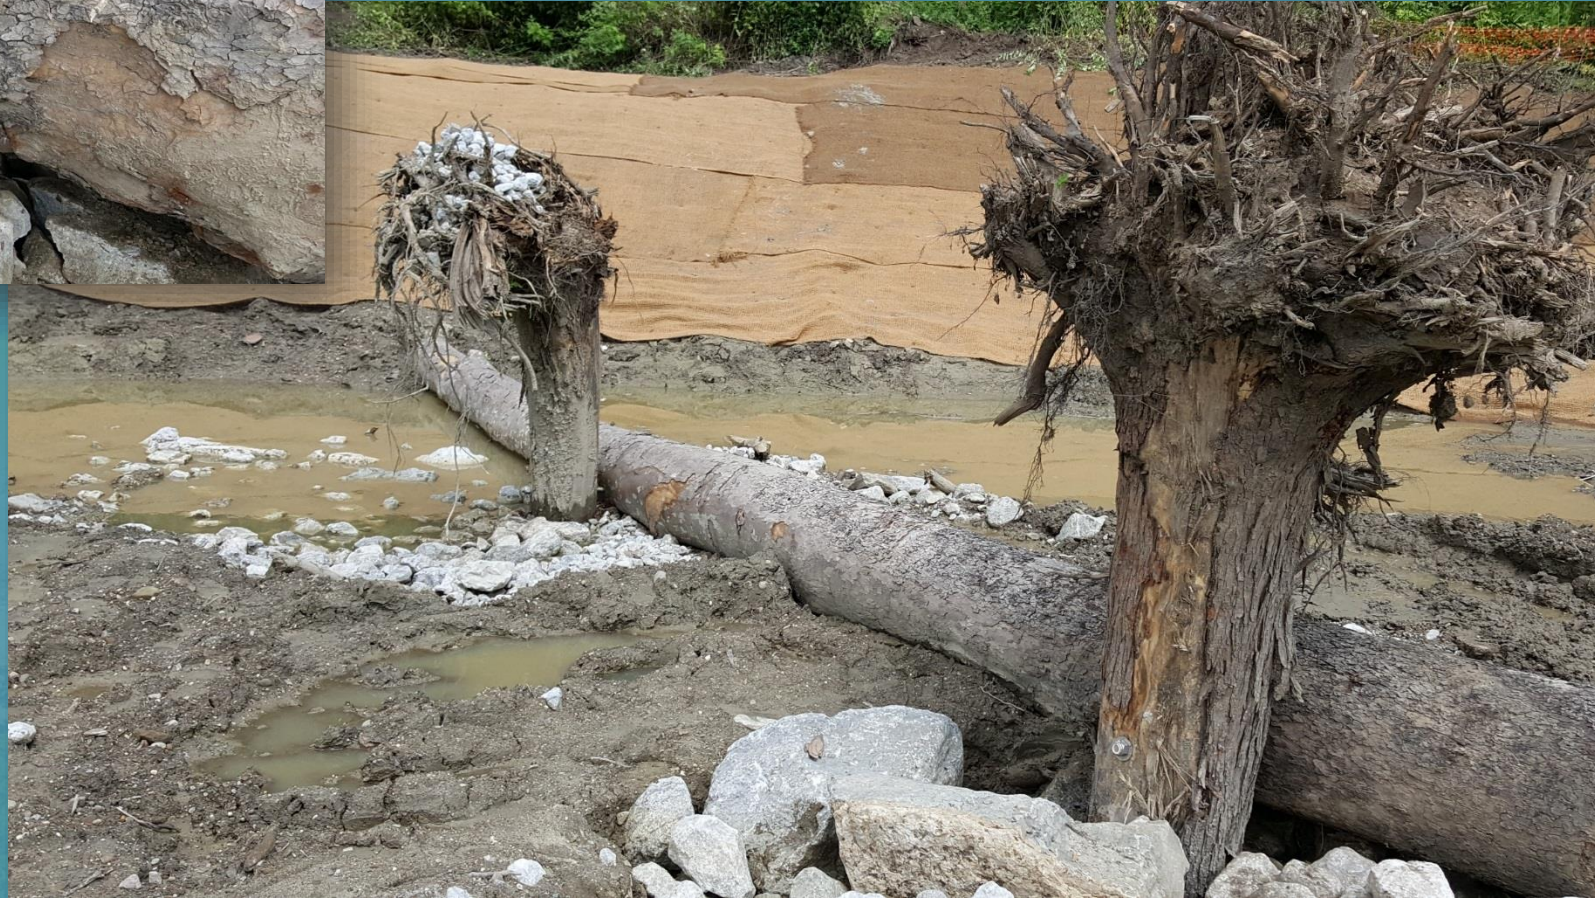
LWD Structures Installation
