Stabilization Along the Cuyahoga River: Avoiding a “Tow Away Zone”

*Kristen Buccier, NEORSD
Shannon Conway, Stantec*

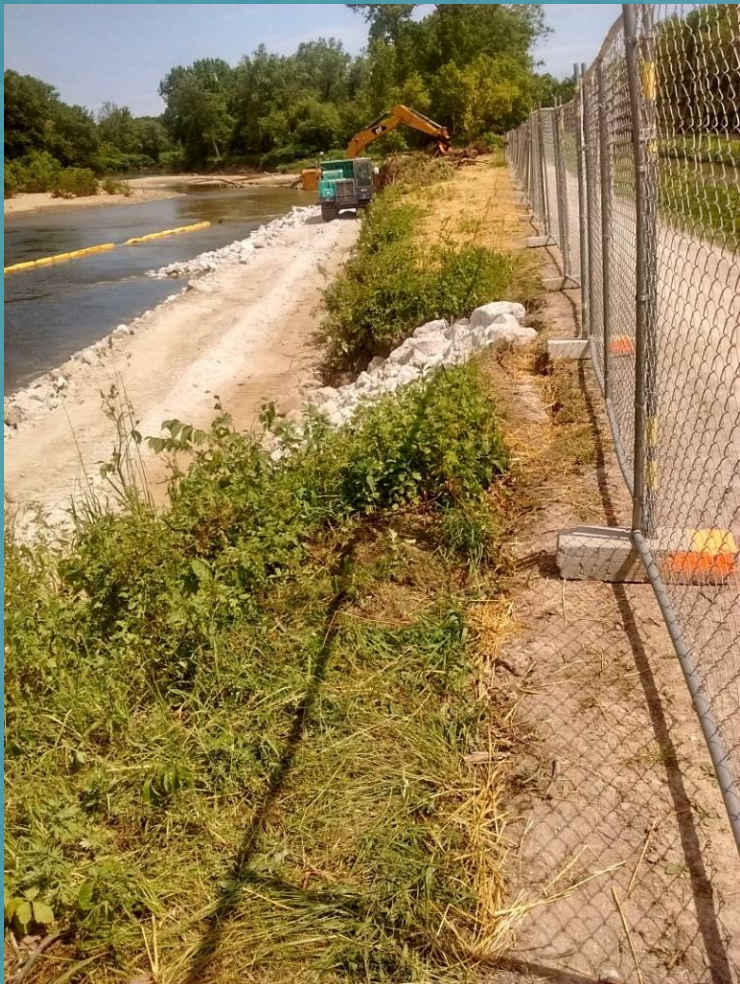
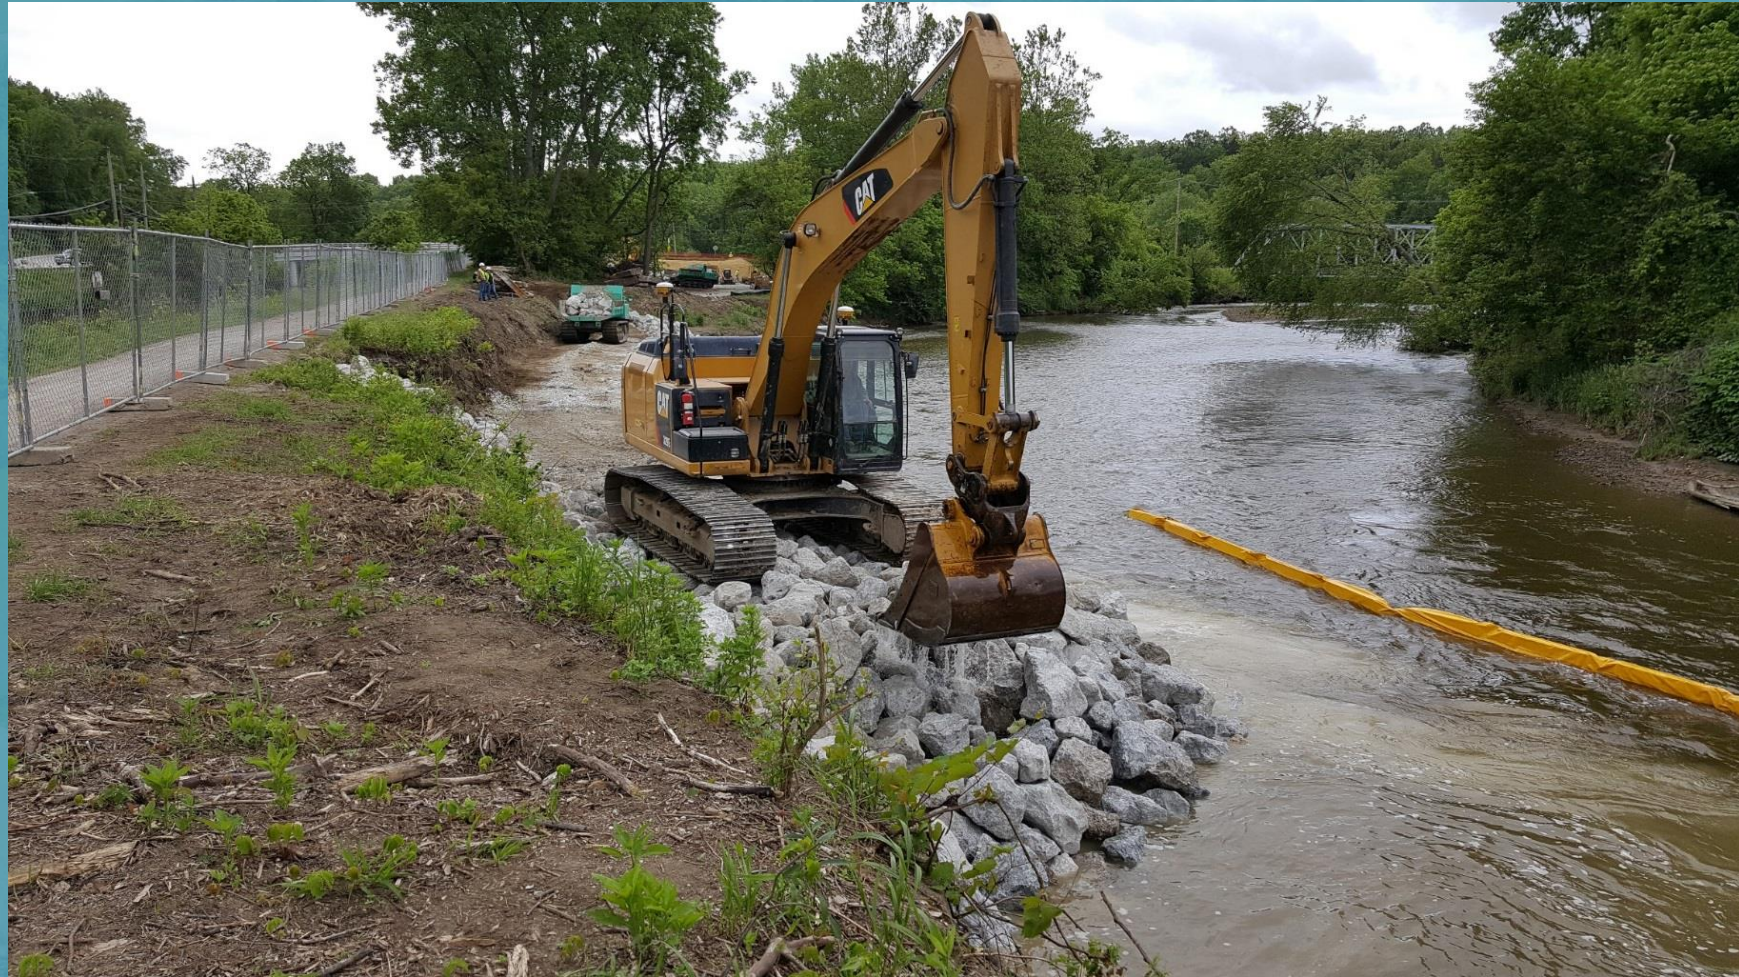
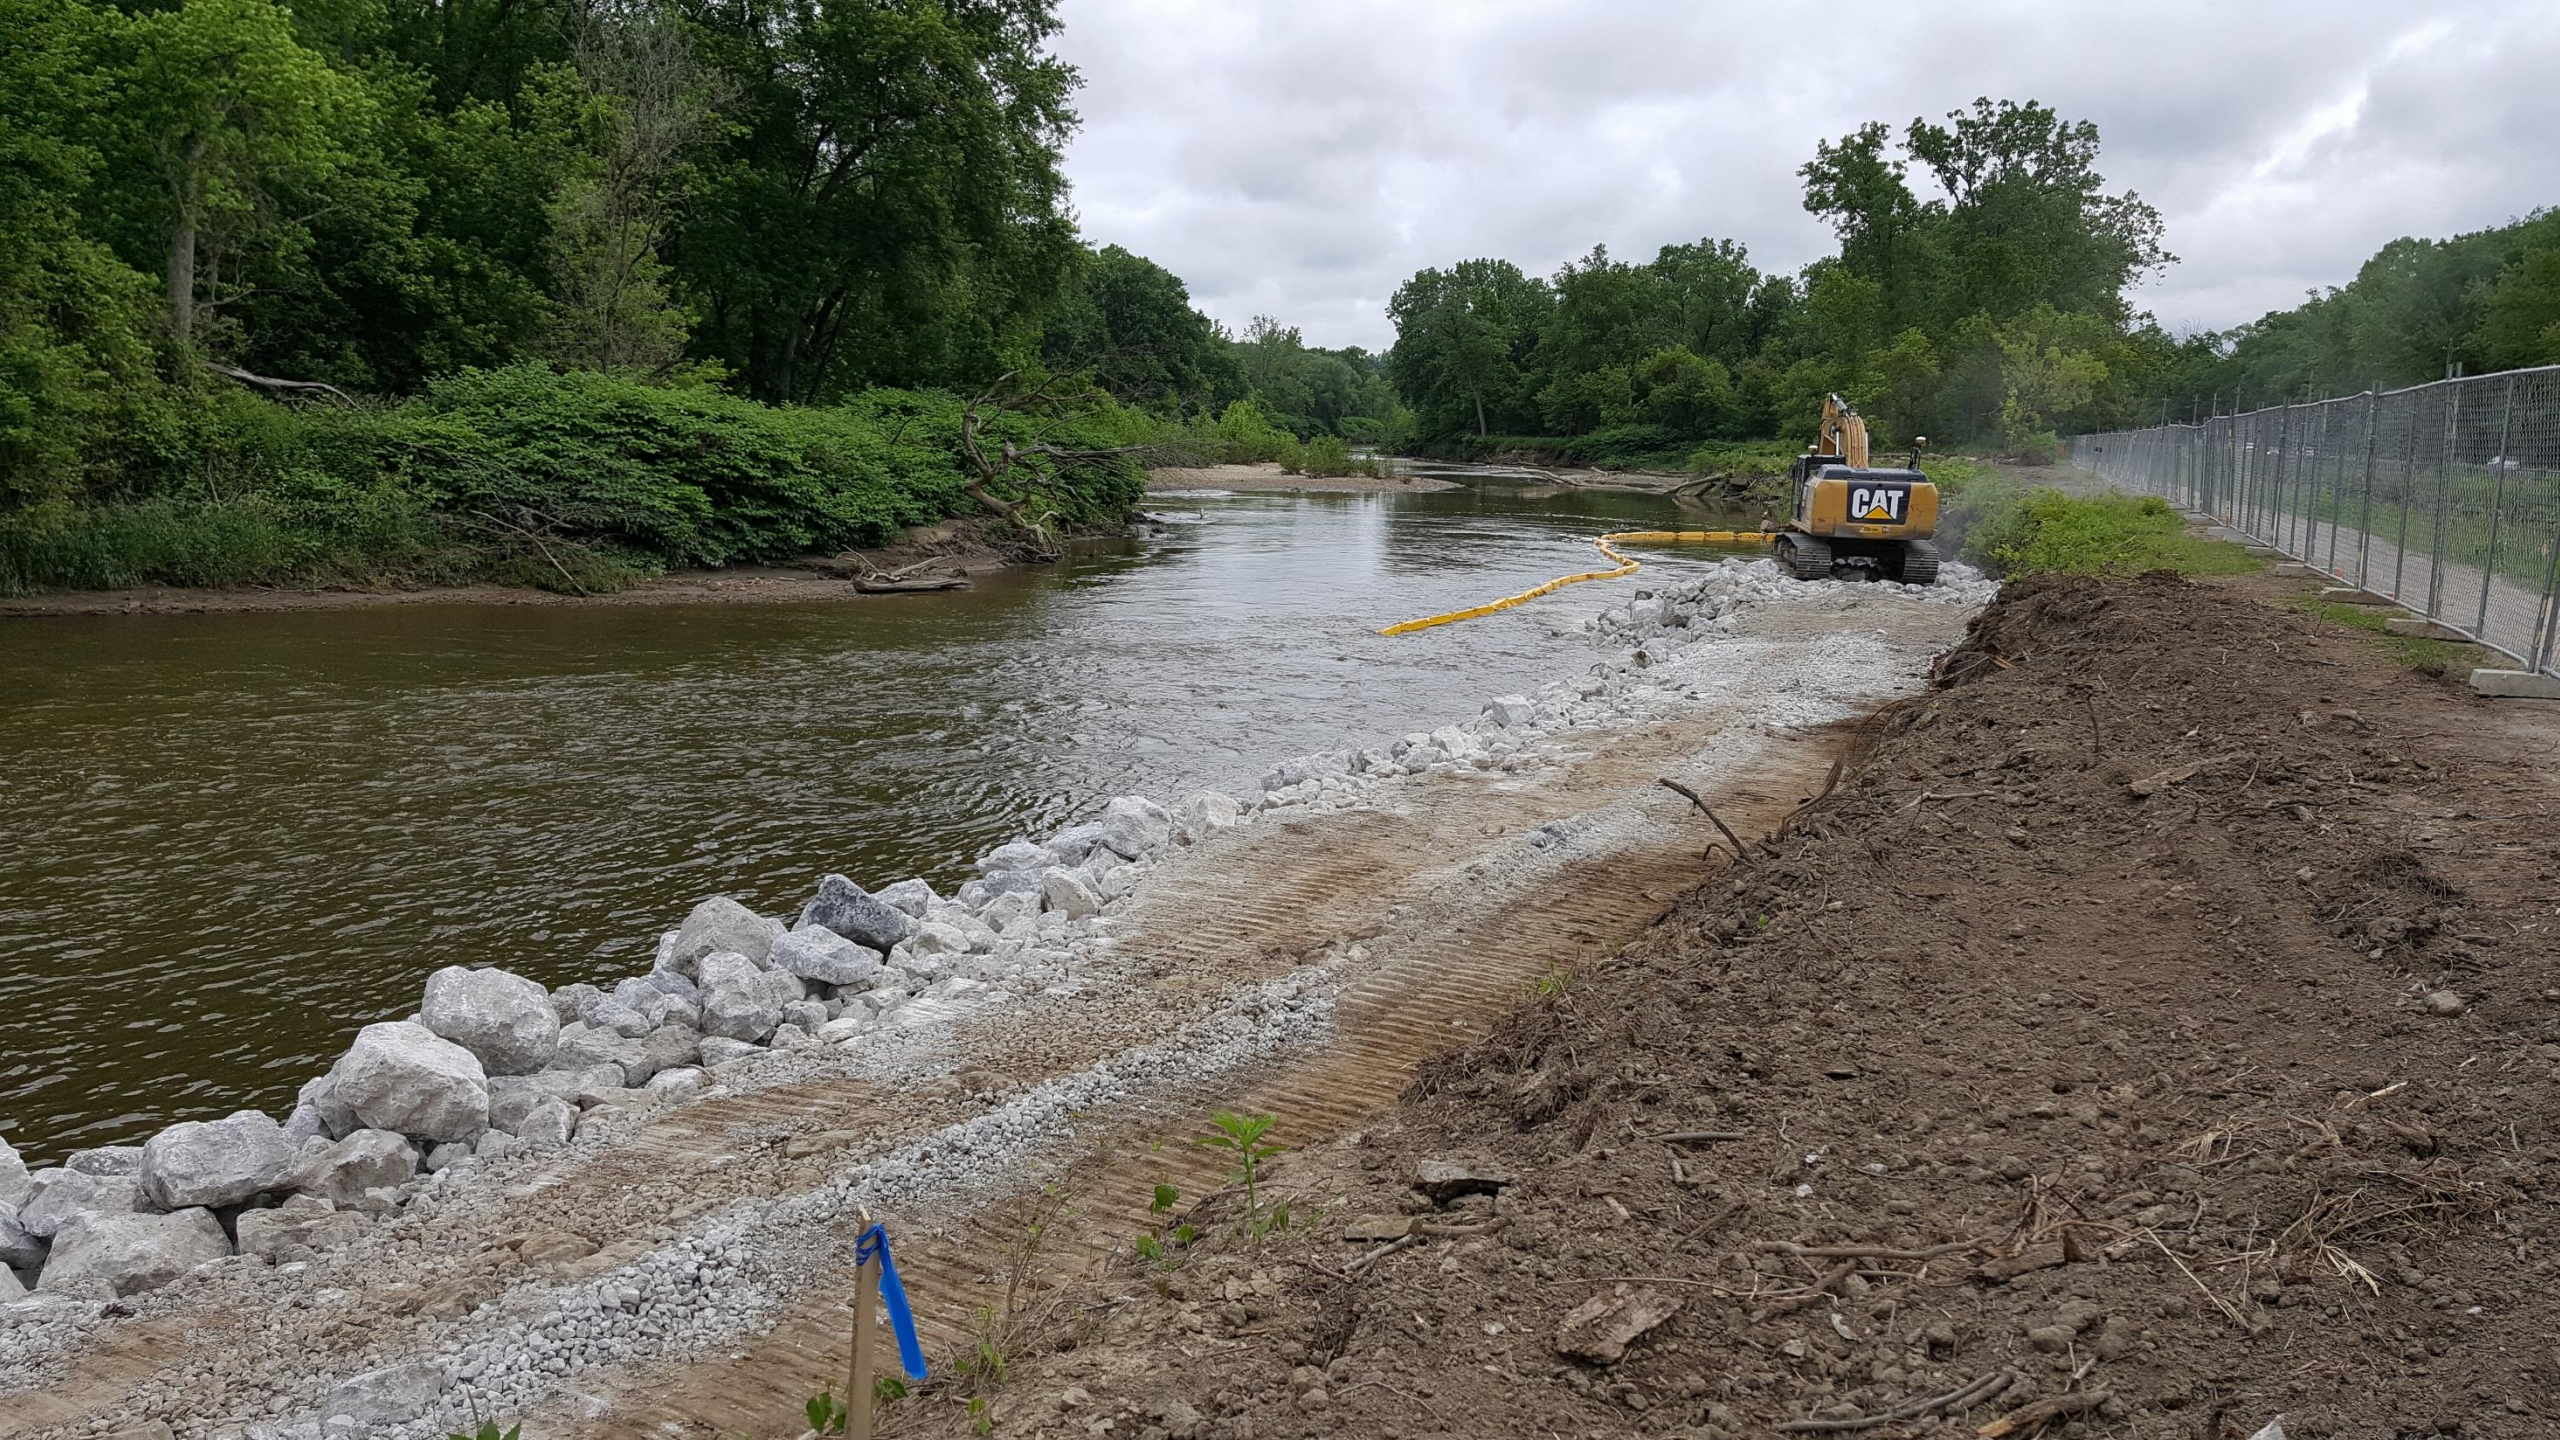
Contractor's Site Access Approach to Minimize Towpath Trail Closures

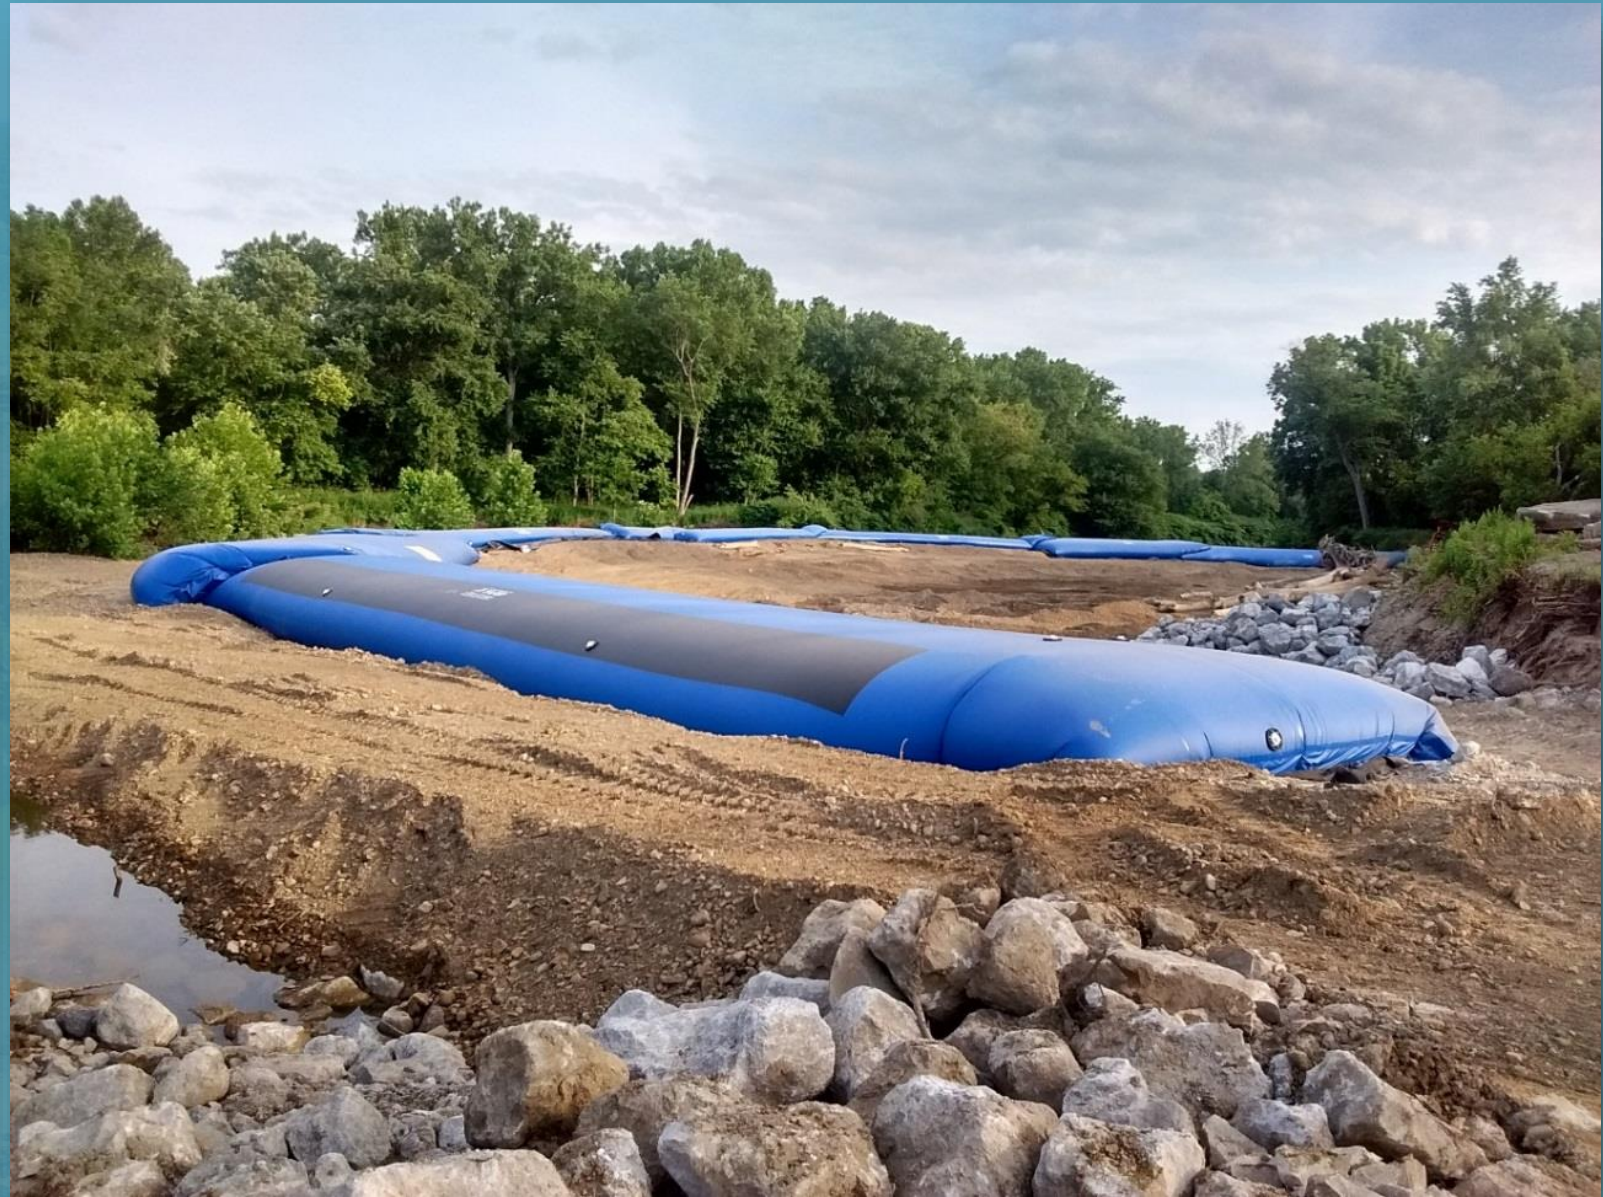
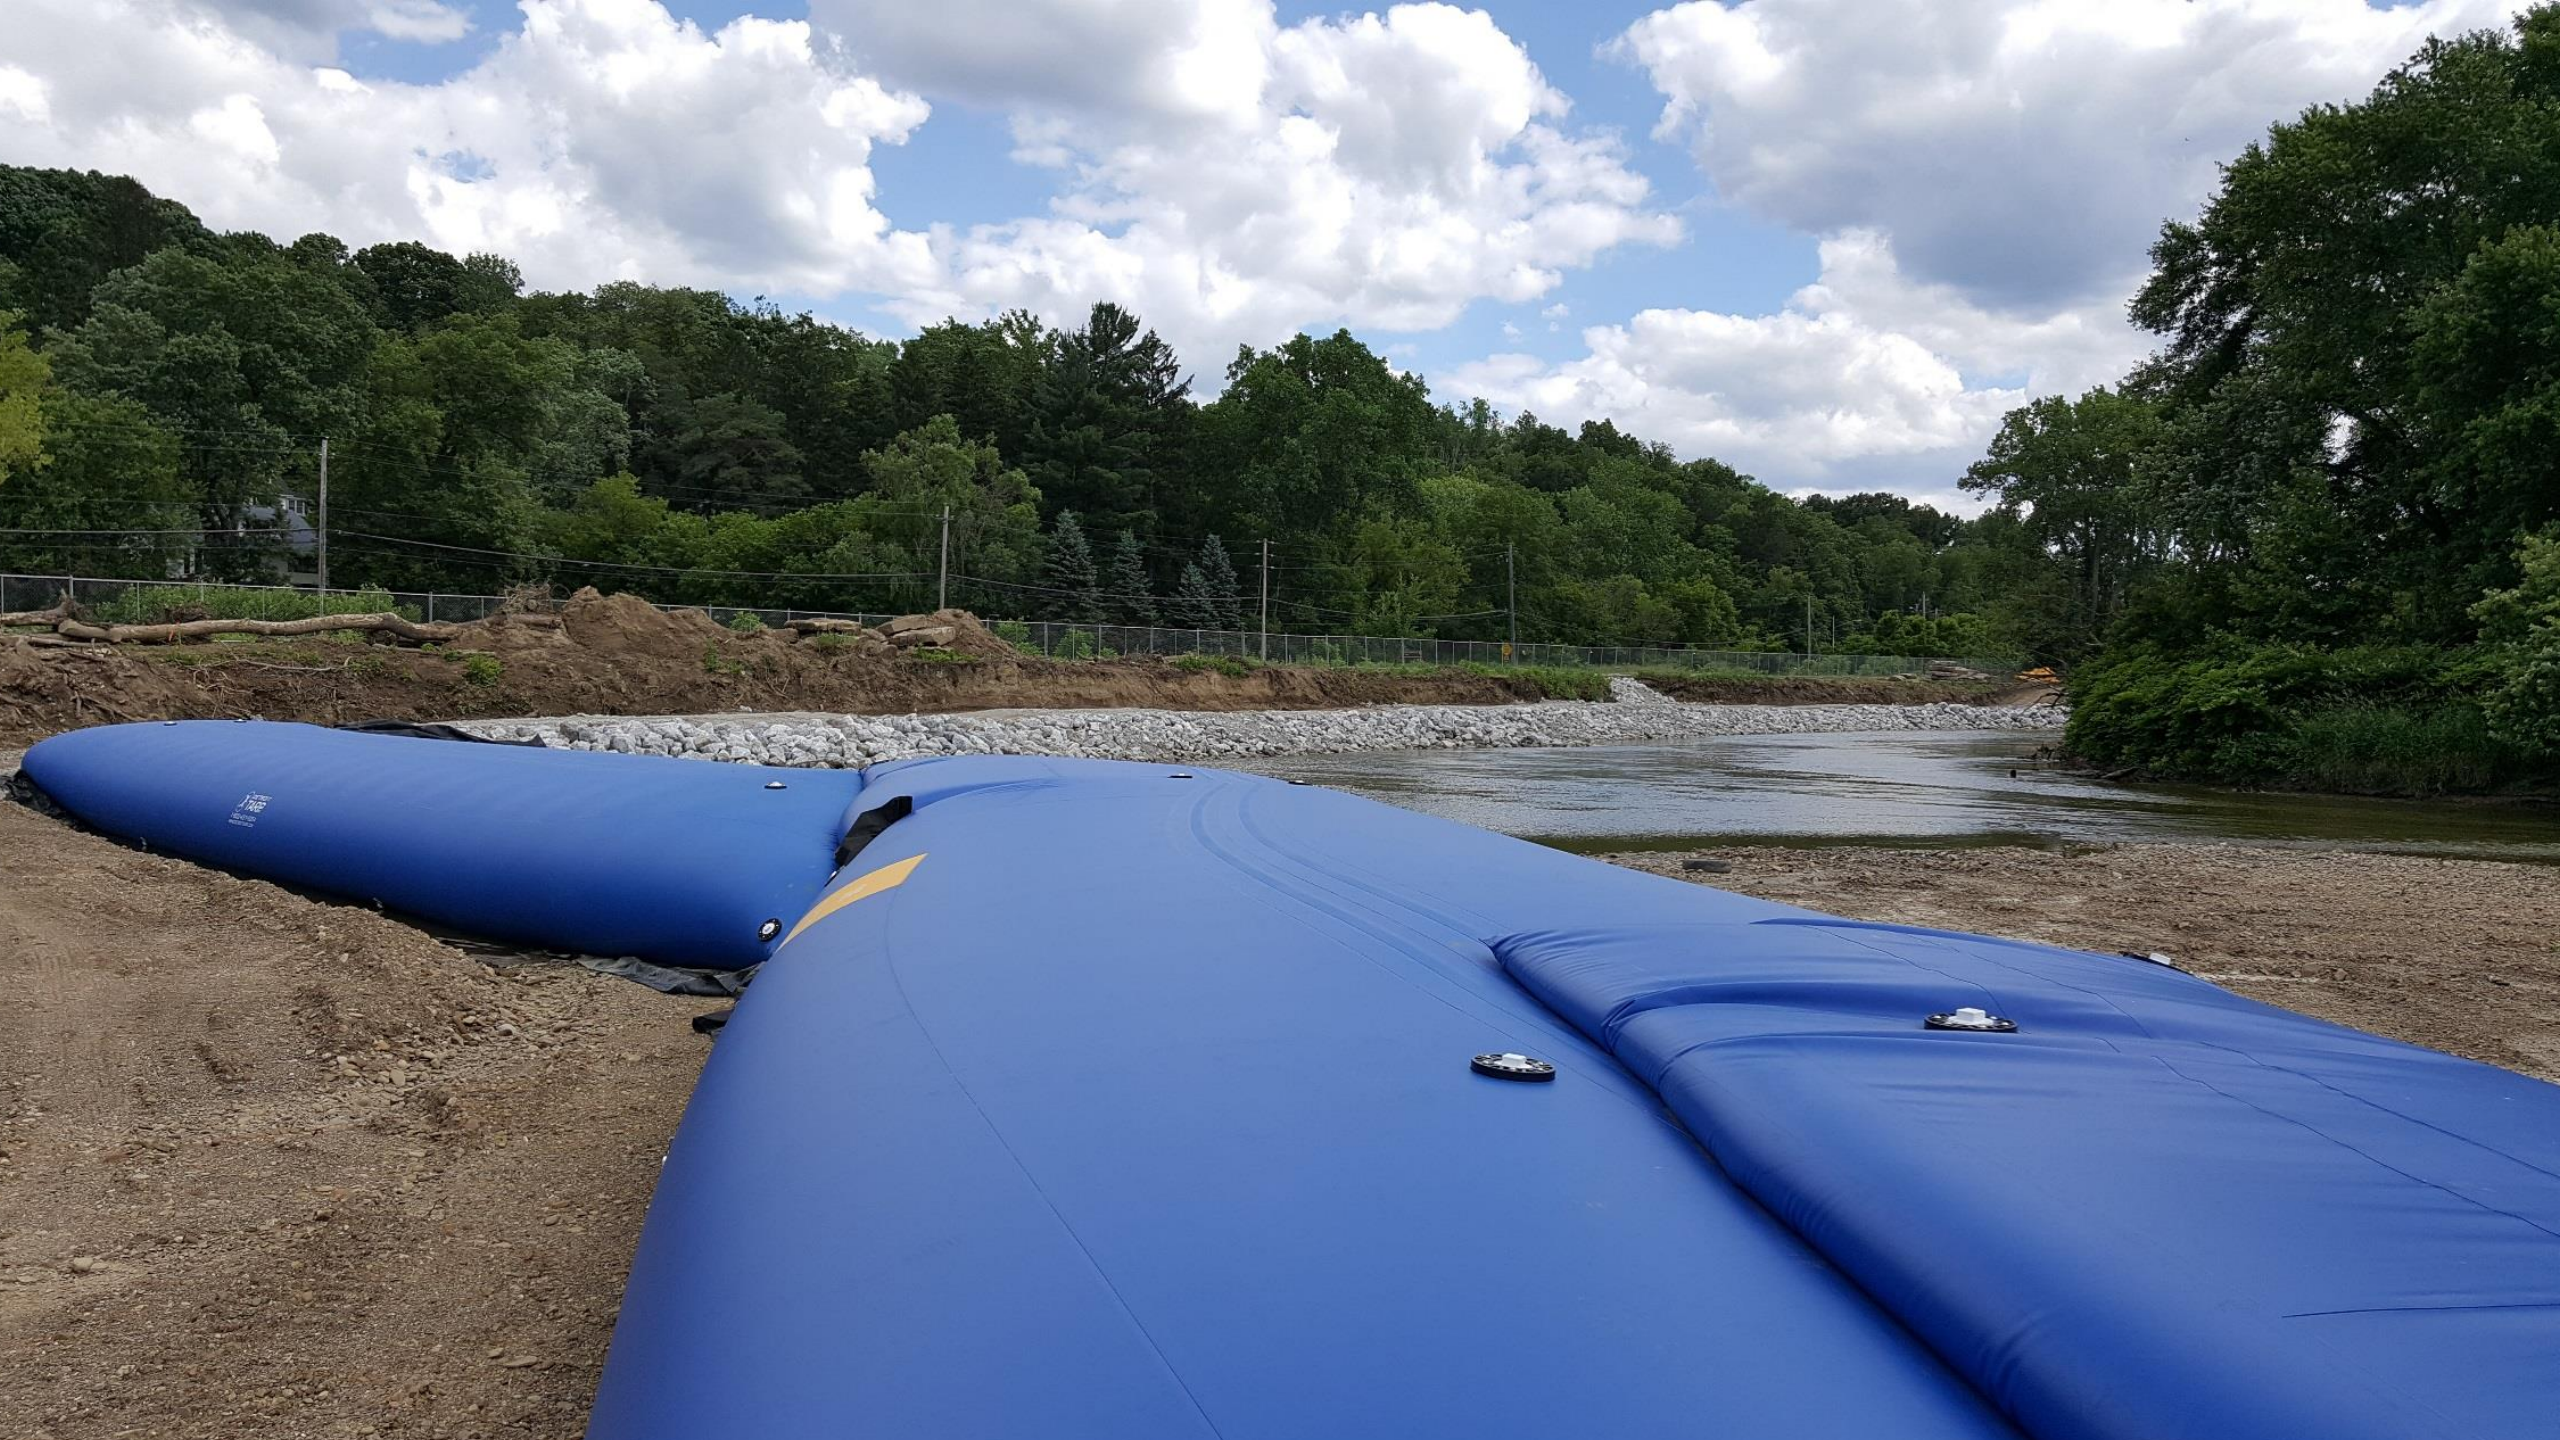
Inflatable Cofferddam Used for Installation of LWD Structures

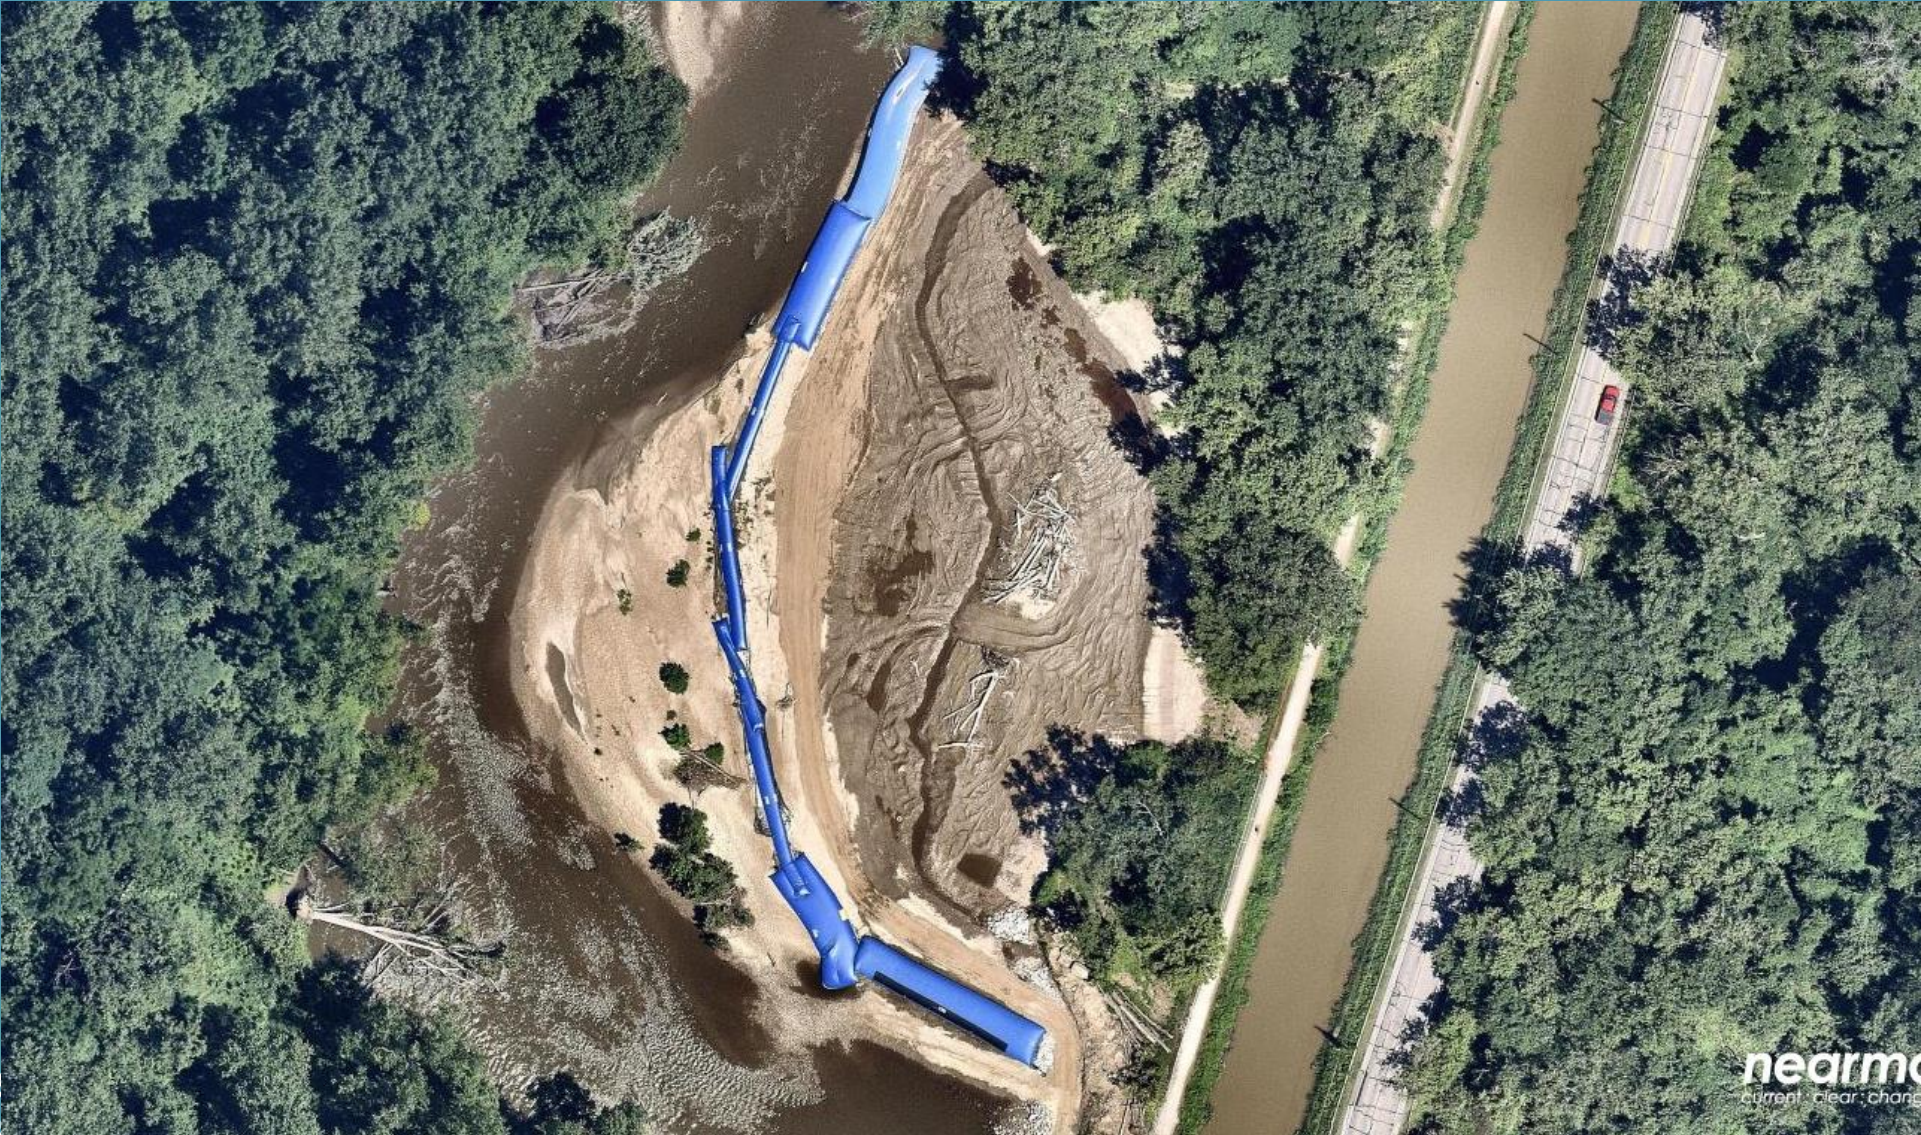
Cofferdam around Large Woody Debris Installation

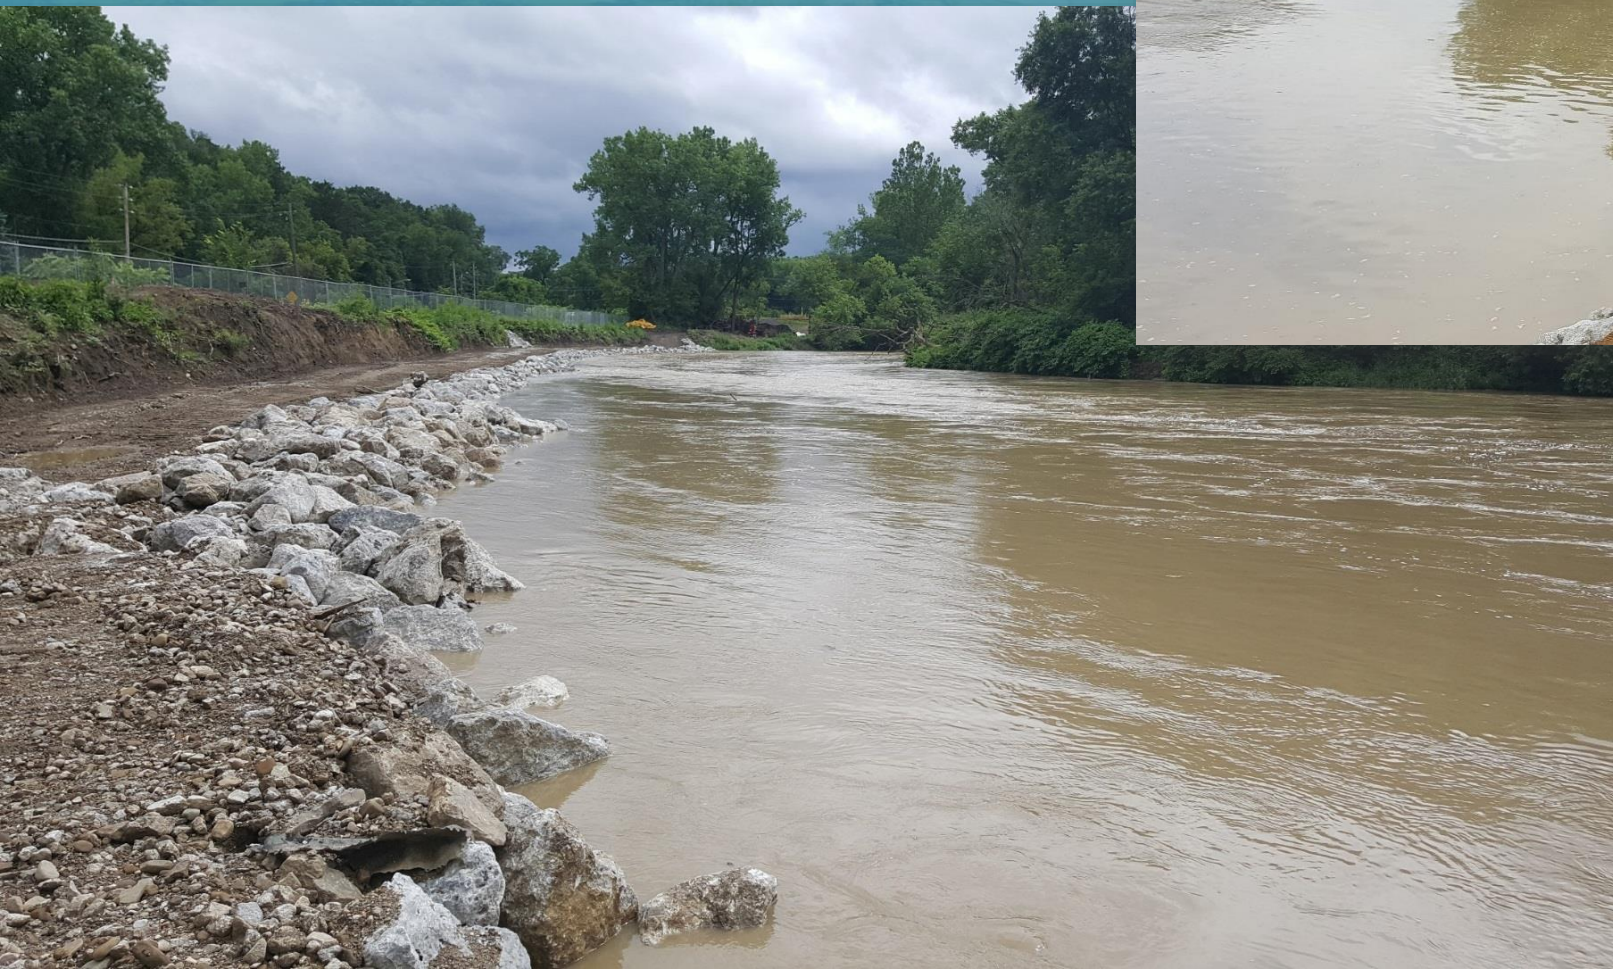
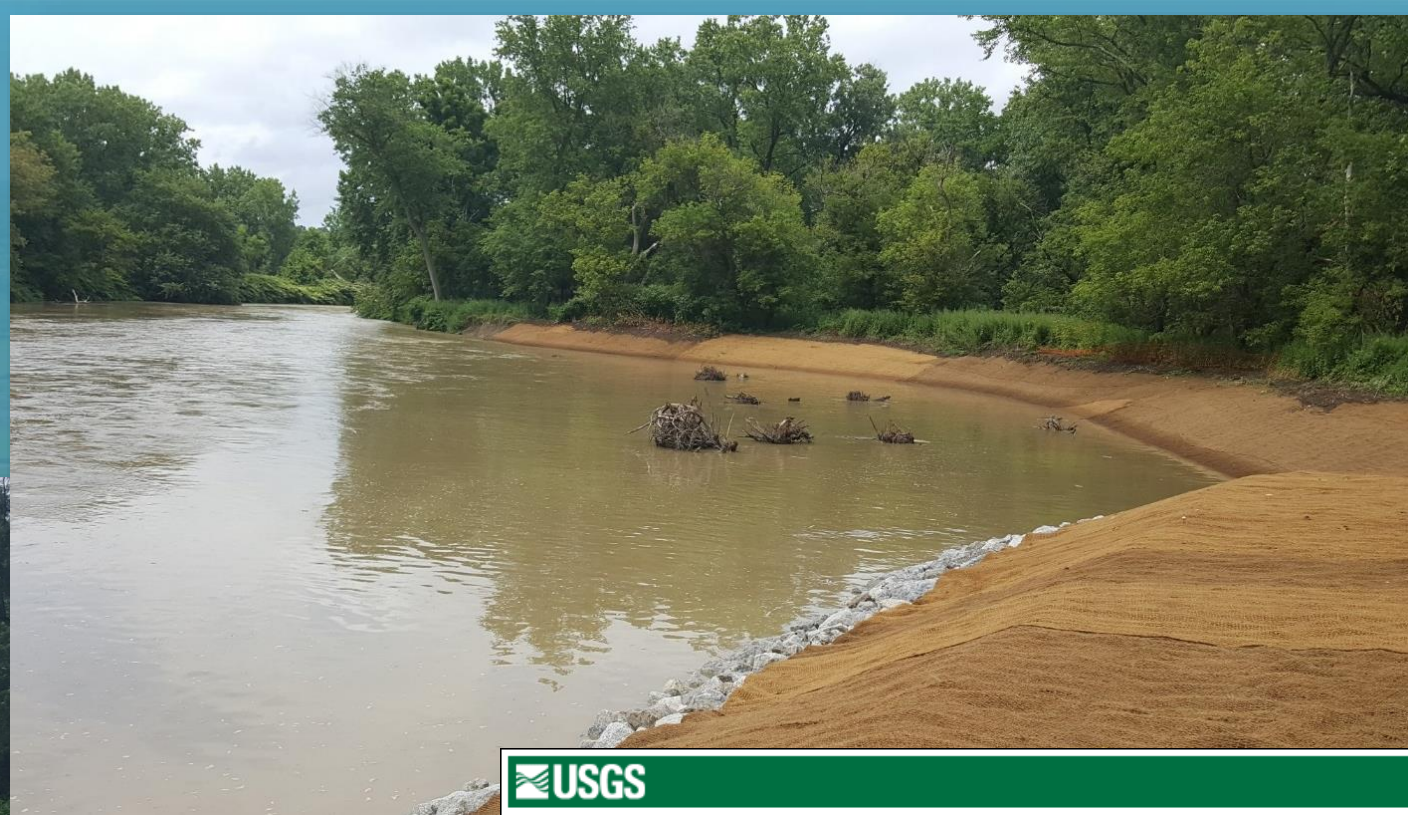
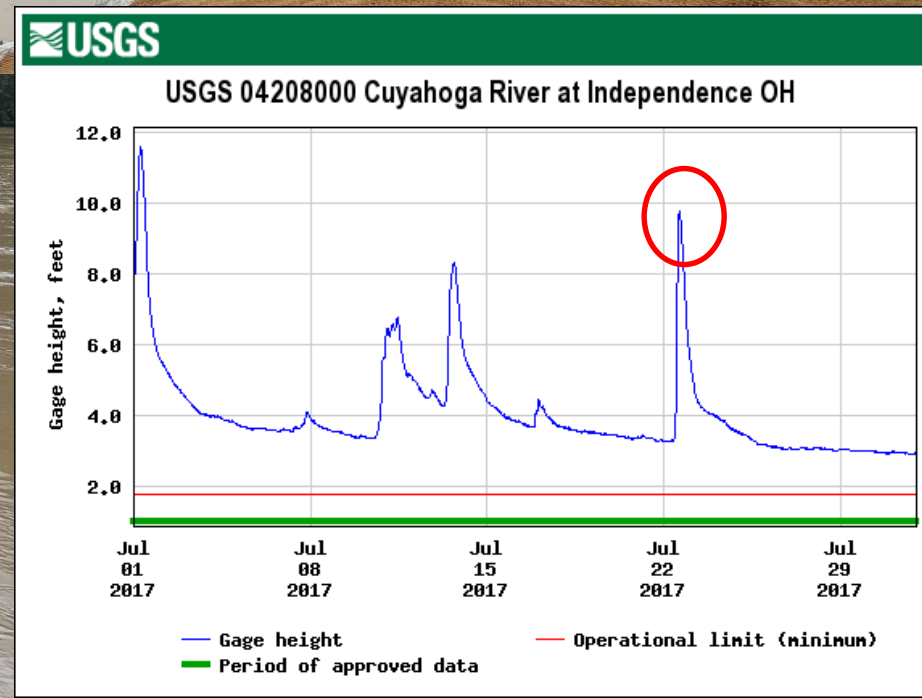
Post-Construction

July 22, 2017 Storm Event
