Stabilization Along the Cuyahoga River: Avoiding a “Tow Away Zone”

*Kristen Buccier, NEORSD
Shannon Conway, Stantec*

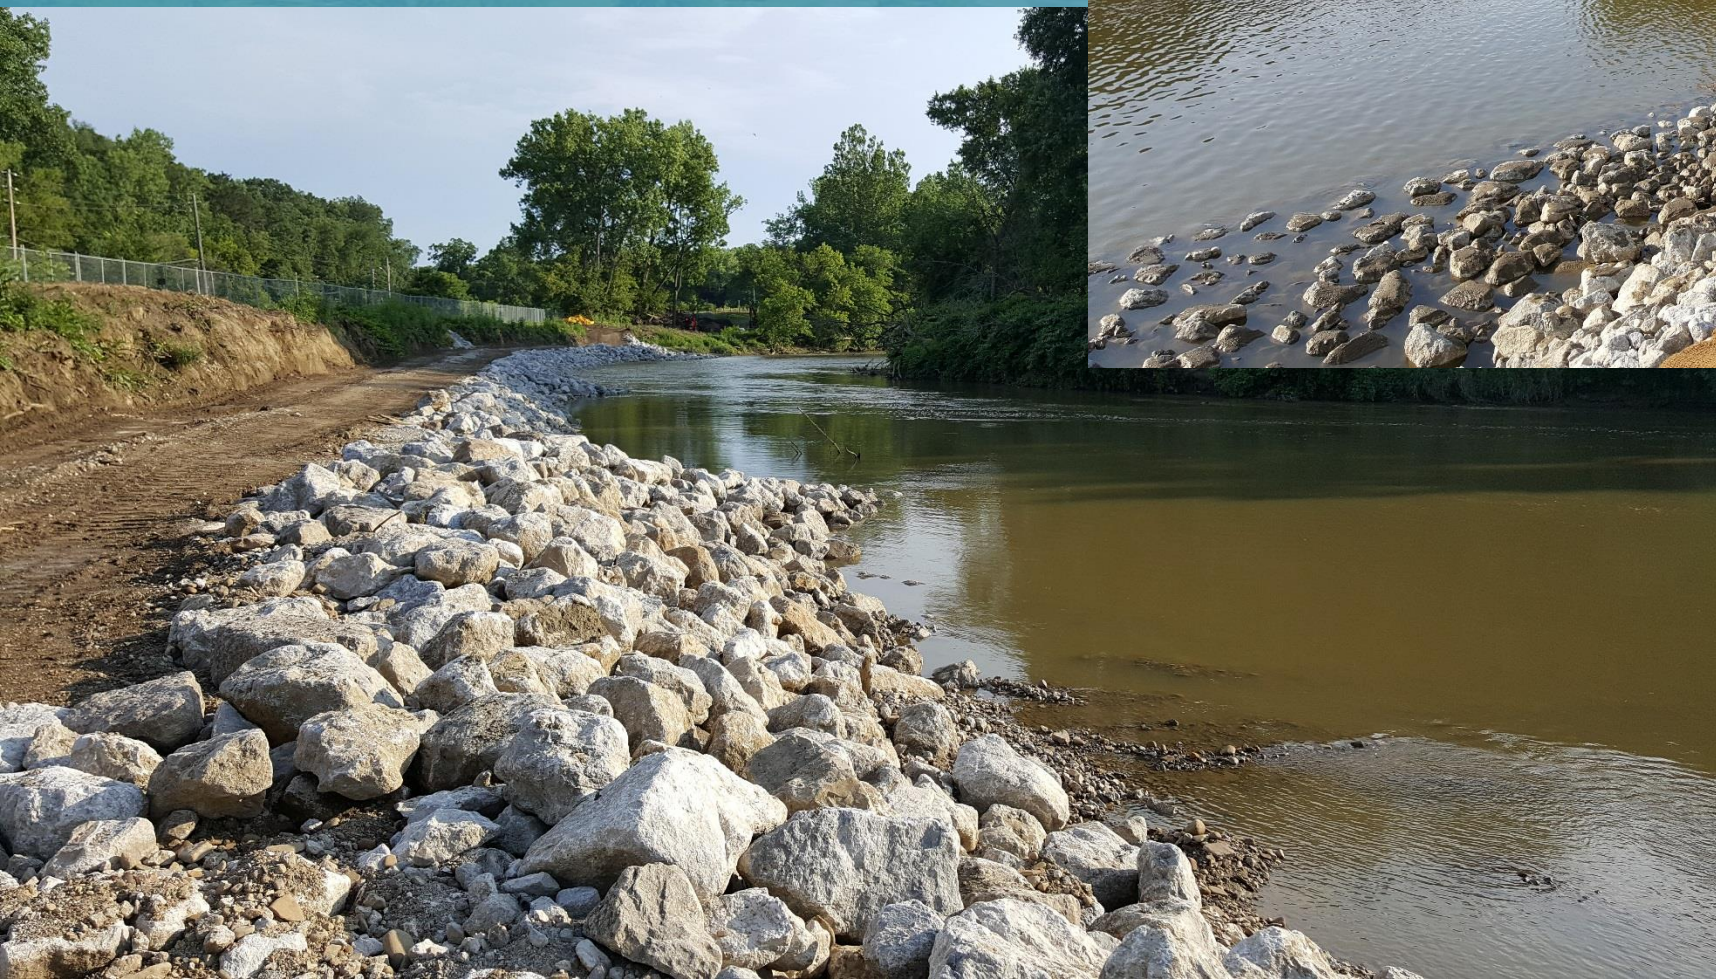
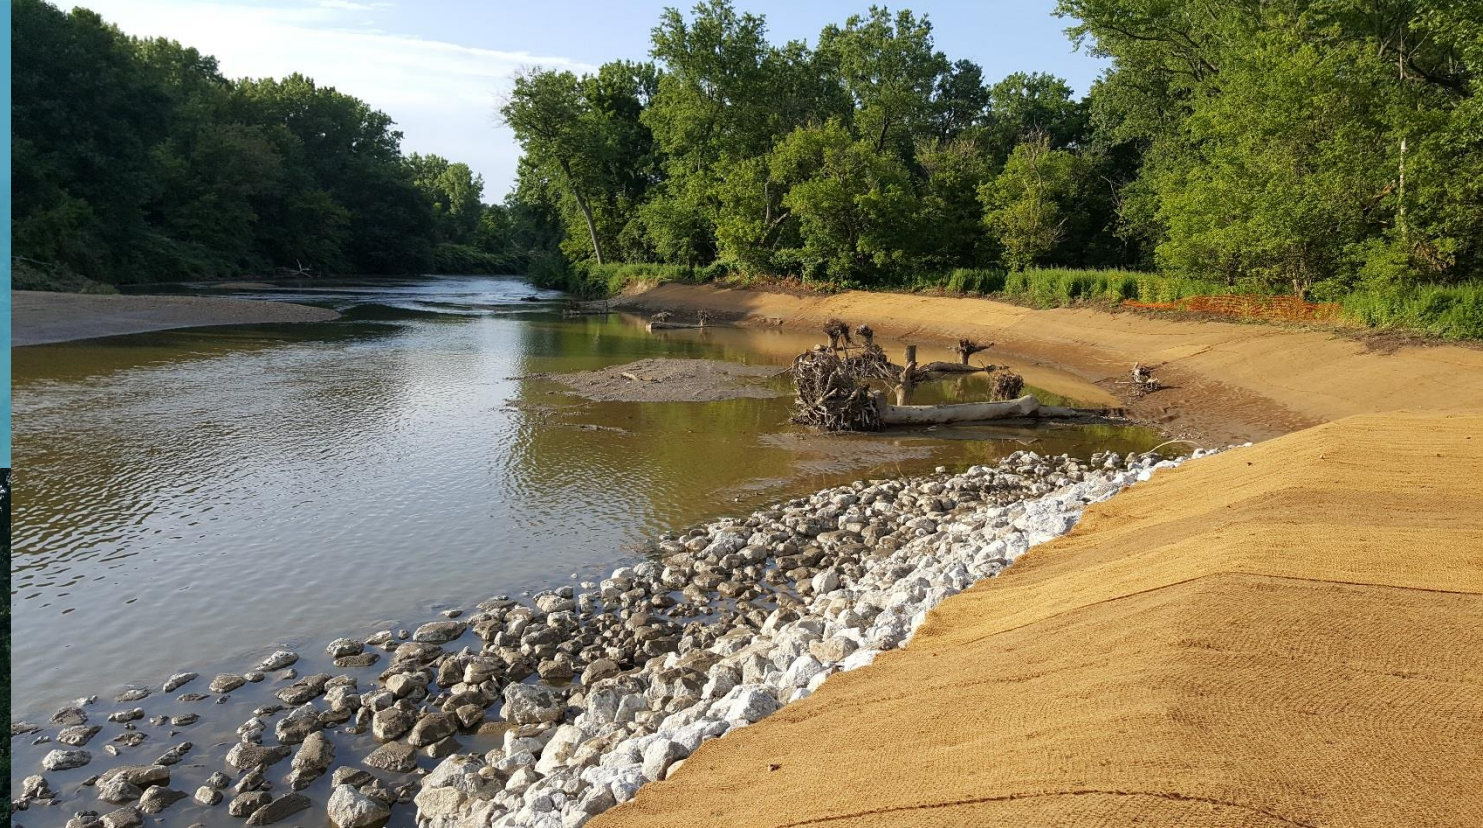
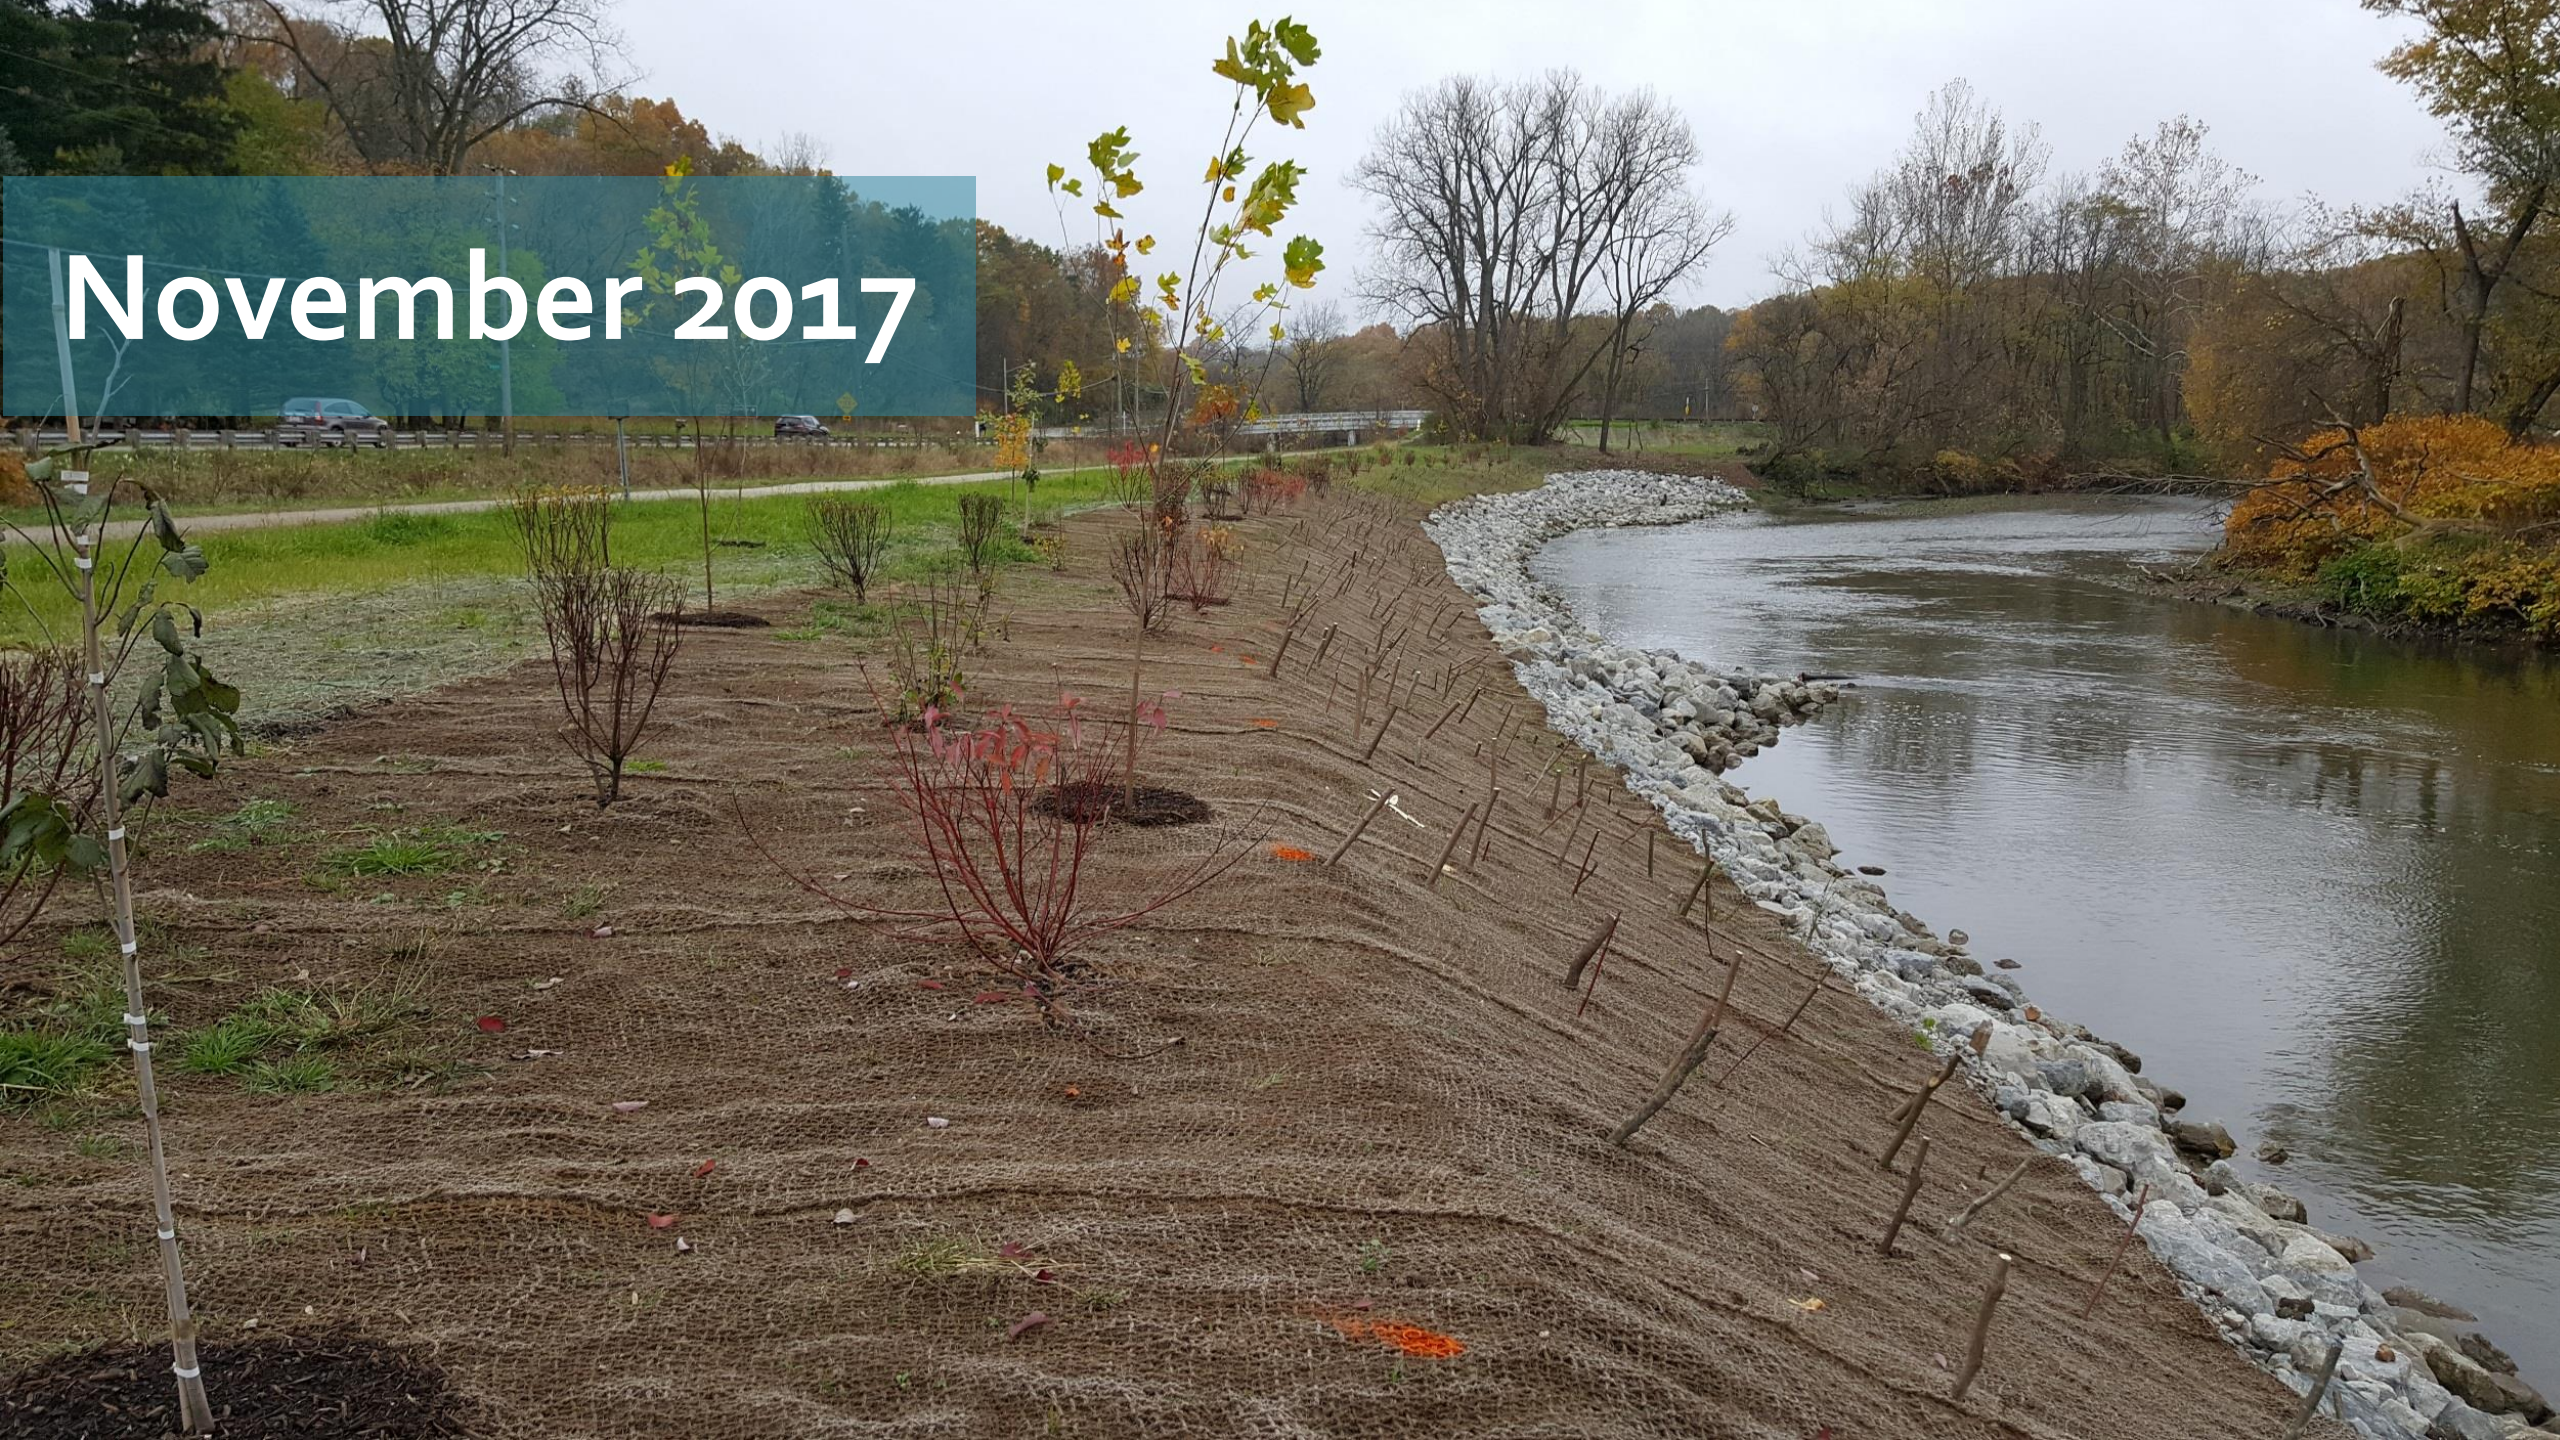
July 23, 2017 Post-Storm Event
