*GREEN INFRASTRUCTURE GUARDIANSHIP:*

OPERATIONS & MAINTENANCE PROGRAM LESSONS LEARNED

*Ohio Stormwater Conference – March 11, 2018*

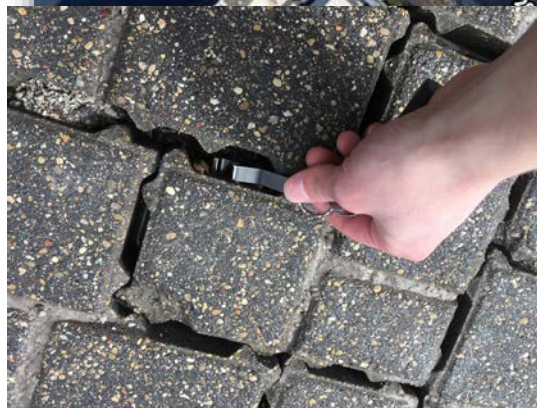
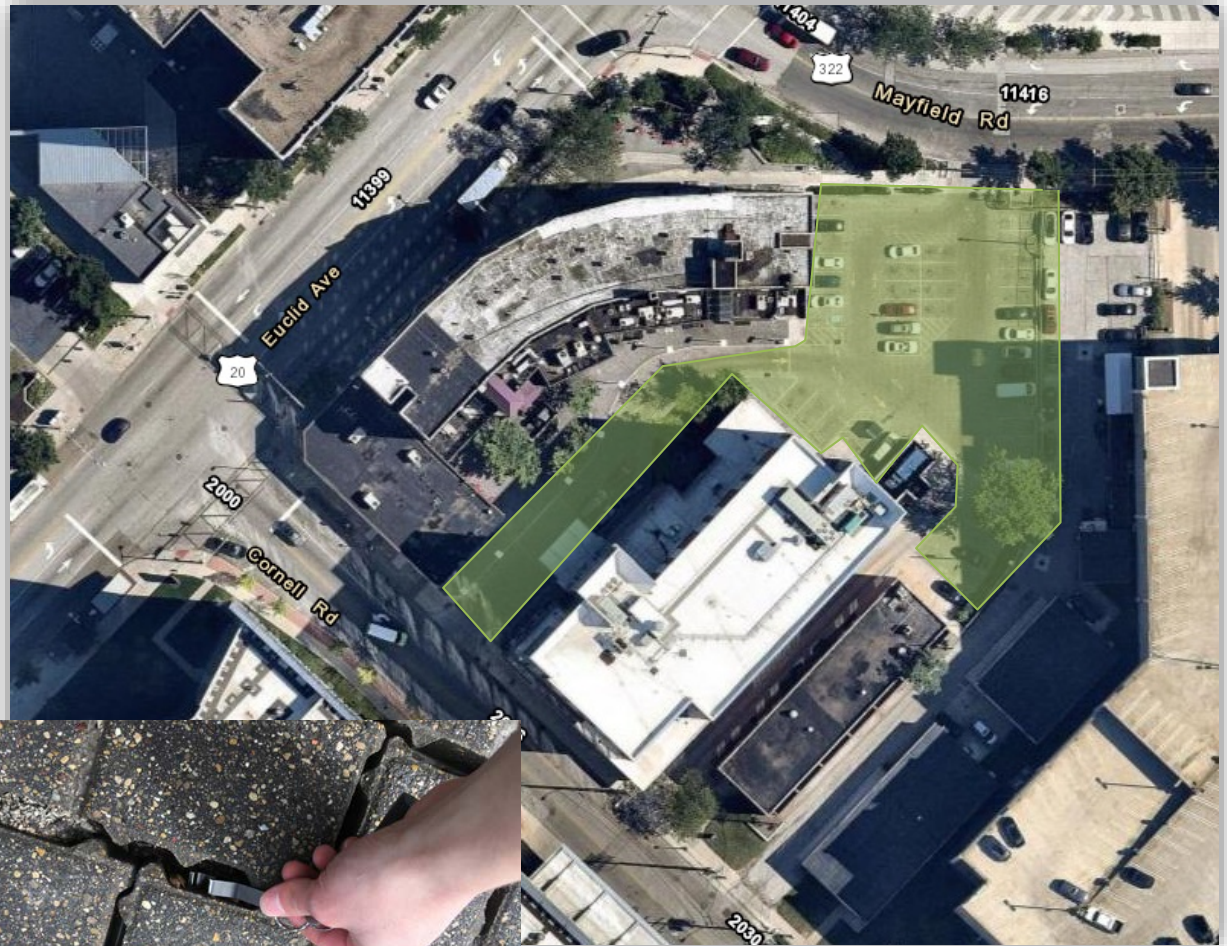
# UCI

- 1 PERVIOUS PAVER PARKING
- 1 UNDERGROUND  
CHAMBER
- 1 INTERPRETIVE SIGN
- CATCH BASIN
- INFILTRATION

- 1) Completed in 2014
- 2) Pavers were cleaned  
prior to contract

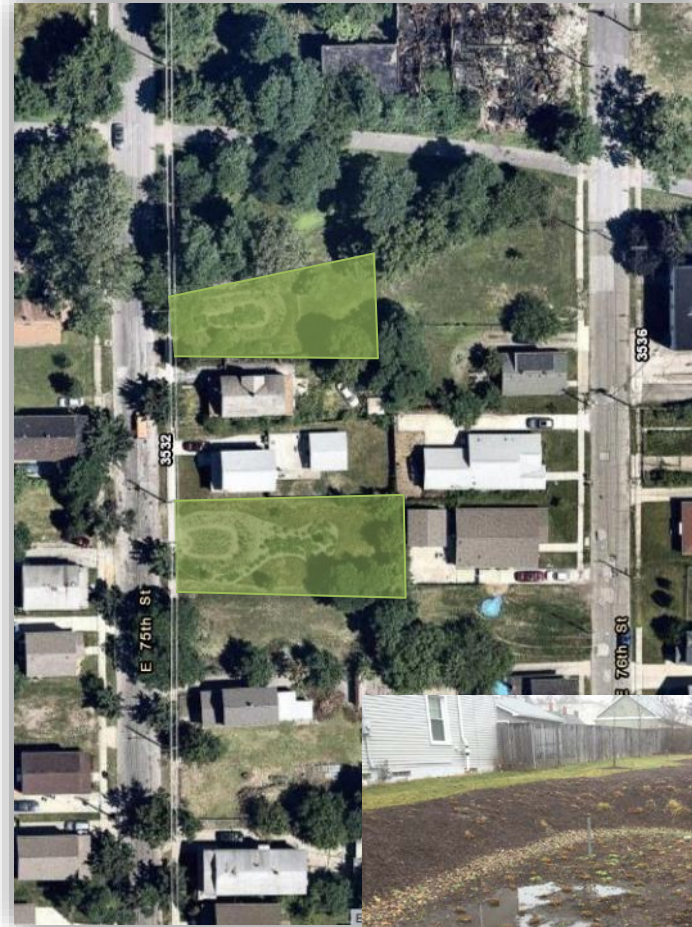
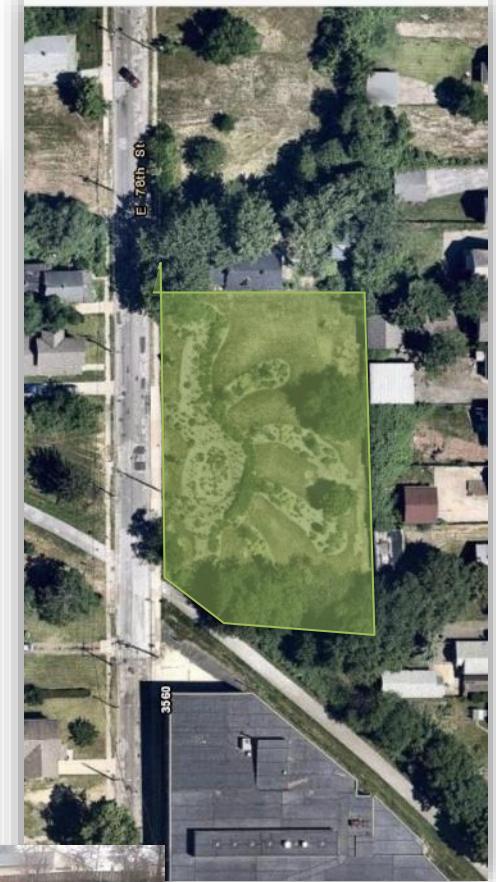
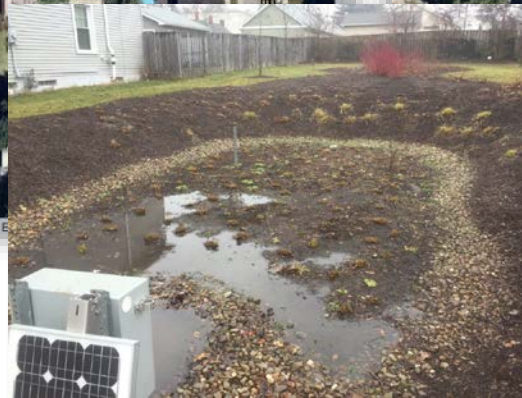
# SLAVIC VILLAGE

3 BIORETENTION AREAS

3 INTERPRETIVE SIGNS

2 TRENCH DRAINS

- 1) Completed in 2014-2015
- 2) Had been maintained and replanted previously
- 3) Three locations

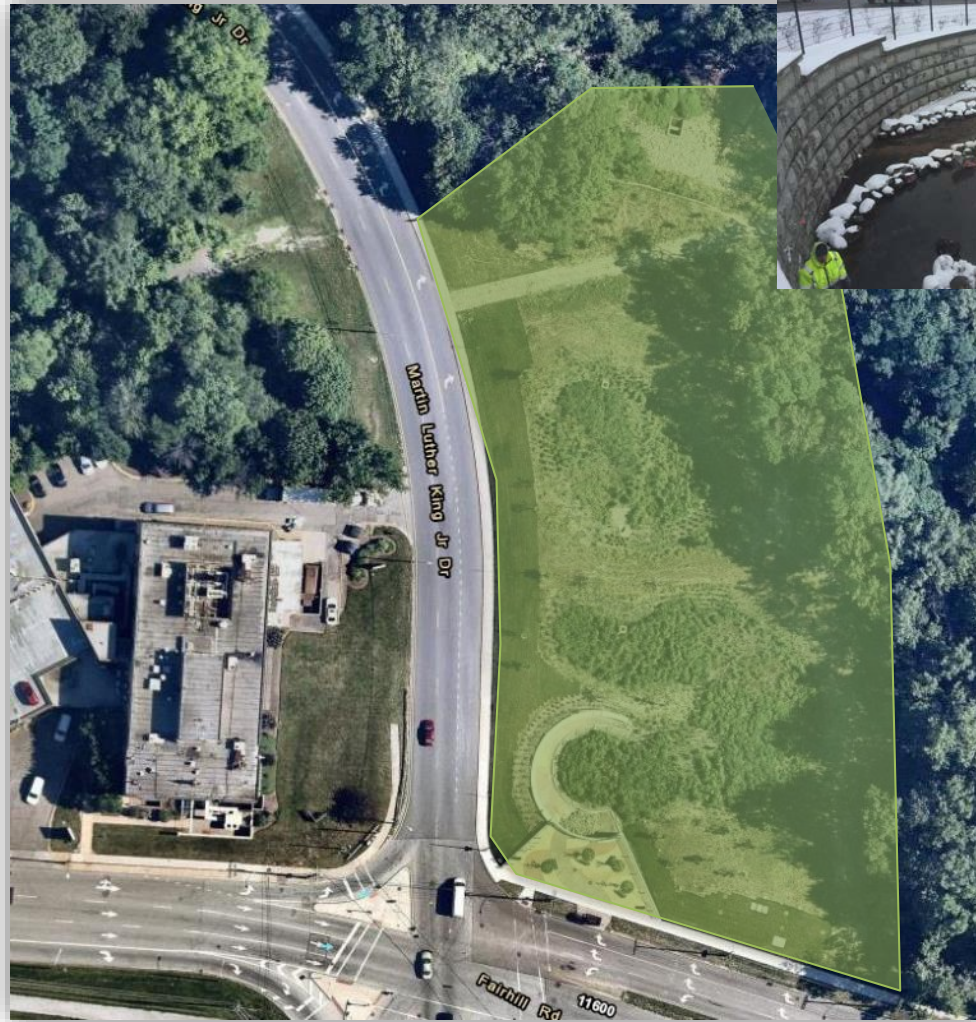
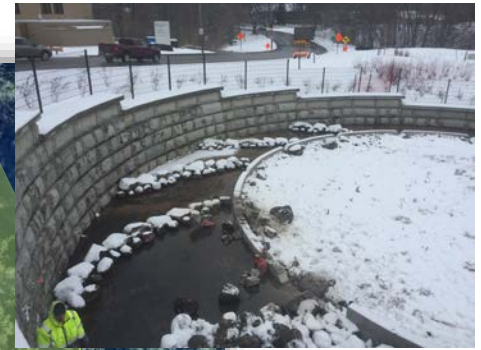
# FAIRHILL/MLK

- 2 BIORETENTION AREAS
  - 1 RIVERSIDE RESTORATION
  - 1 DIVERSION STRUCTURE
  - 1 PRETREATMENT DEVICE
  - 1 LARGE RETAINING WALL
  - 1 PERVIOUS PAVERS
  - 1 PLAZA
  - 1 INTERPRETIVE SIGN
  - 2 TRASH CANS
  - BENCHES
  - LIGHTS
- OFFLOADING

- 1) Completed in December 2016
- 2) Repairs already performed

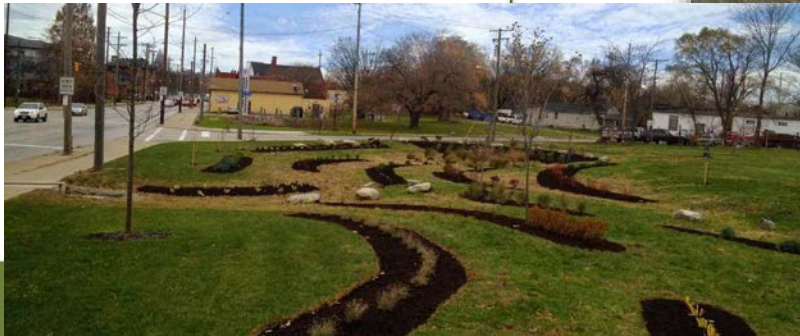
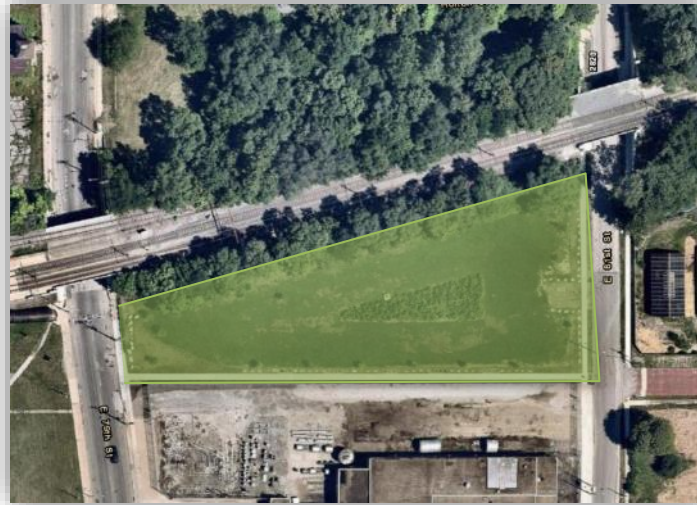
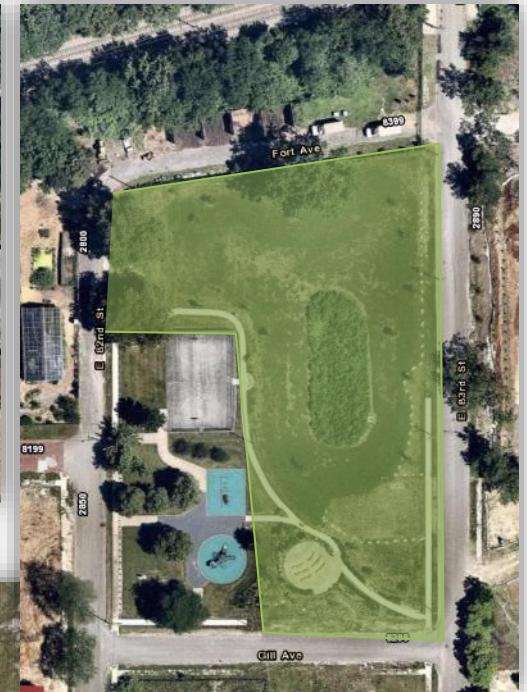
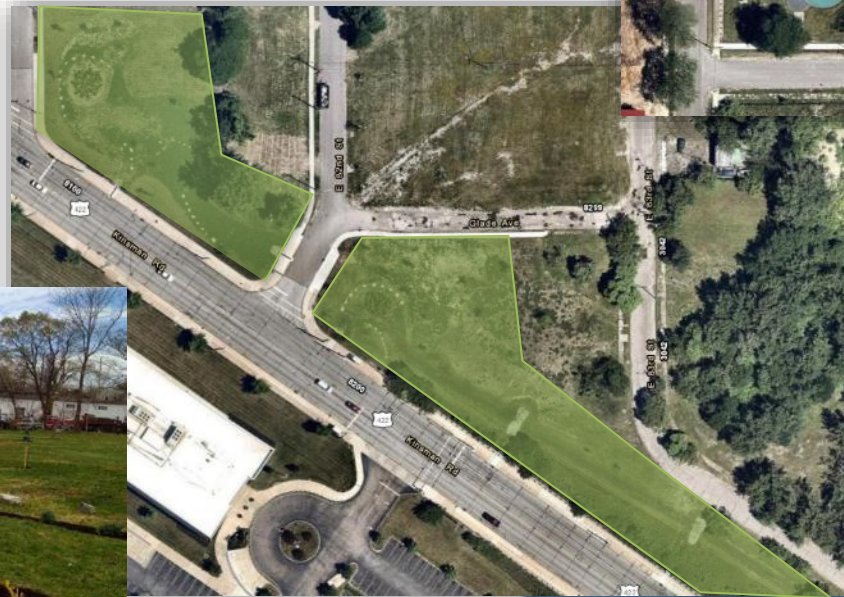
# URBAN AG

- 2 WQ BIORETENTION
- 2 BIORETENTION/DETENTION
- 1 PERVIOUS PAVERS
- AMPHITHEATER
- 3 INTERPRETIVE SIGNS
- PLANTING AREAS
- 2 PRETREATMENT DEVICES

- 1) Completed in 2016
- 2) Four locations
- 3) Lawn being maintained by Non-Profit

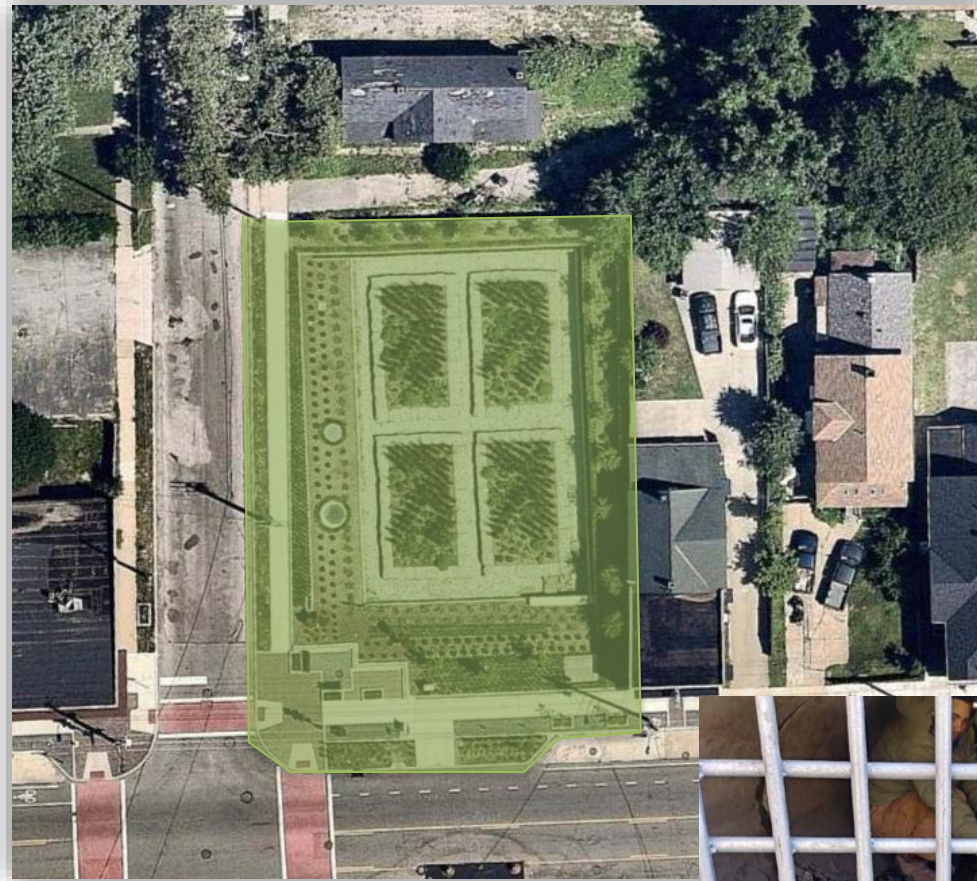
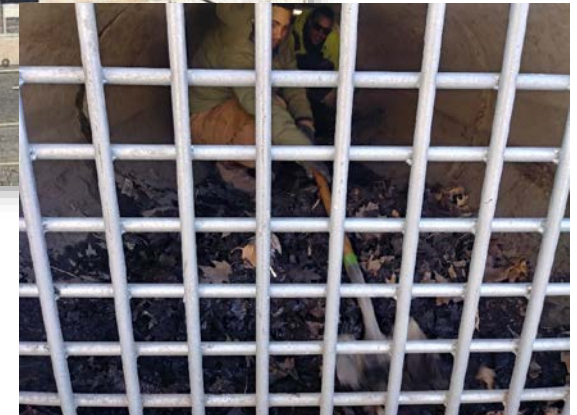
# FLEET AVENUE

INFILTRATION BASIN  
FLOATING BIORETENTION  
ROADSIDE RAINGARDEN  
PERVIOUS PAVERS  
DIVERSION STRUCTURE  
PRETREATMENT STRUCTURE  
PLANTING AREAS  
LAWN  
KIOSK  
TRASH CAN  
BIKE RACKS  
BENCHES  
INTERPRETIVE SIGN  
ART PIECES  
CATCH BASINS  
INFILTRATION

1) Substantial completion July  
2017 – site not completed until  
August 2017

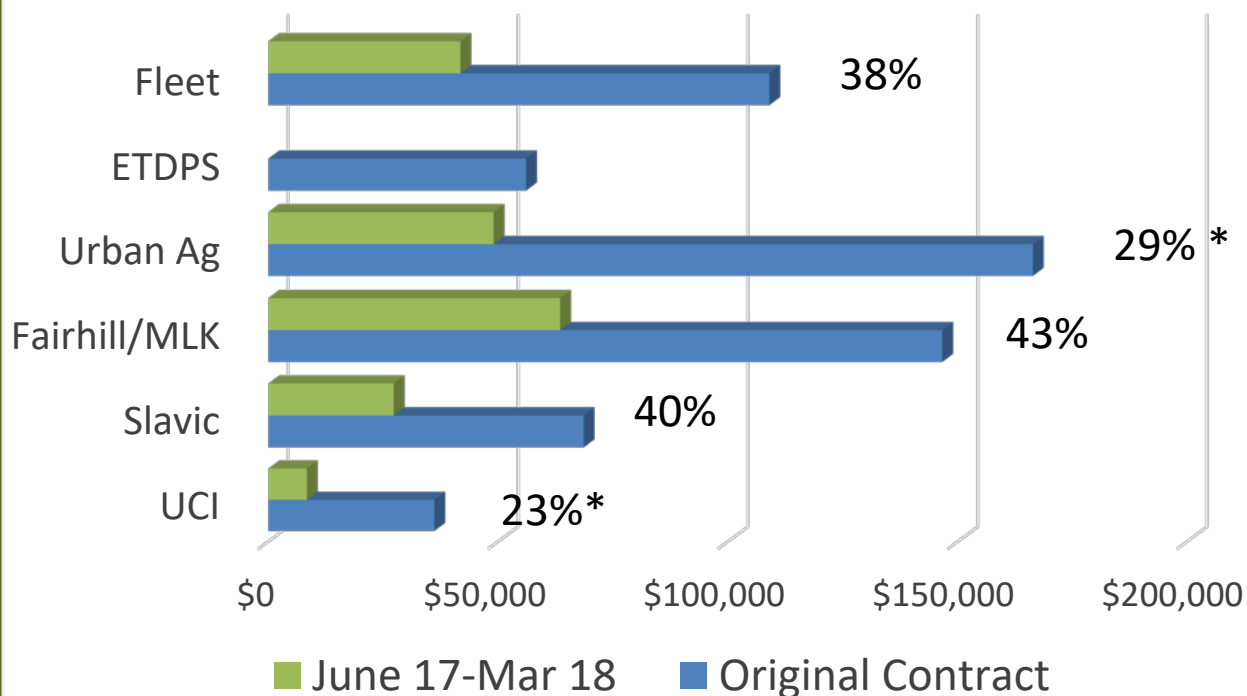
## Original Estimate Per Site to Current Costs

\* UCI - Non profit performs snow plowing

\* Urban Ag – Non profit performs mowing and trash removal

\*\* Costs include PM oversight costs

SITE	H2O (MG)	CSO (MG)	Construction \$\$	O&M \$/month	O&M \$/MG H2O/Month
UCI	1.00	0.1	\$186,694	\$1,971	\$840*
Slavic	0.20	0.1	\$218,717	\$3,857	\$13,635
Fairhill/MLK	17.0	2.4	\$5,614,089	\$7,477	\$374
Urban Ag	7.00	1.6	\$6,460,815	\$6,030	\$700*
Fleet	4.70	0.5	\$1,997,989	\$5,308	\$889
Typ. Sewer Cleaning (USEPA)				\$2,823/mile/year	
Typ. Gray Basin (USEPA)				\$40,000/MG Capacity

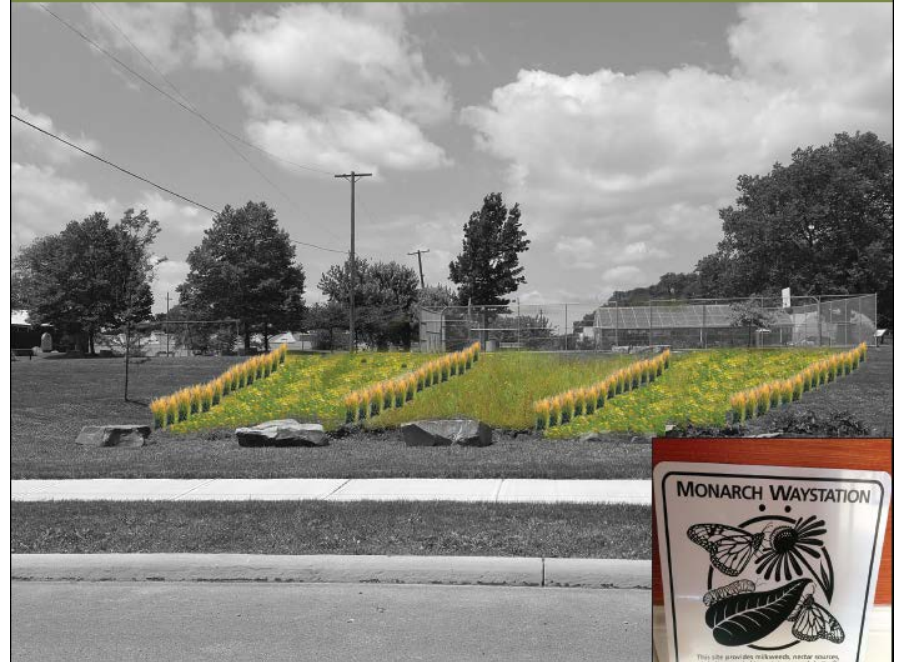
### EAST BIORETENTION

#### **Curb Appeal:** Improvement of aesthetics from sidewalk on E 82ND

Option A) Remove and reseed side slopes

\$18,000 to \$25,000 (kill off all weeds/clover, reseed as per plan)

Option B) Create three distinct zones of wildflower areas, mow rest, install educational signs (140 x 60)

\$7,500 to \$10,000 (work with NEORSR graphics staff for signs, remove three areas of seed, plant Karl Foerster or Big bluestem rows, reseed using seed mixes in plans)
