Utilizing Green Infrastructure as a TMDL Implementation Tool: *A Case Study in the Kids Creek Watershed*

Troy Naperalala

AECOM

Kids Creek Restoration Project

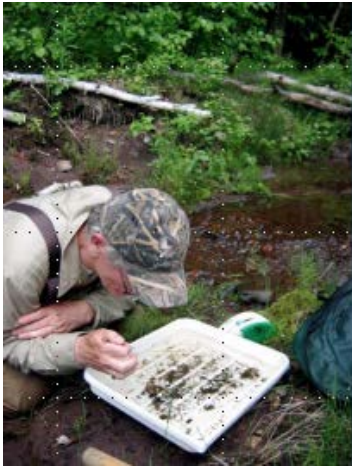
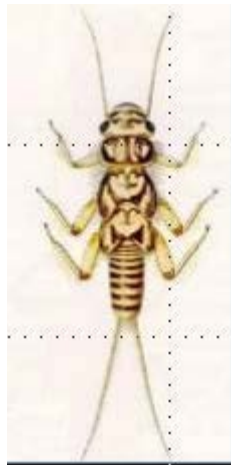
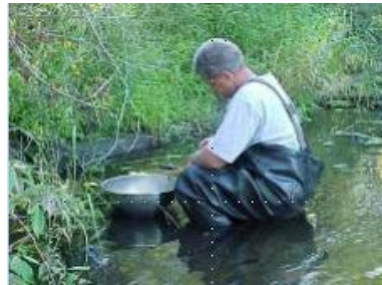
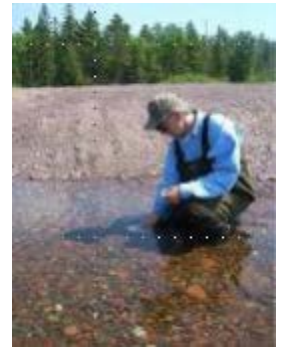
Data Collected

- Qualitative aquatic organism and habitat data
- Limited VOC samples
- Limited water column samples for metals and nutrients

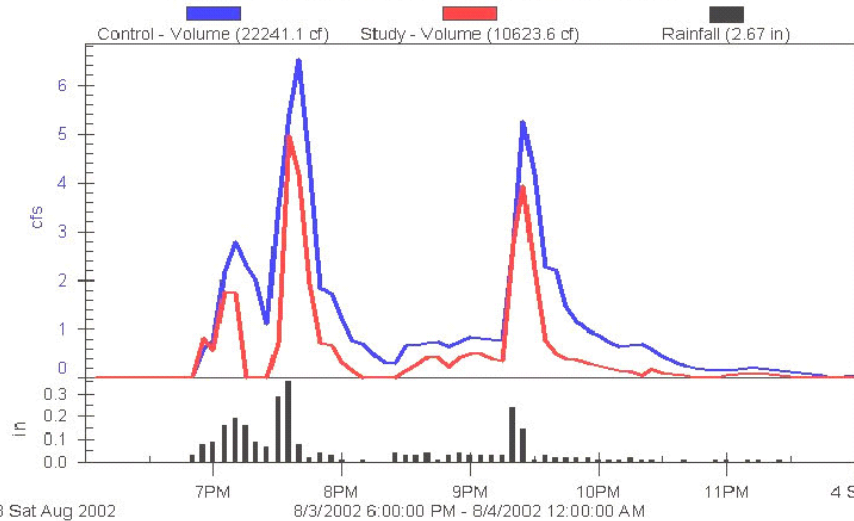
Pre-Construction Runoff - August 3, 2002

Blue: Control
*Red: With Rain
Gardens*

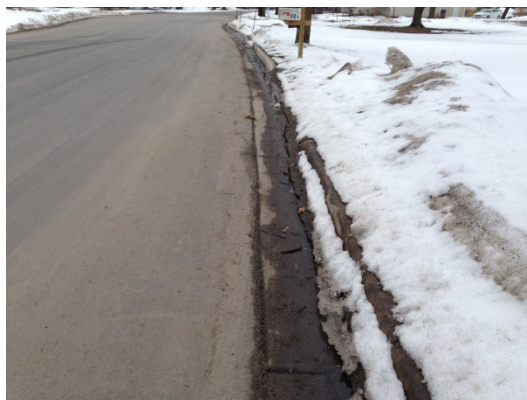
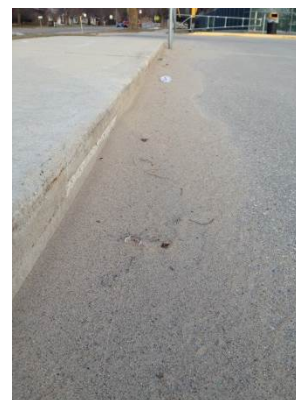
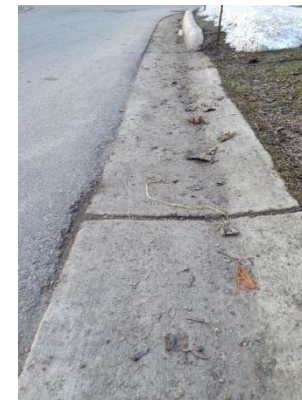
Examples of
watershed
sediment storage

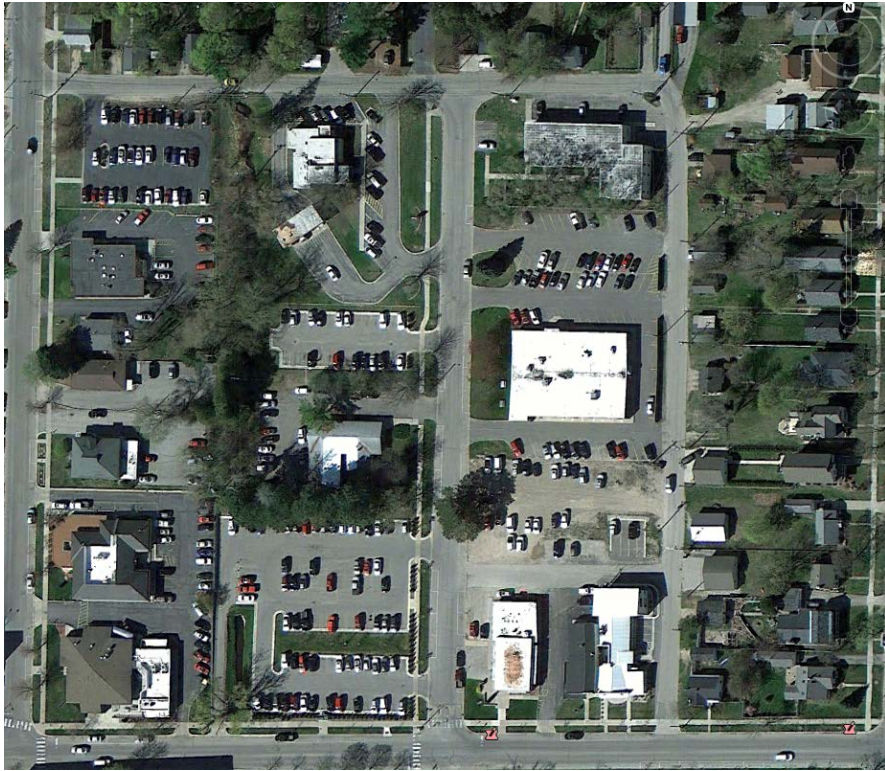
2012

Restoration of Tributary AA to Kids Creek

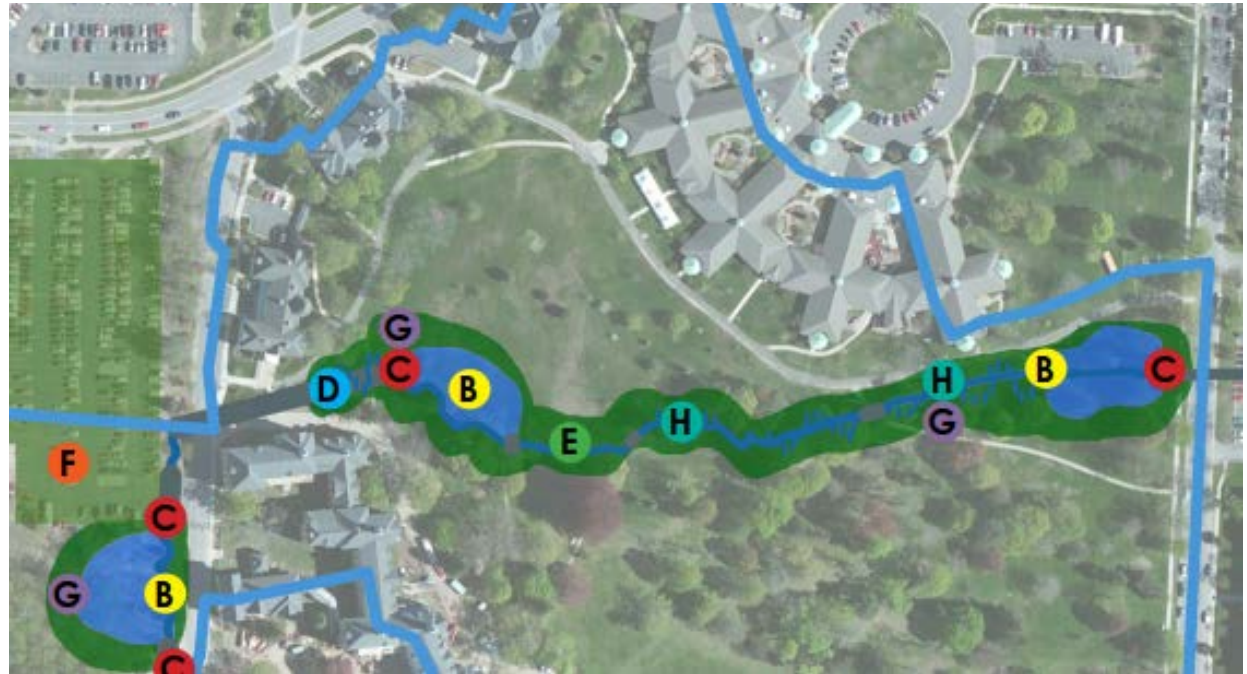
90° Creek/ Floodplain Restoration

- B** Provide in line detention to increase capacity and water quality. This will also reduce flow rates and erosion.
- C** Repair/replace clogged and sediment-filled culverts to reduce back-up.
- D** Daylight part of culverted section to increase capacity and water quality.
- E** Provide new headwall configuration to prevent erosion swales.
- H** Adjust channel profile and sinuosity
- G** Increase or provide riparian buffer to increase water quality and infiltration and decrease flow rates.

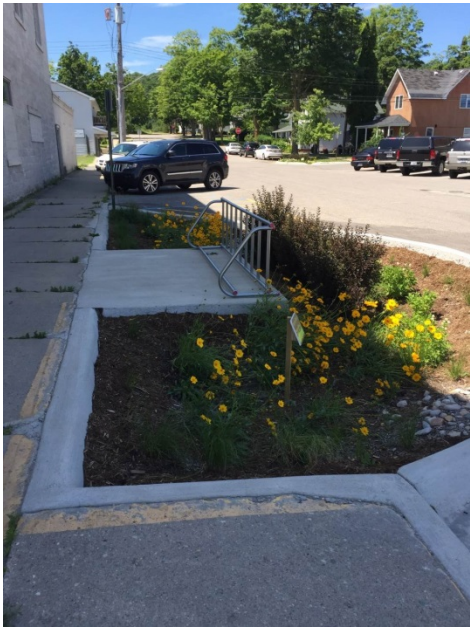
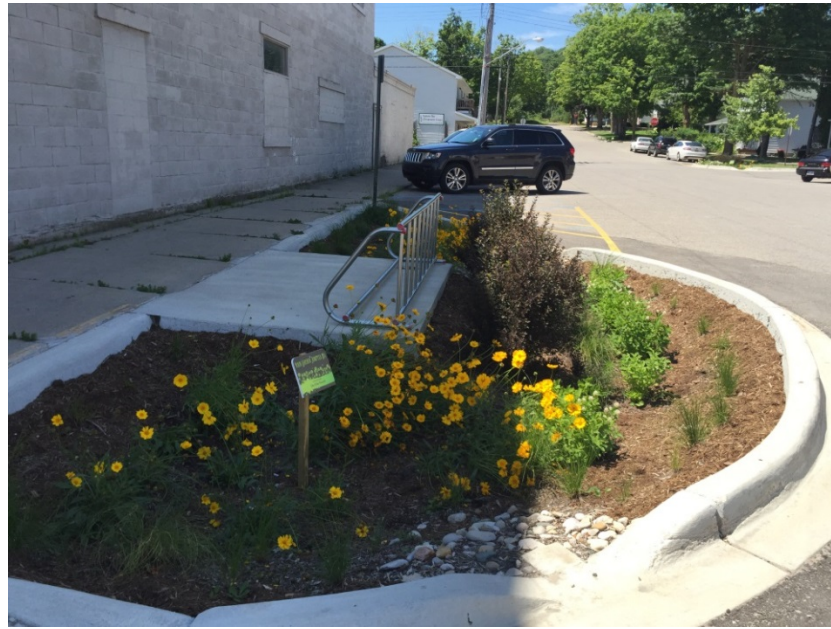
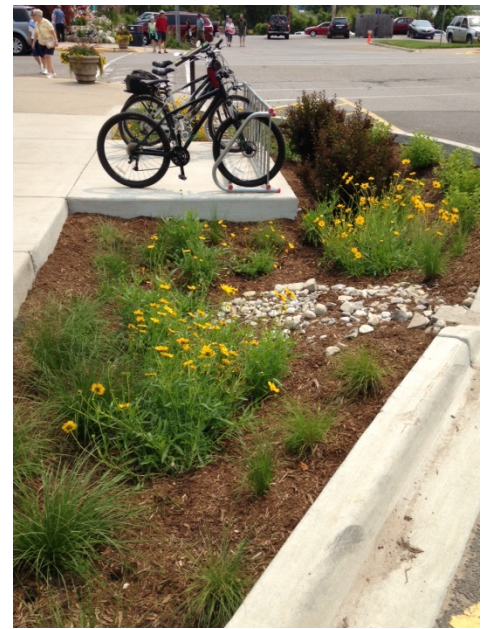
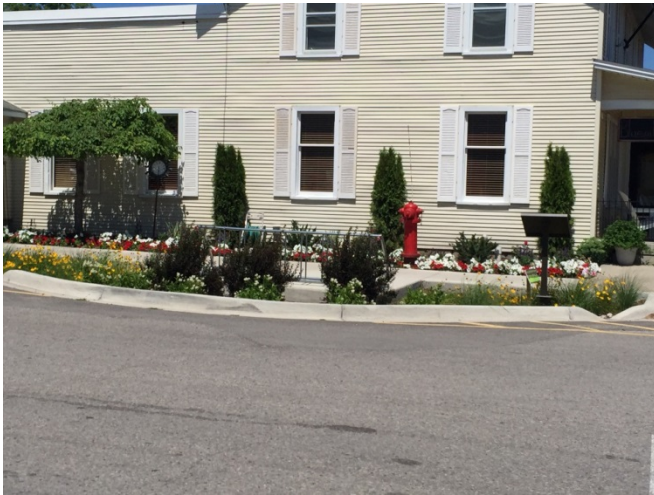
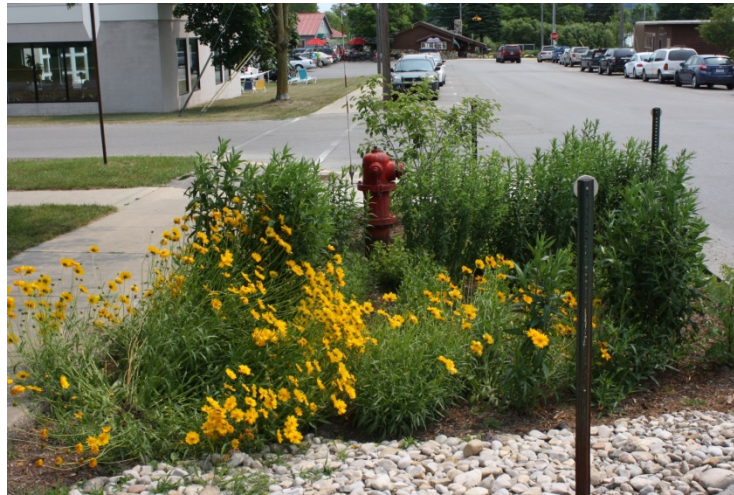
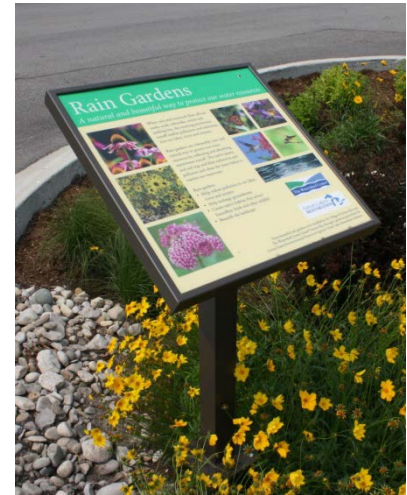
Planned BMP System: Infiltration Trenches

- Know what materials are available locally
- Review and question all as-built drawings
