Aquatic Habitat Restoration along the Black River Using Fish Shelves

THE LOWER BLACK RIVER FISH HABITAT RESTORATION PROJECT

BLACK RIVER FISH HABITAT SHELVES

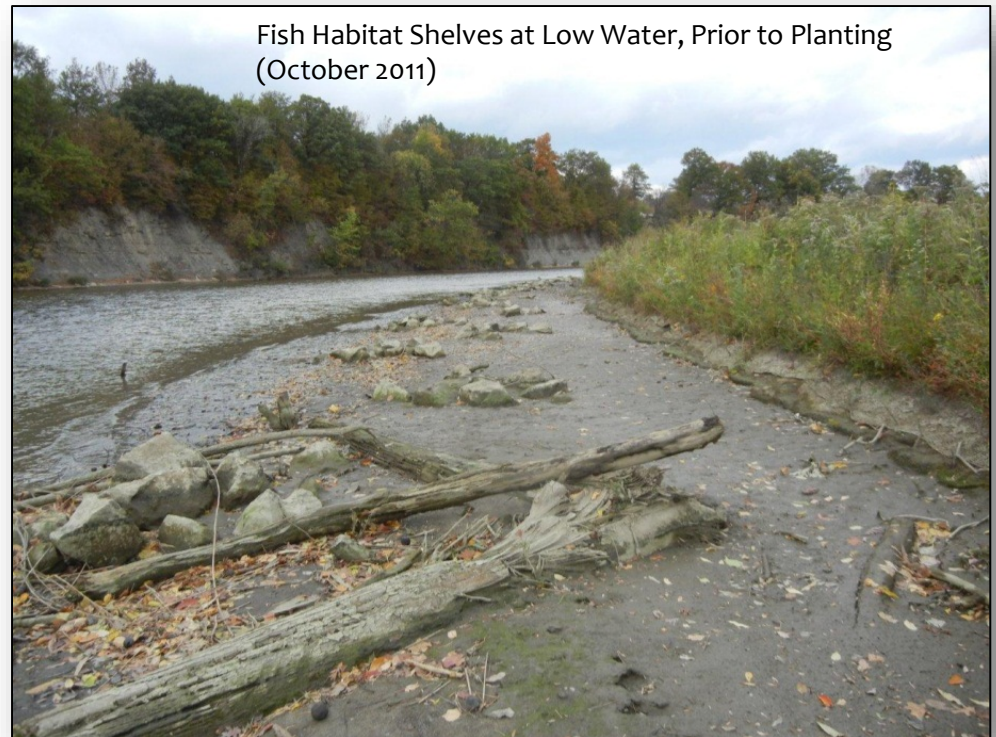
Traditional Fish Shelf

- Fish Shelves and Other In-Stream Structures
 - Substrate Diversity
 - Shallows
 - Cover and Structure
 - Spawning and Refuge
- Bank Restoration
 - Erosion Reduction
 - Native Vegetation

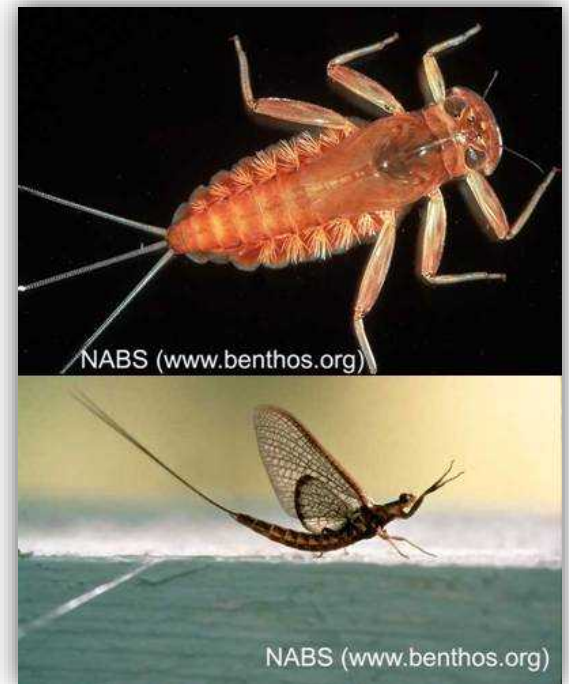
- Little improvement of macroinvertebrate assemblage
 - Consistently **Very Poor** to **Poor**
- Lack of improvement suggests multiple stressors influence
 - Legacy pollutants
 - WWTP, HSTS
 - Non Point Source Pollution
 - Sediment

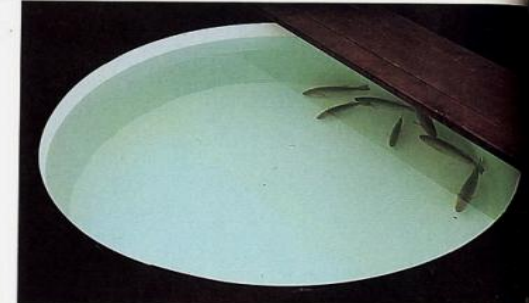
A BOARD over one edge of the tank provides acceptable cover for the bass. The fish station themselves in the shade under the board.

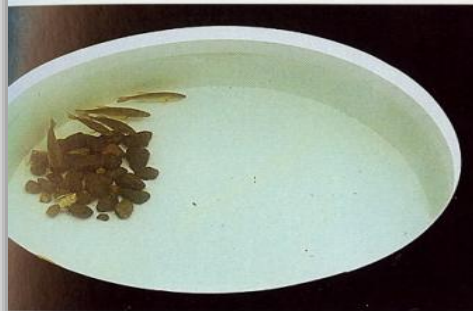
ROCKS piled in one area of the tank attract the bass immediately. They form a closely-packed school above and along the edge of the rock pile.

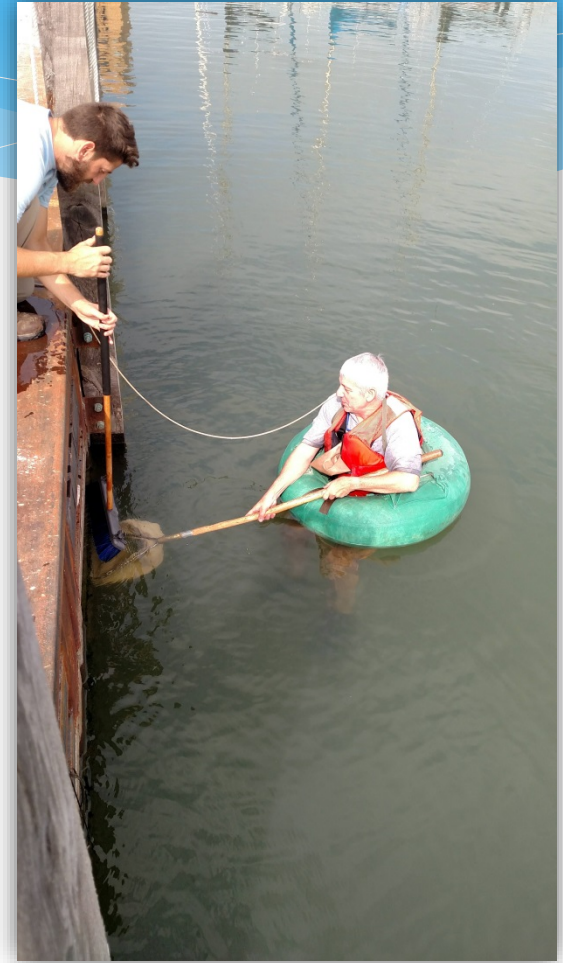
Hybridized Fish Habitat Monitoring and Results

Electro-fishing and macroinvertebrate sampling were conducted pre-and post-construction in 2017 and 2018 respectively

- 84% increase in Largemouth Bass density
- 80% increase in Centrarchidae species richness (Bluegill, LMB, rock bass, etc.)
- 25% increase in total fish species richness
- 100% increase in EPT taxa abundance and species richness
- Rapid colonization/utilization by organisms only 4-6 months following construction
- Follow-up assessments planned for 2019, 2020
