Stormwater Project Challenges: Lessons Learned from a Culvert Rehabilitation Project

*Derek Vogel, NEORSD
Randall Berkley, Jacobs*

47 Spring Creek Culvert Rehabilitation

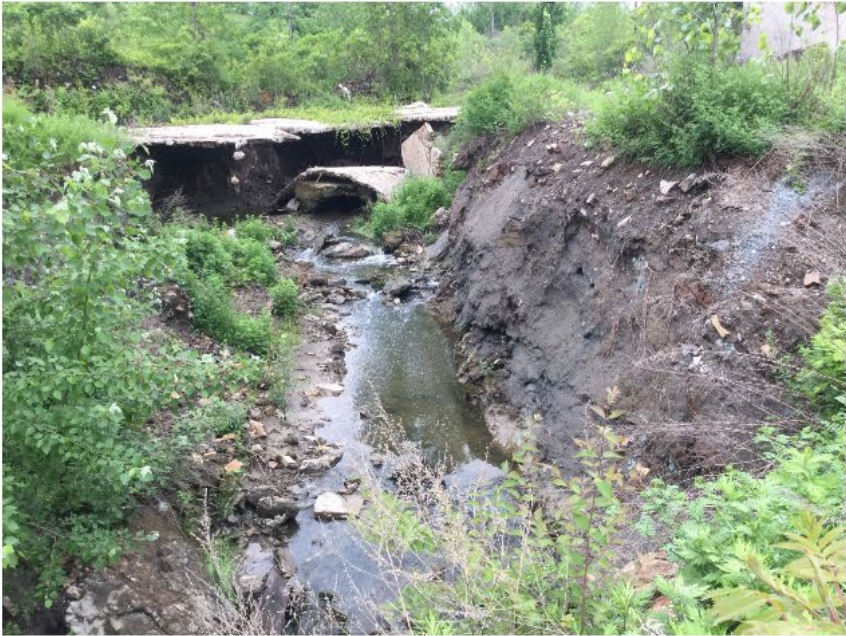
Project Name: Spring Creek Culvert Rehabilitation
Community: Cleveland
Watershed Team Leader: [J. Jowett](#)
Watershed: Cuyahoga River North
Subwatershed: Spring Creek
Summary: The project includes replacing and rehabilitating a 72-inch culvert within the

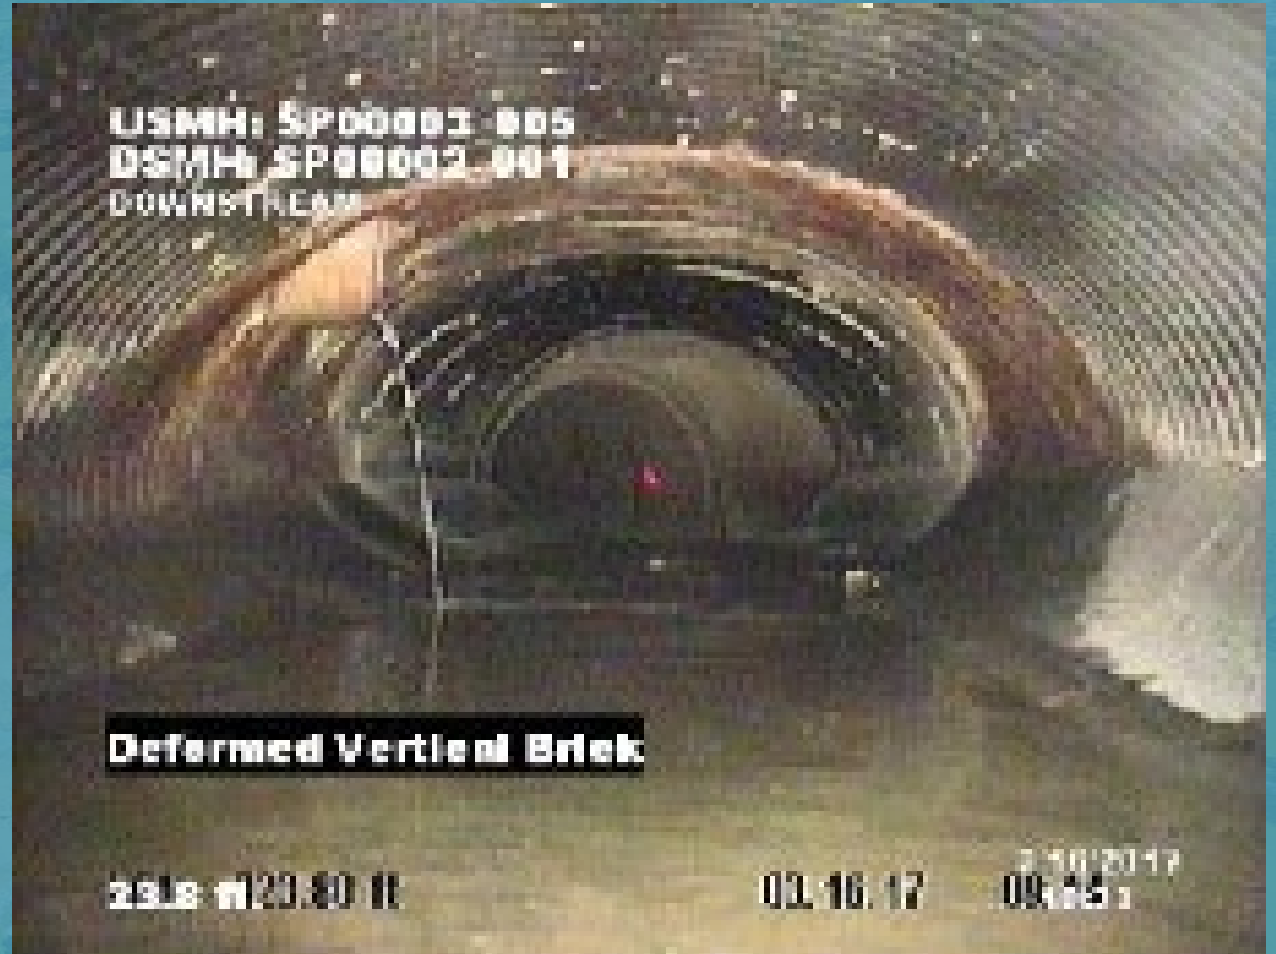
Pipe Rehabilitation – Geopolymer Lining:

- Consistent method of repair for multiple sections
- Minimal flow capacity reduction
- Structural integrity
- Low schedule impact

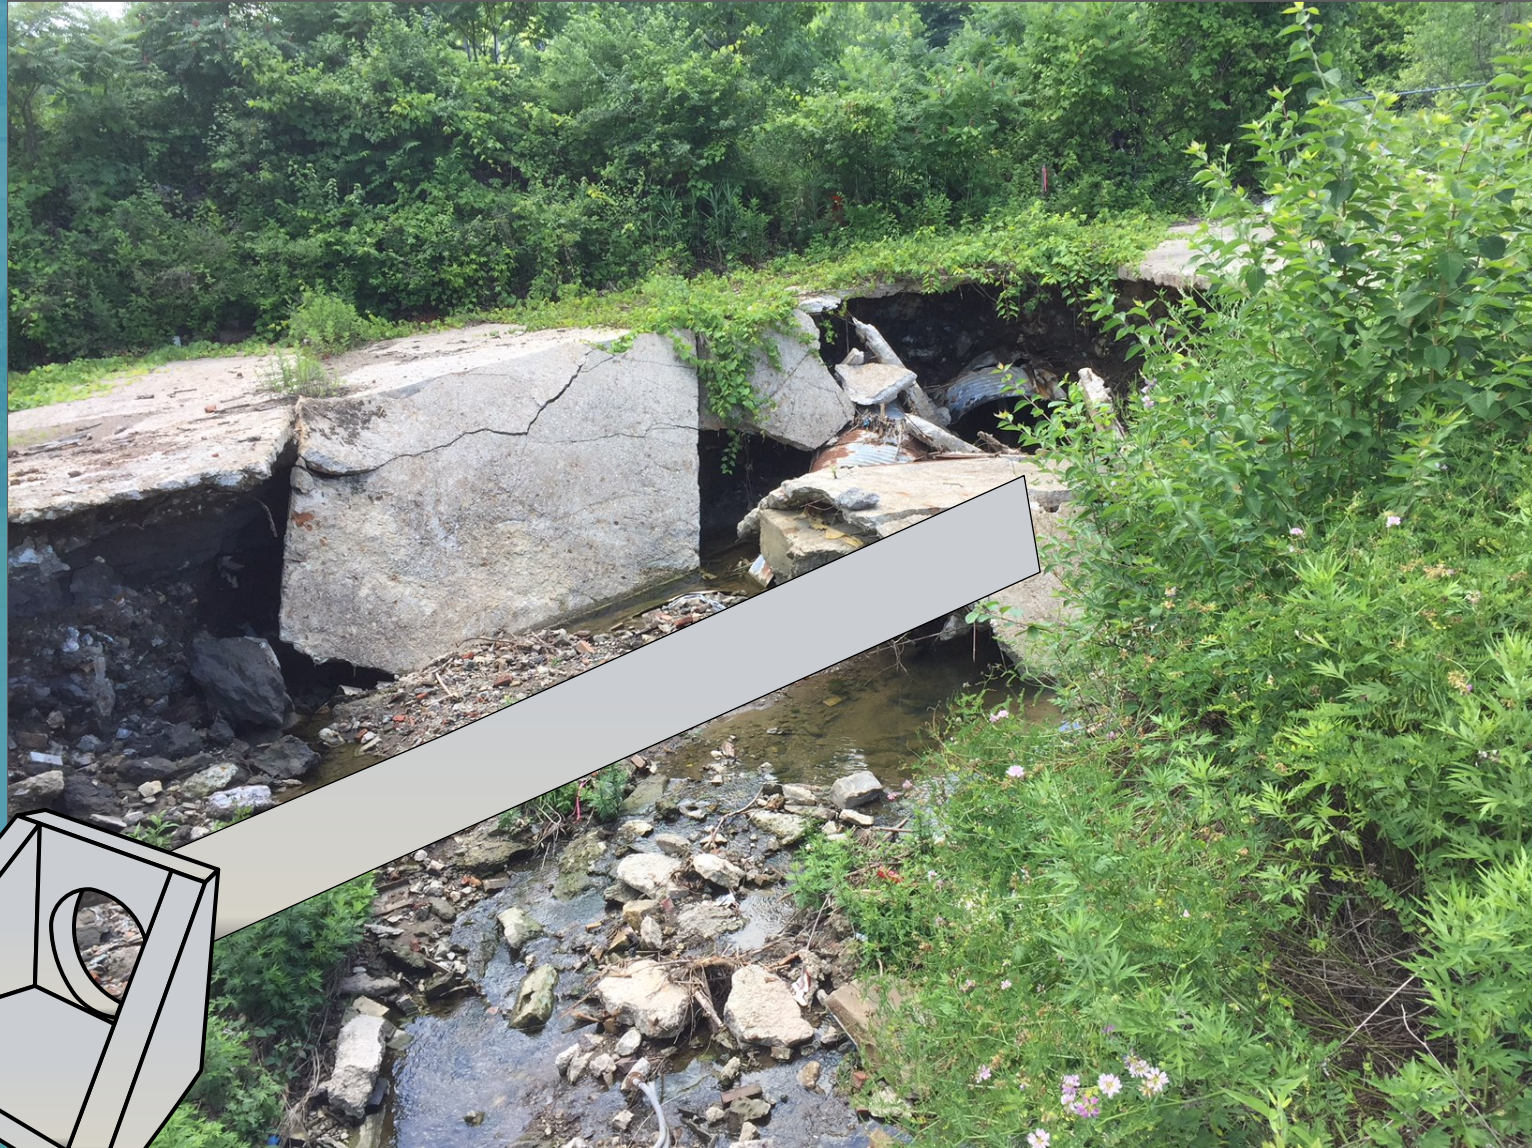
Collapsed Section –
New Pipe:

- Soil Contamination
- Property Owner Approval
- Headwall

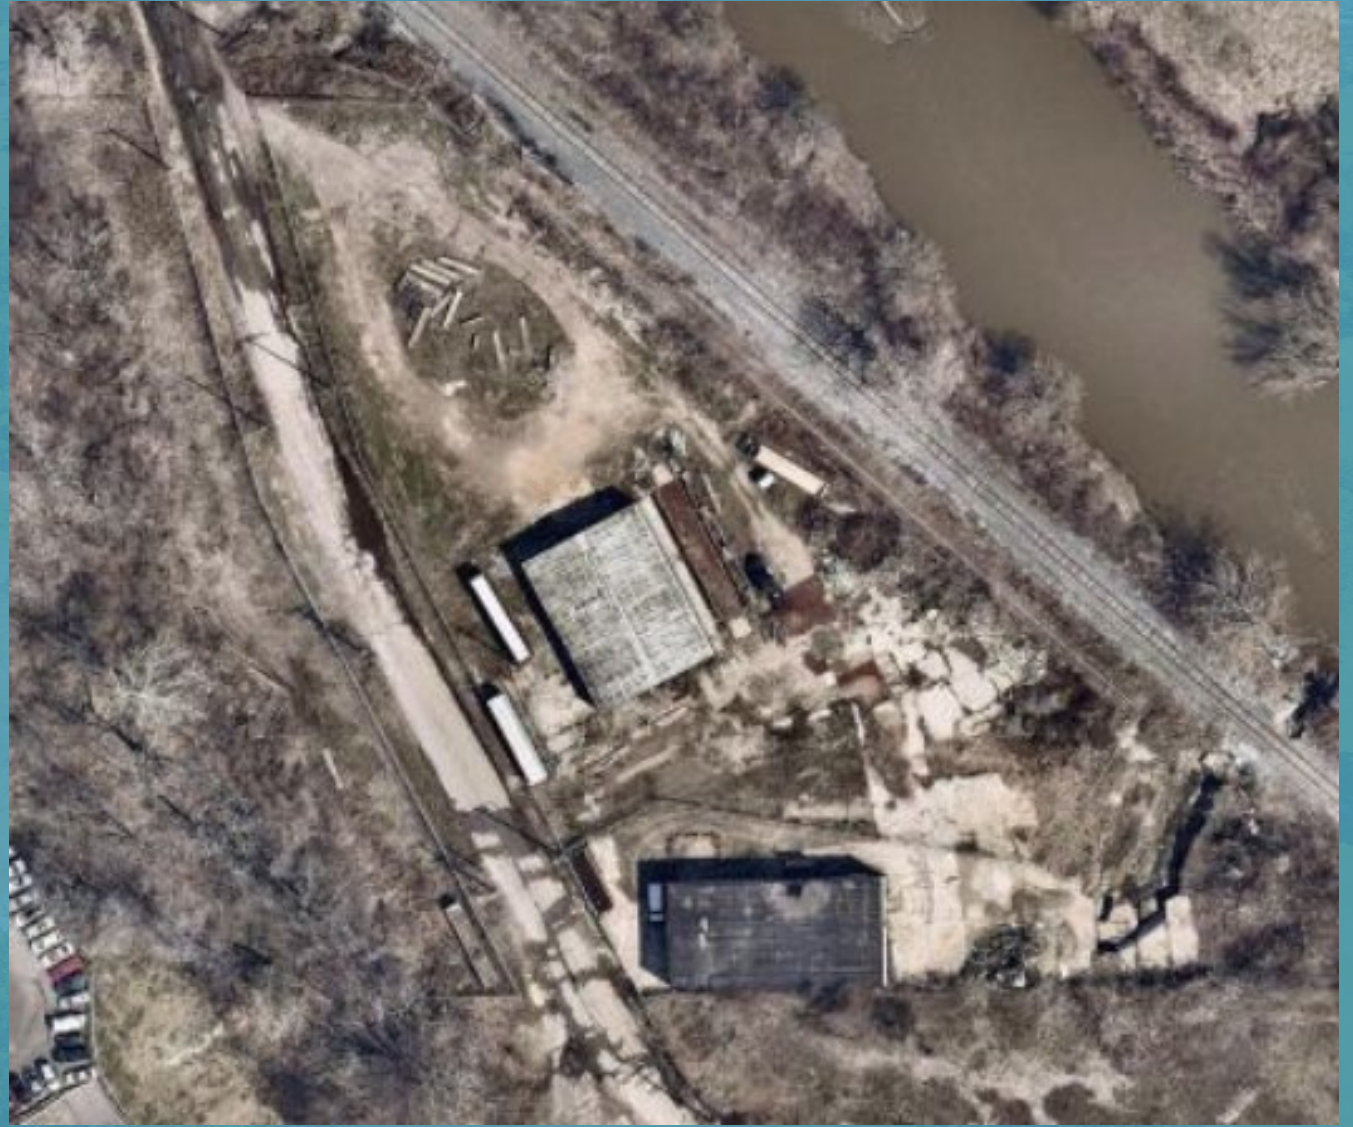
Lesson Learned: Property Issues

- The easement value negotiation process
- Current and future use of the property
- Construction Access
- Debris Stockpiles
- Lateral Connections

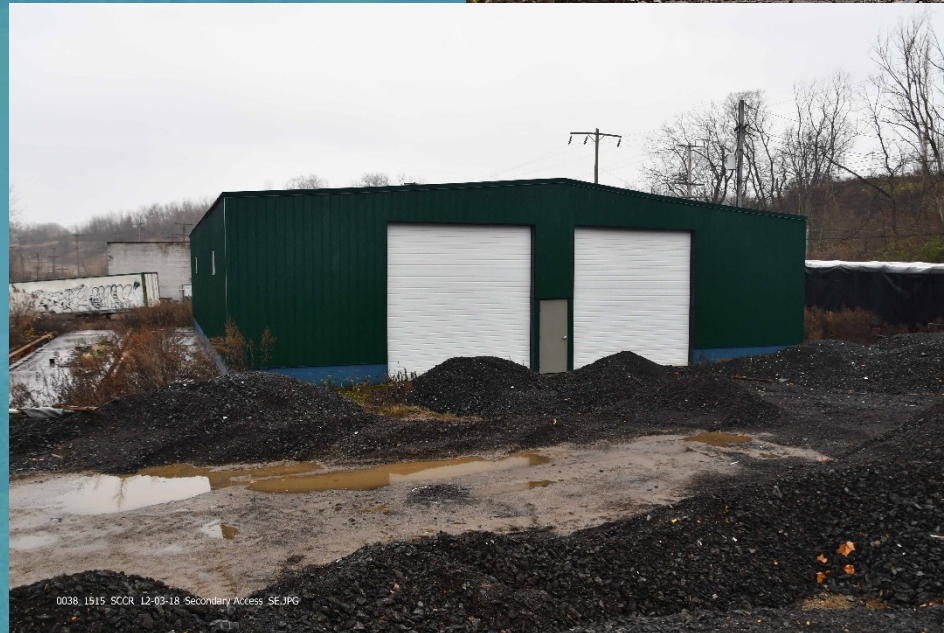
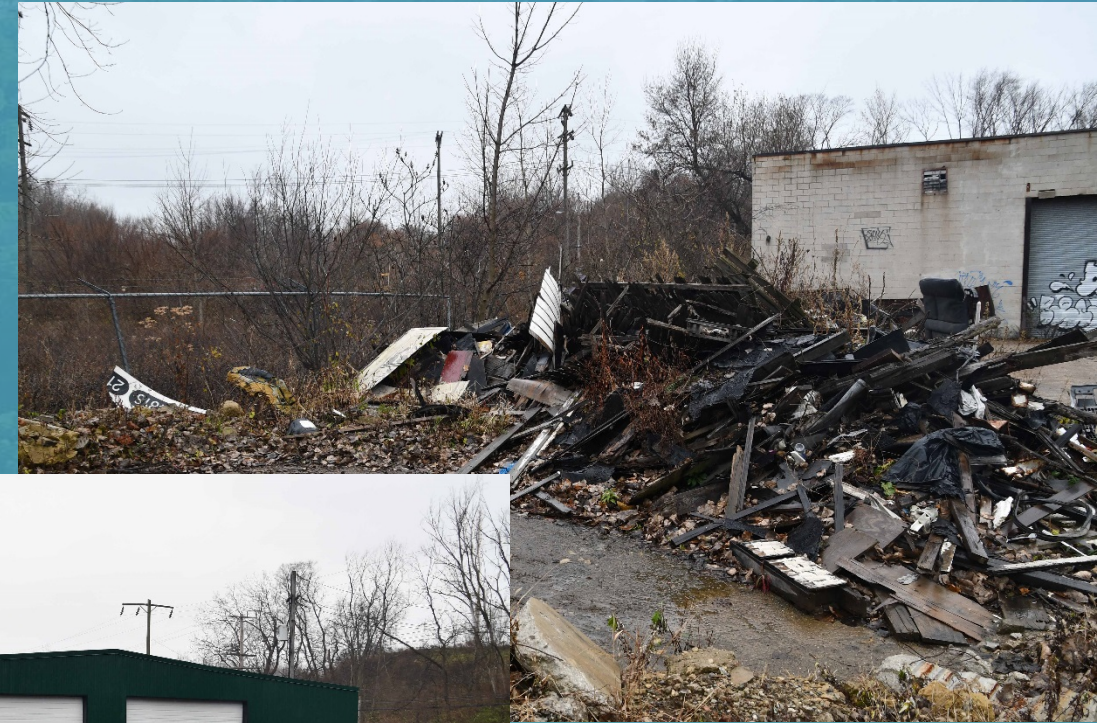
Lesson Learned: Property Issues

- The easement value negotiation process
- Current and future use of the property
- Construction Access
- Debris Stockpiles
- Lateral Connections

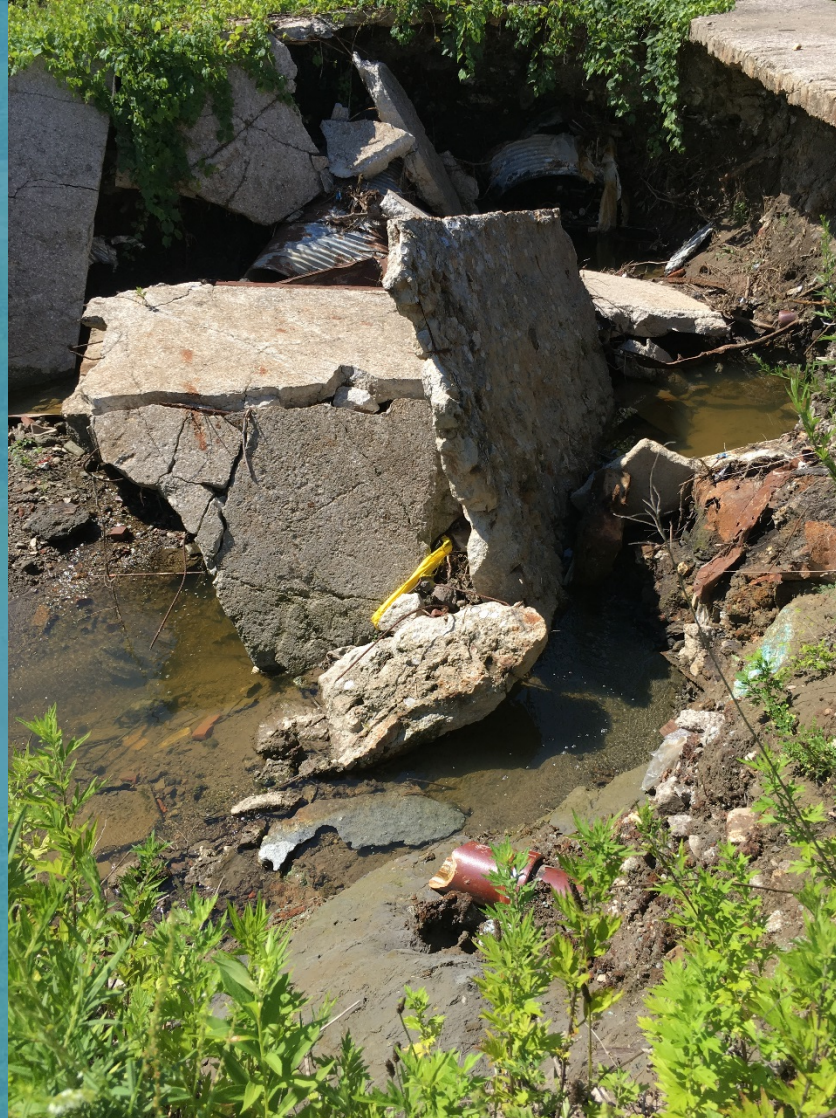
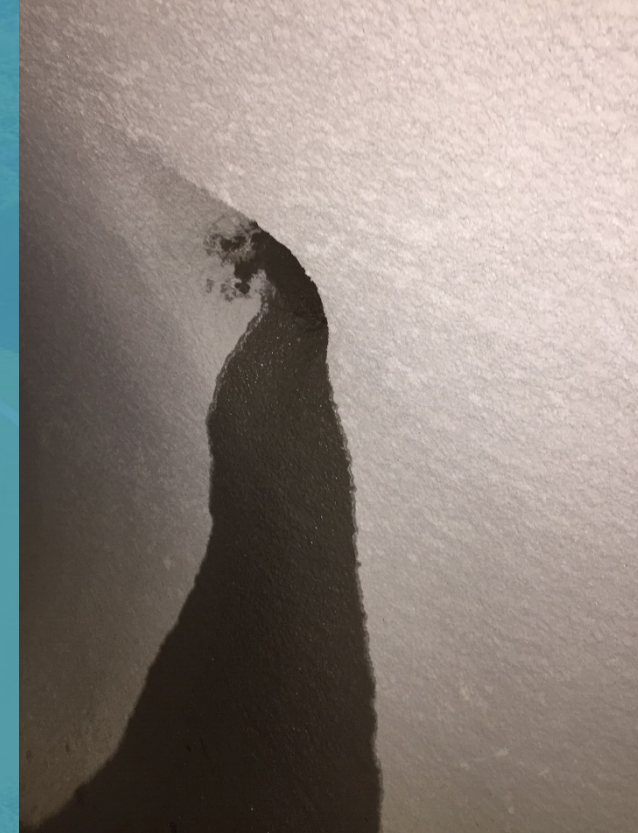
Lesson Learned: Property Issues

- The easement value negotiation process
- Current and future use of the property
- Construction Access
- Debris Stockpiles
- Lateral Connections
