Office Building Green Infrastructure

Permeable Pavement, Rain Garden, Bio-Swales and Bio-Retention

The Sustainable Site

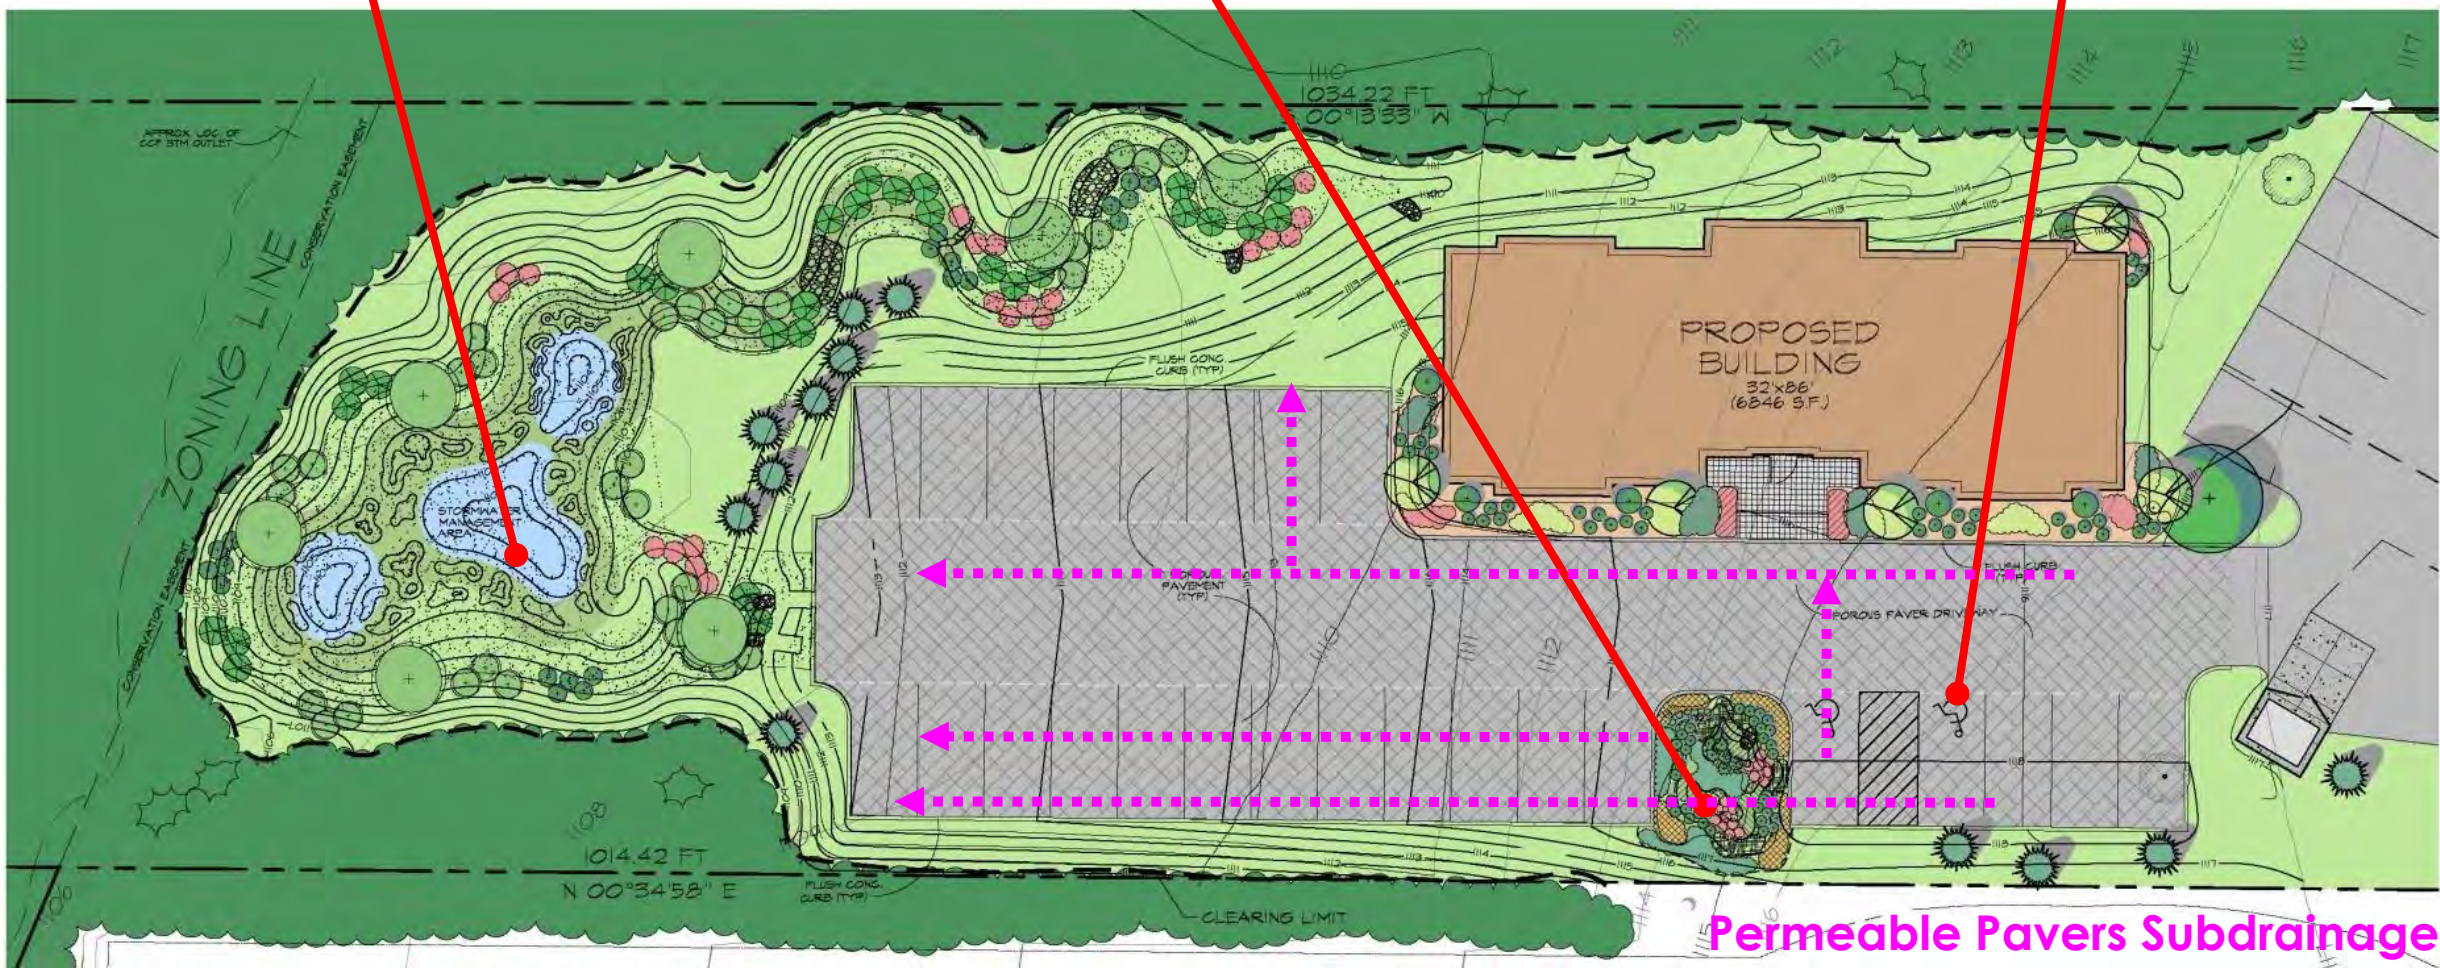
Permeable Pavers Subdrainage

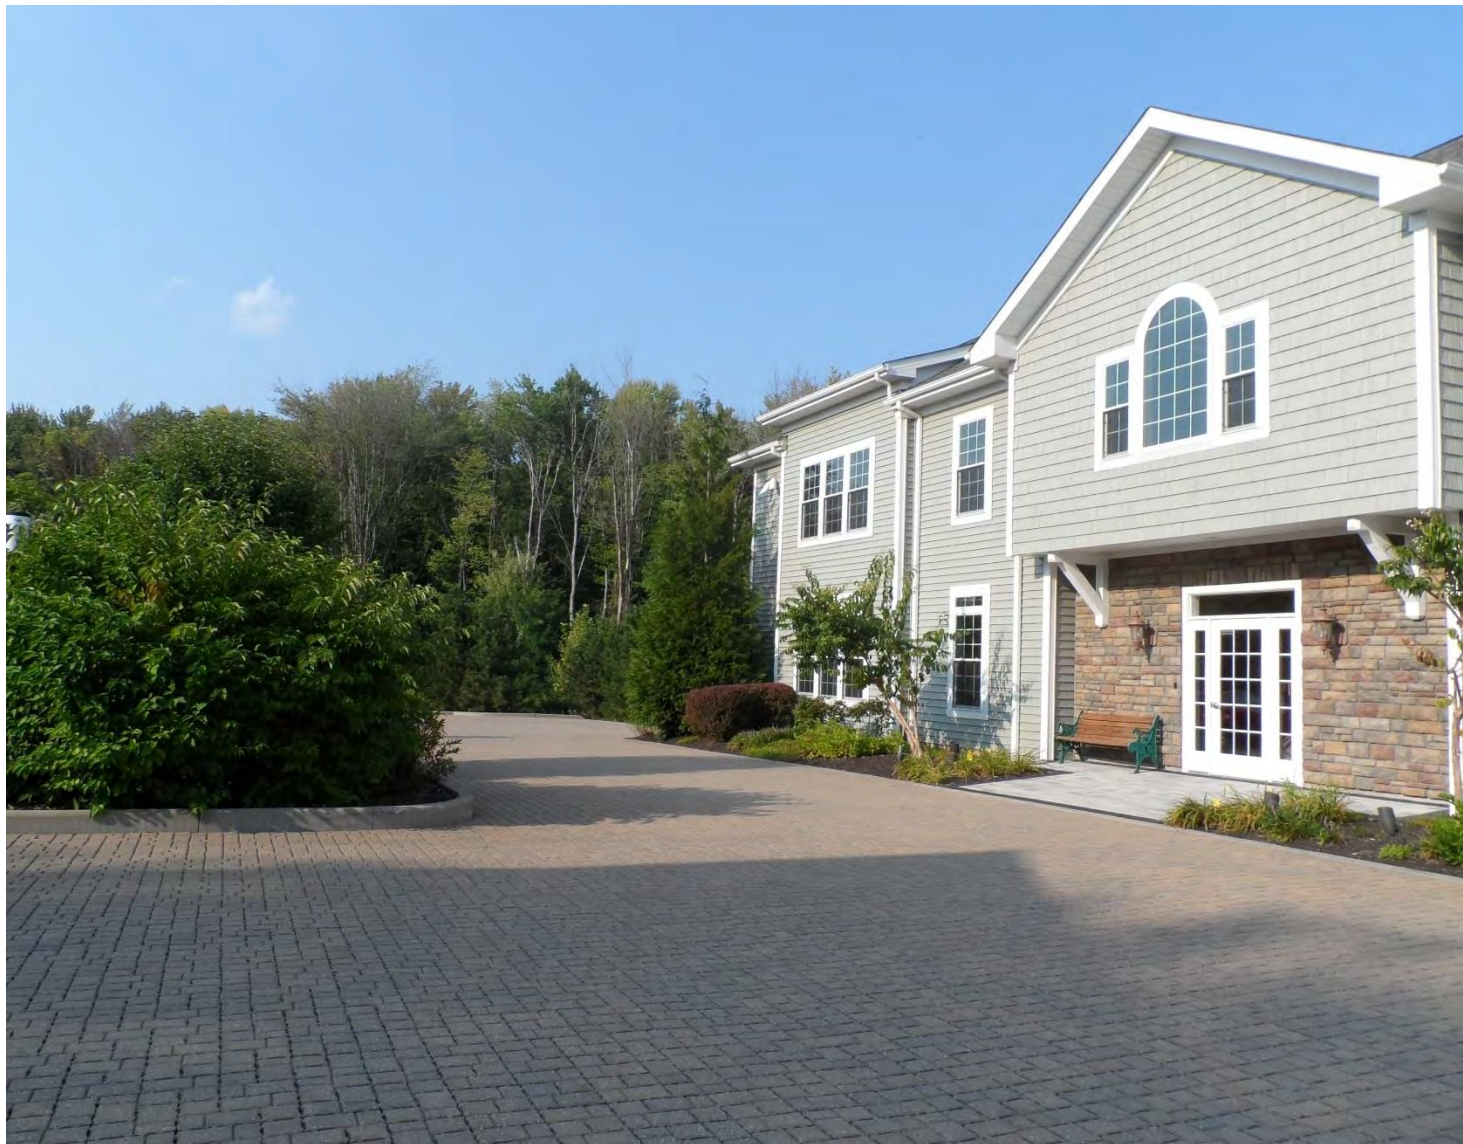
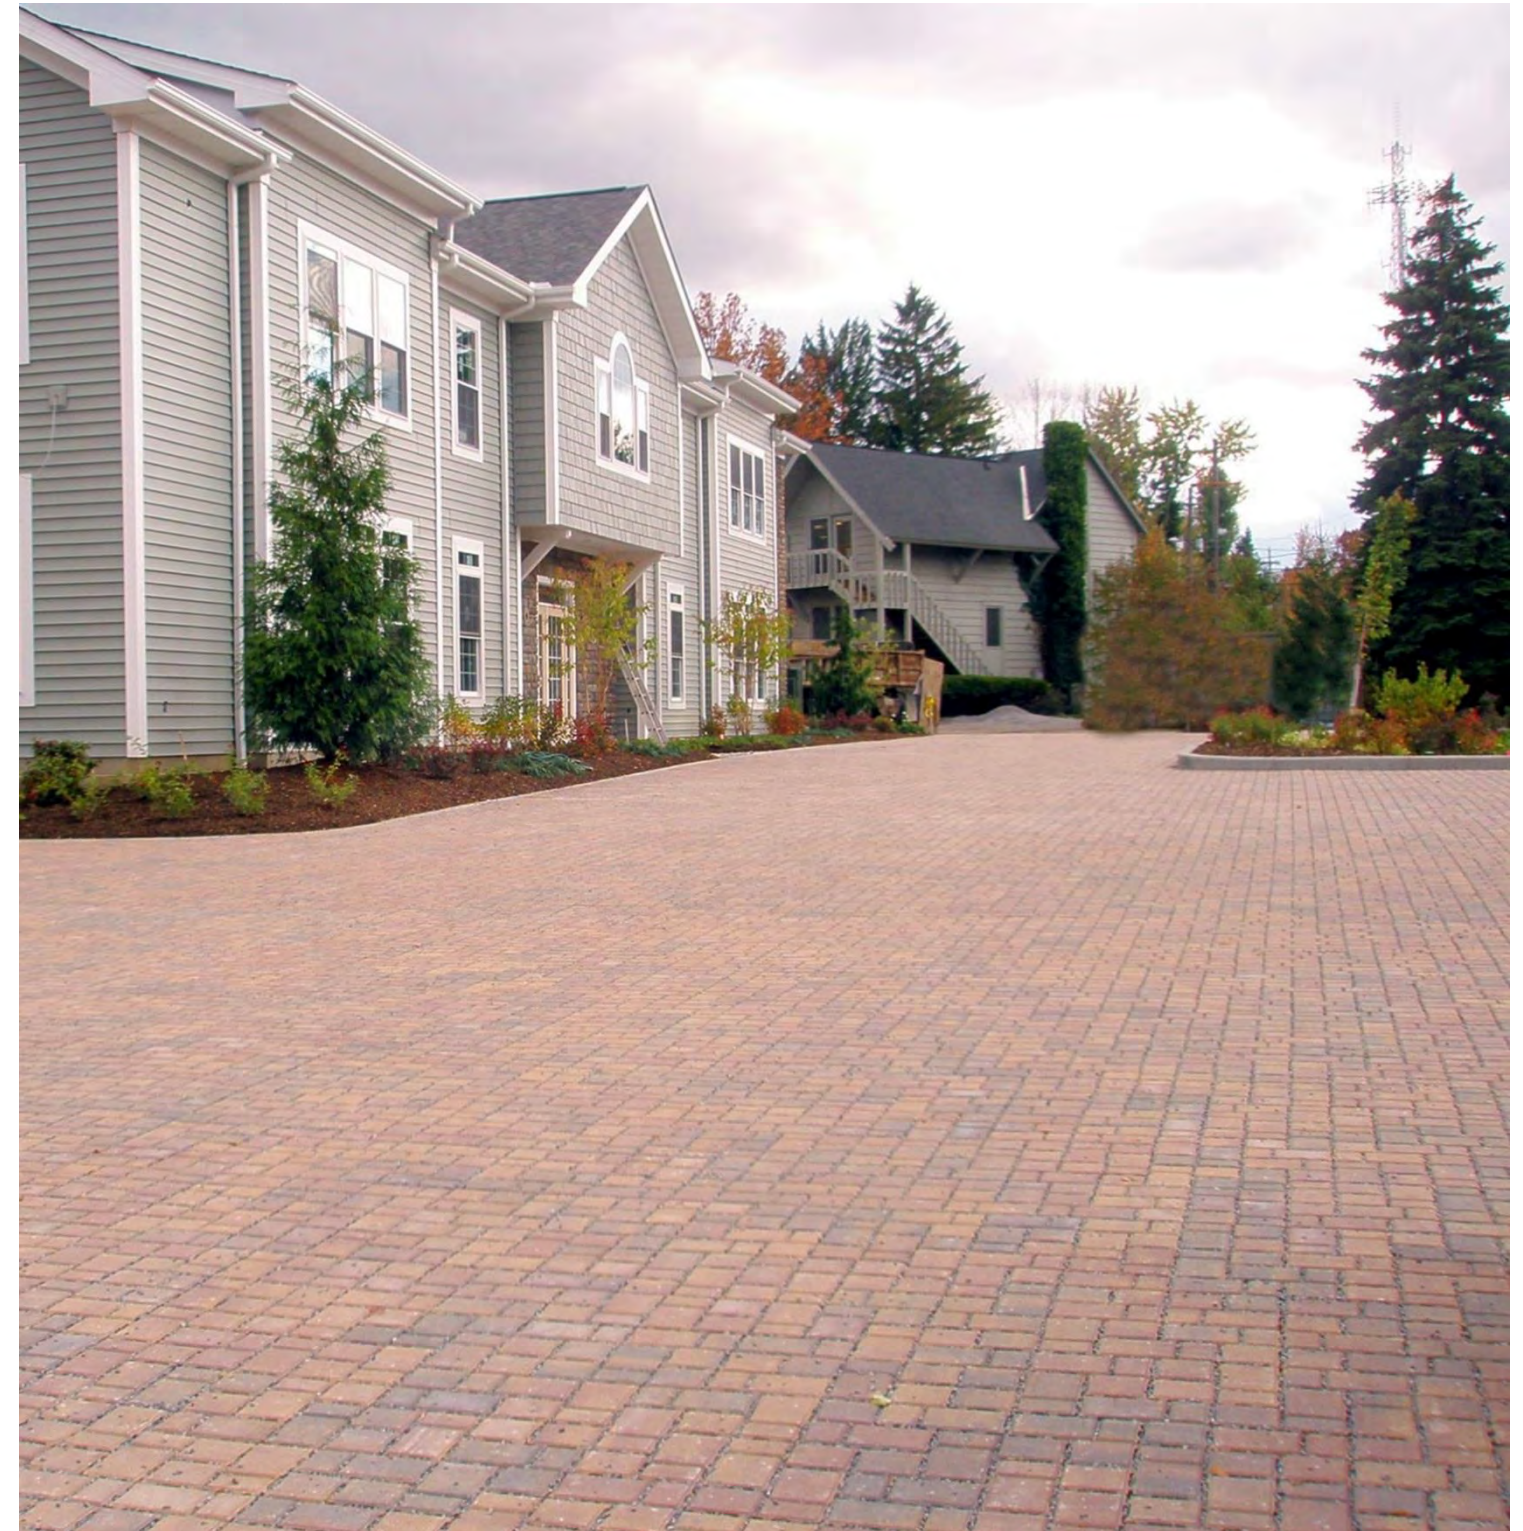
Permeable Pavement Construction

- Permeable pavement using concrete pavers
- 25 cars, 8,200 s.f.

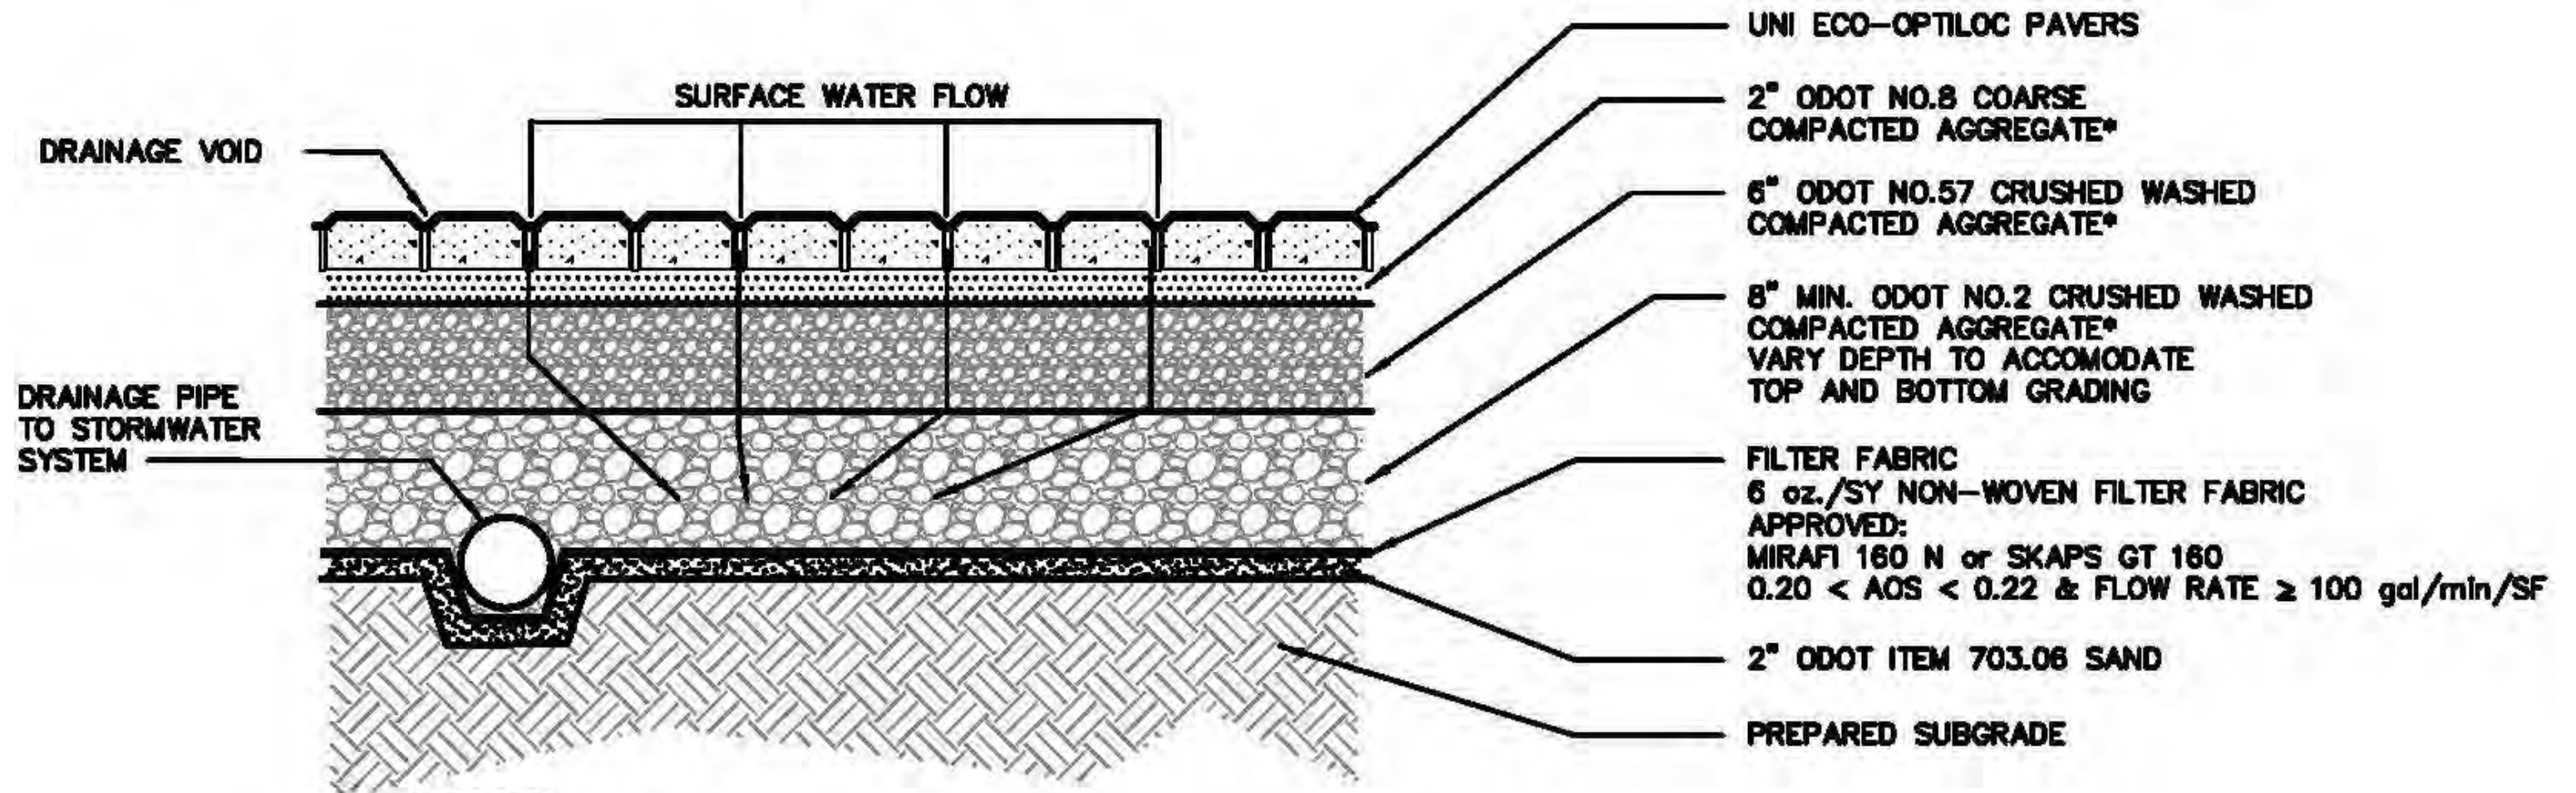
ECO-OPTILOC PAVER SECTION

Permeable Pavement

ALL AGGREGATE COMPACTED TO 70% RELATIVE DENSITY DETERMINED BY ASTM D 4252 AND ASTM D 4253.

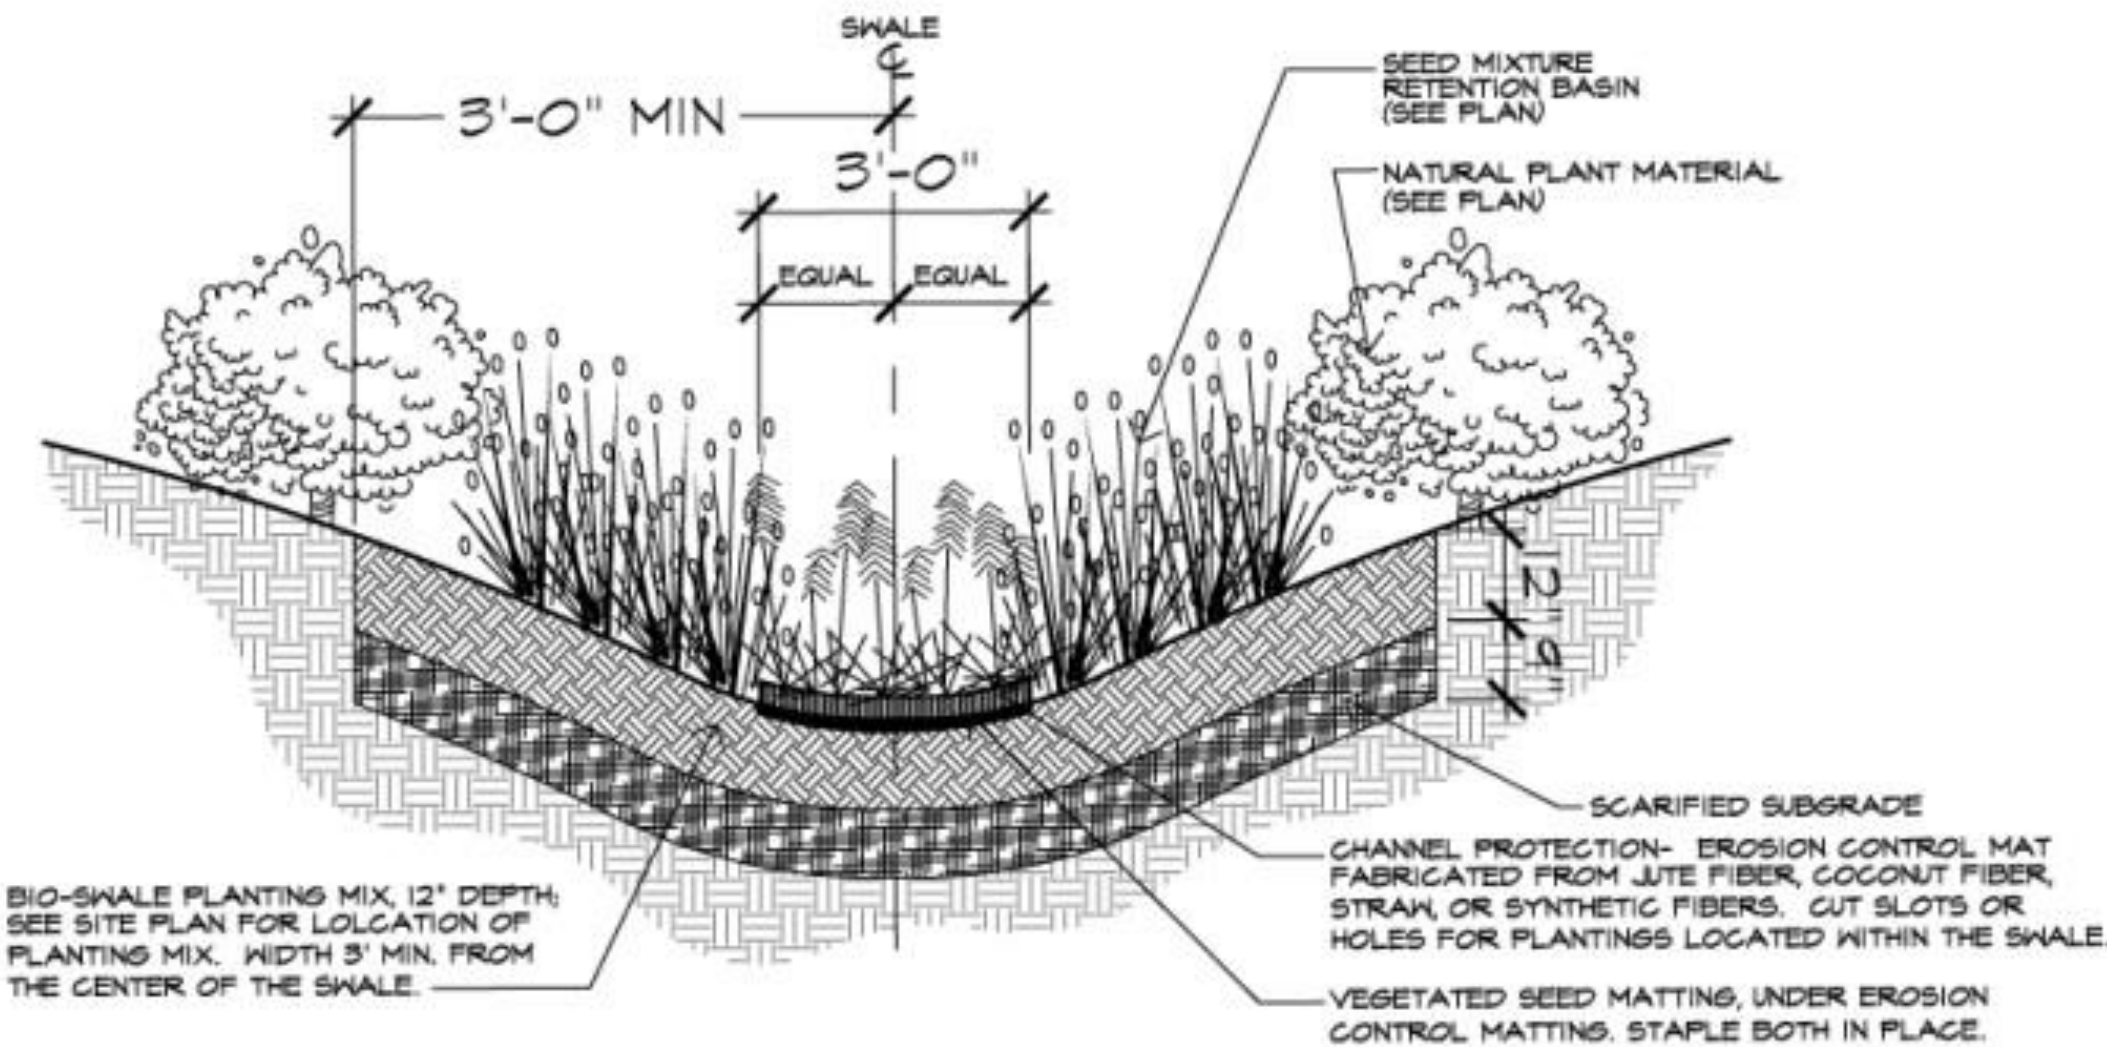
TYPICAL BIO SWALE SECTION

Bio-Swale Section

NOTE: INSTALL EROSION CONTROL MAT PER MANUFACTURER'S RECOMMENDATIONS

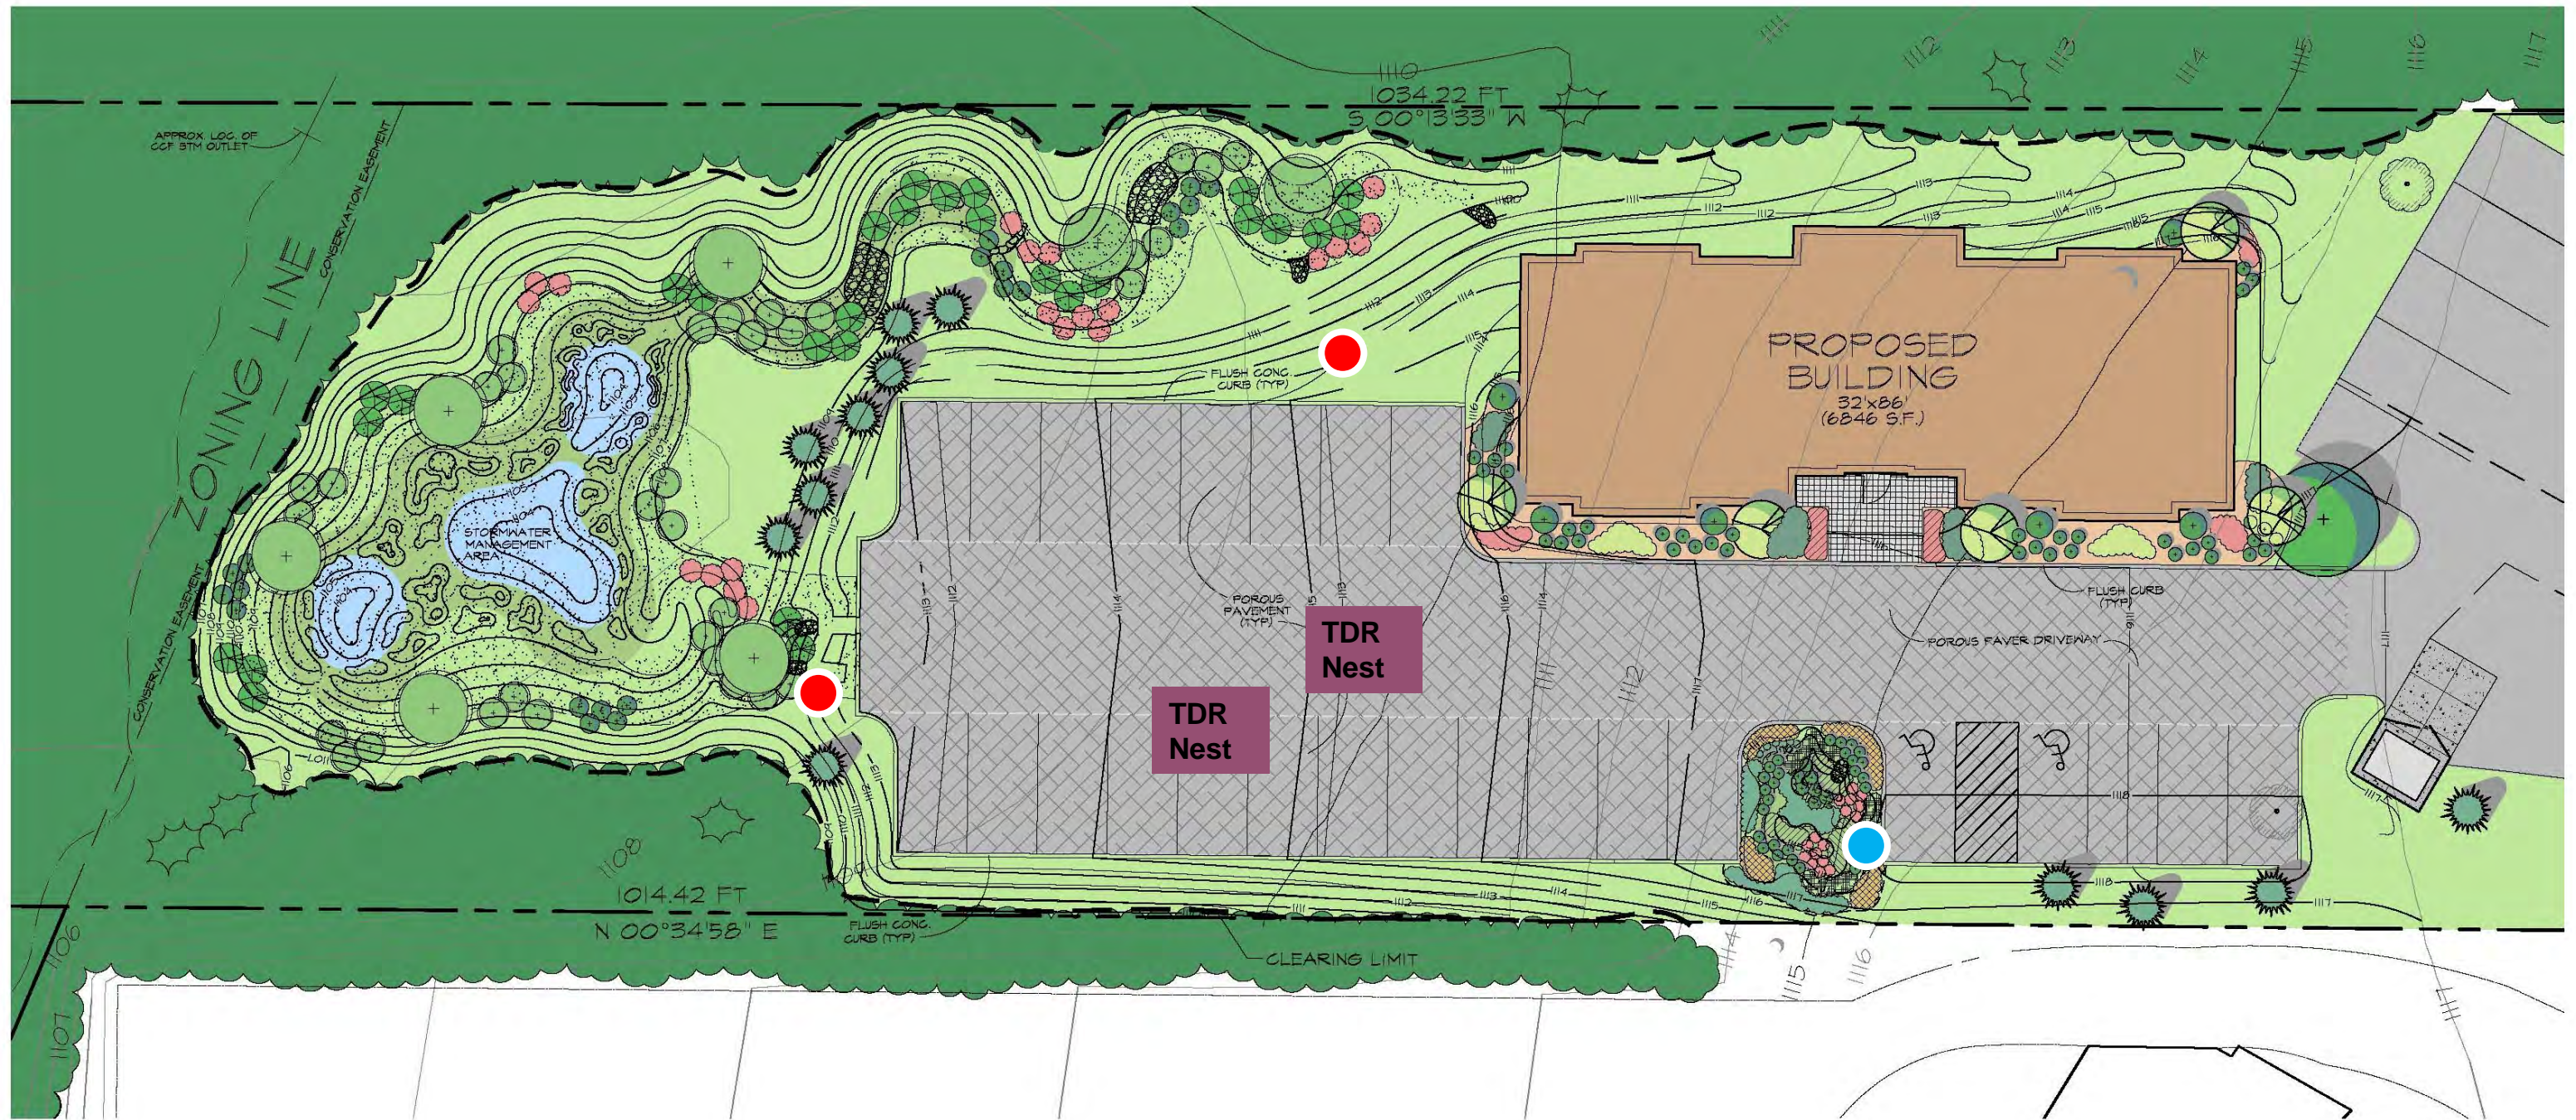
Monitoring Equipment

Automatic Samplers and Flow Gauge ●

Rain Gauge ●

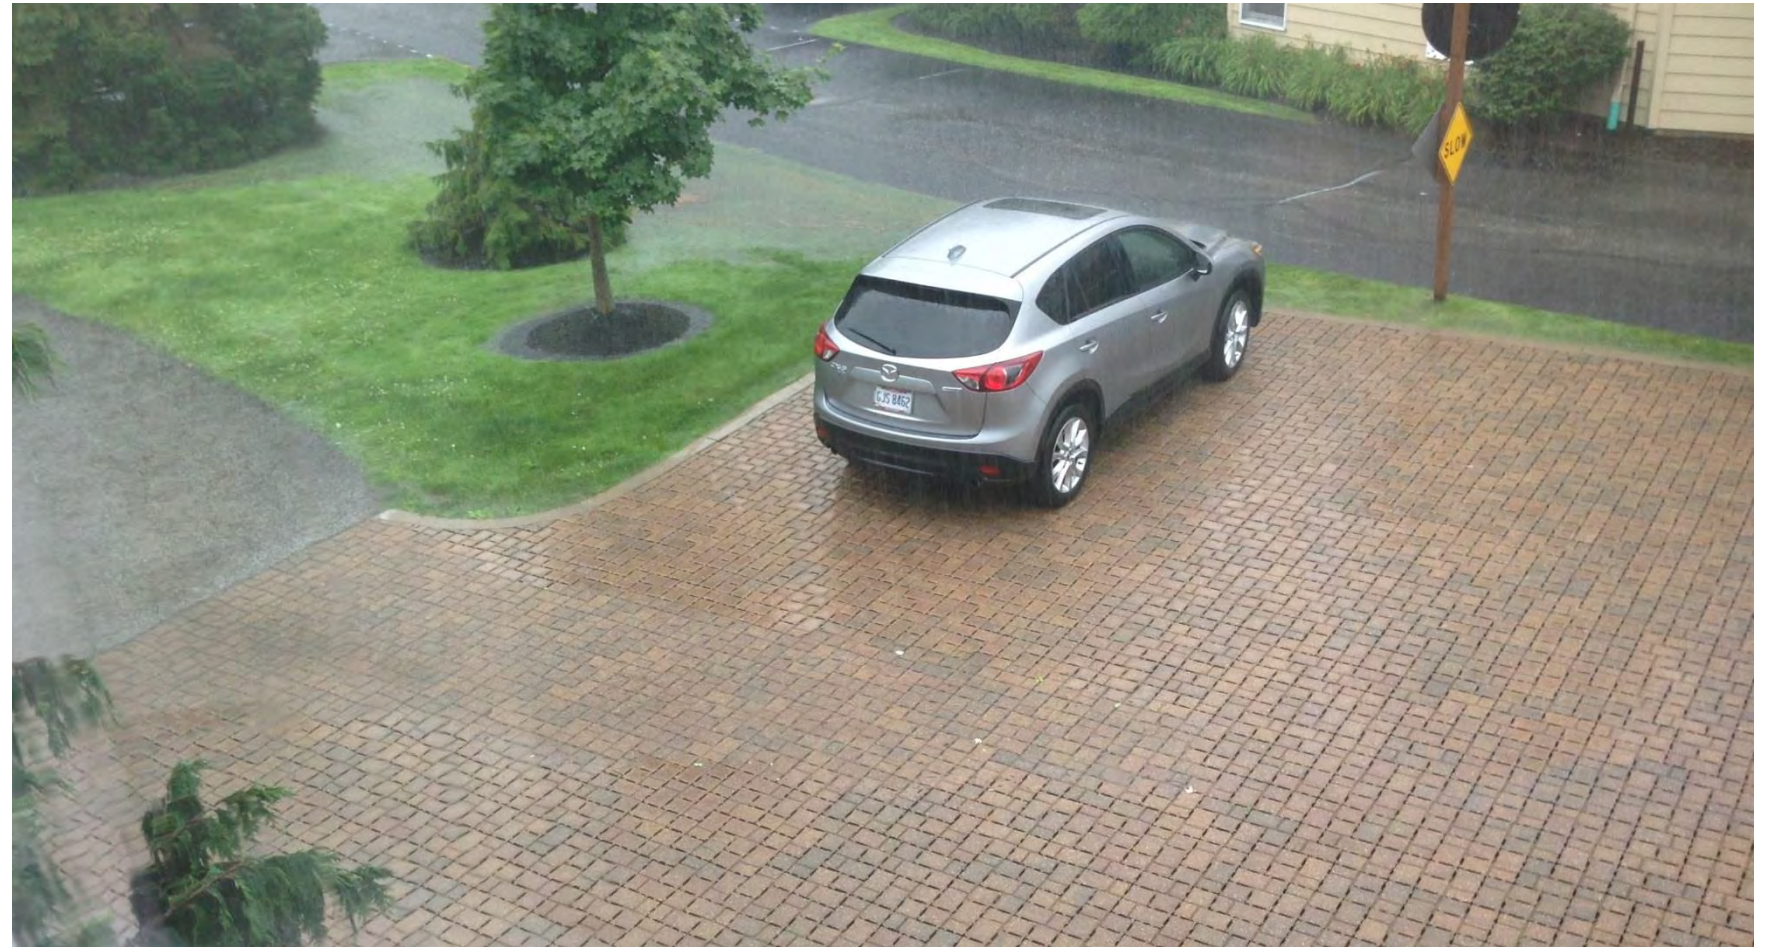
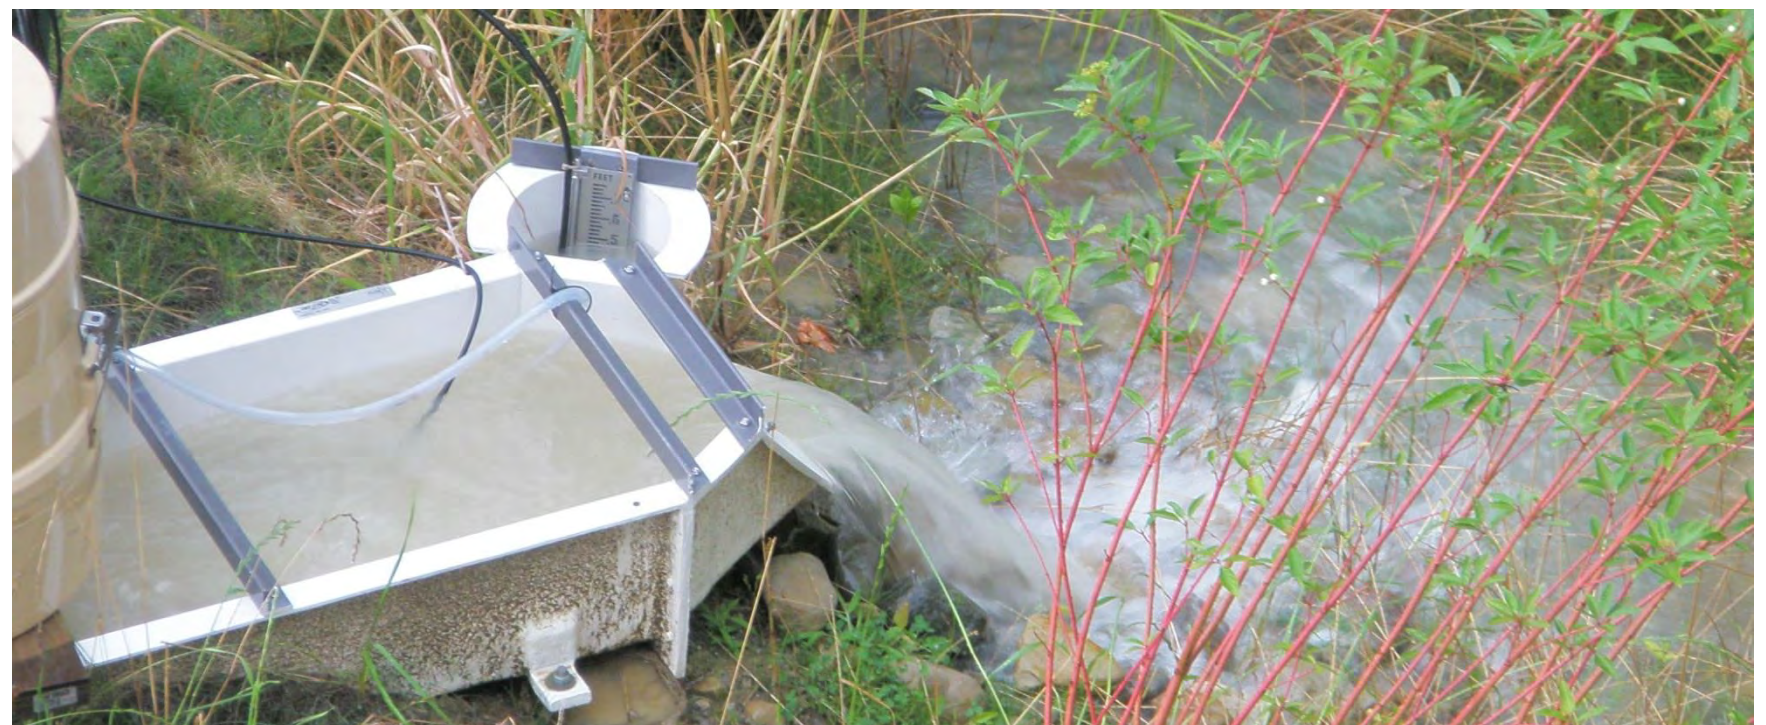
A Case Study – Data Summary

- 5 of 30 rain events less than 0.2 in.
 - 63% average reduction of runoff
 - 40 minutes delay from the beginning of rain event to discharge
- 25 of 30 events of total rain between 0.31 and 1.57 in.
 - 17% average reduction of runoff
 - 10 minutes delay from the beginning of rain event to discharge
 - Rain events lasting about 26 hours with discharge lasting about 52 hours
- Water Quality Data: No Pollutants of Concern from Pavement

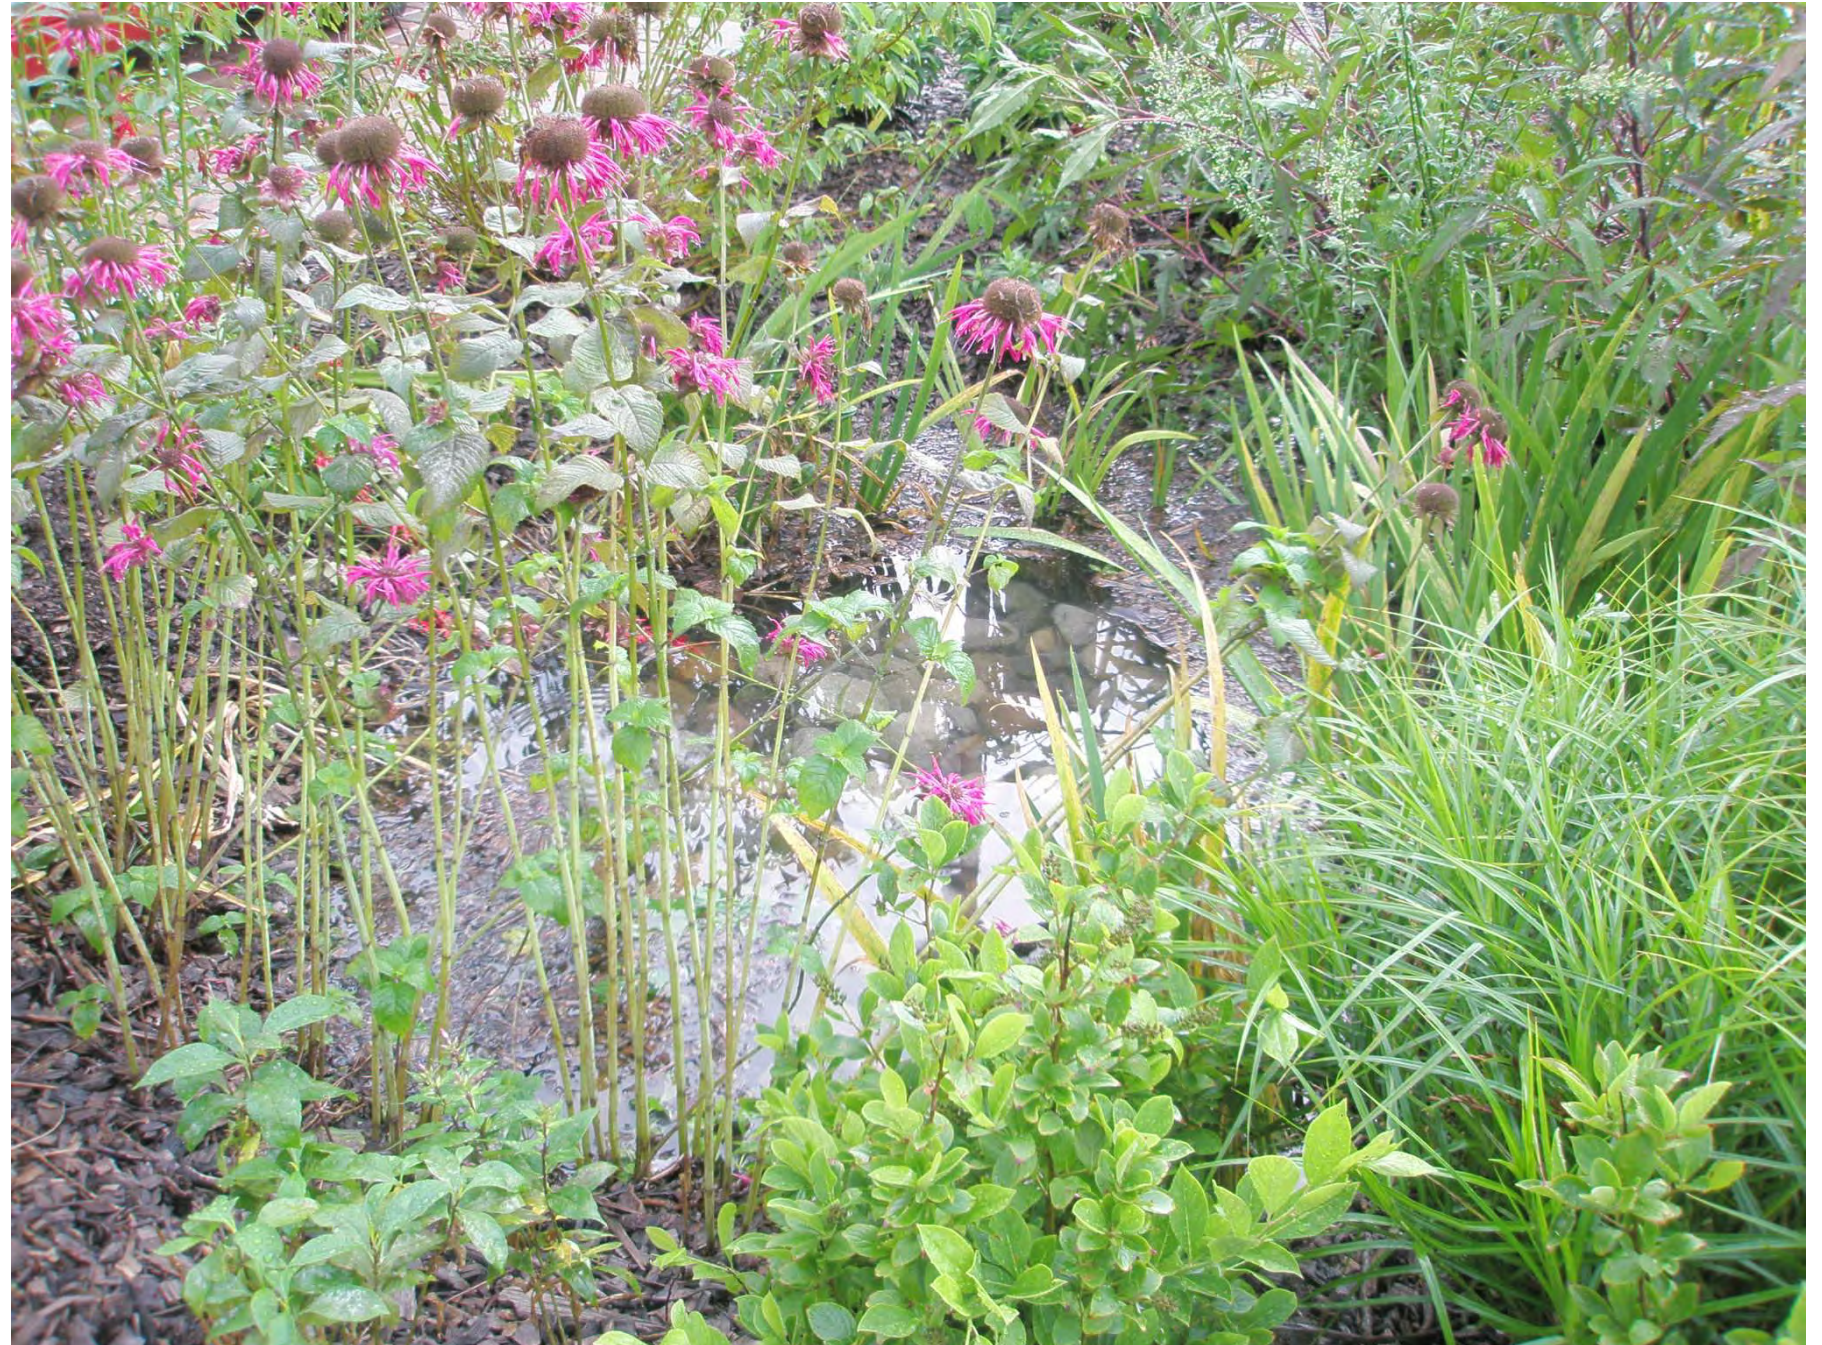
A Case Study – Data Summary

Permeable Pavement Findings

- Preferential Pathways forming within Aggregate Base Material

Rain Garden Findings

- Adding to Runoff Reduction Volumes, Evapotranspiration
- Maturing plantings and root structure penetration into Soils
- Underlying soils creating deeper infiltration

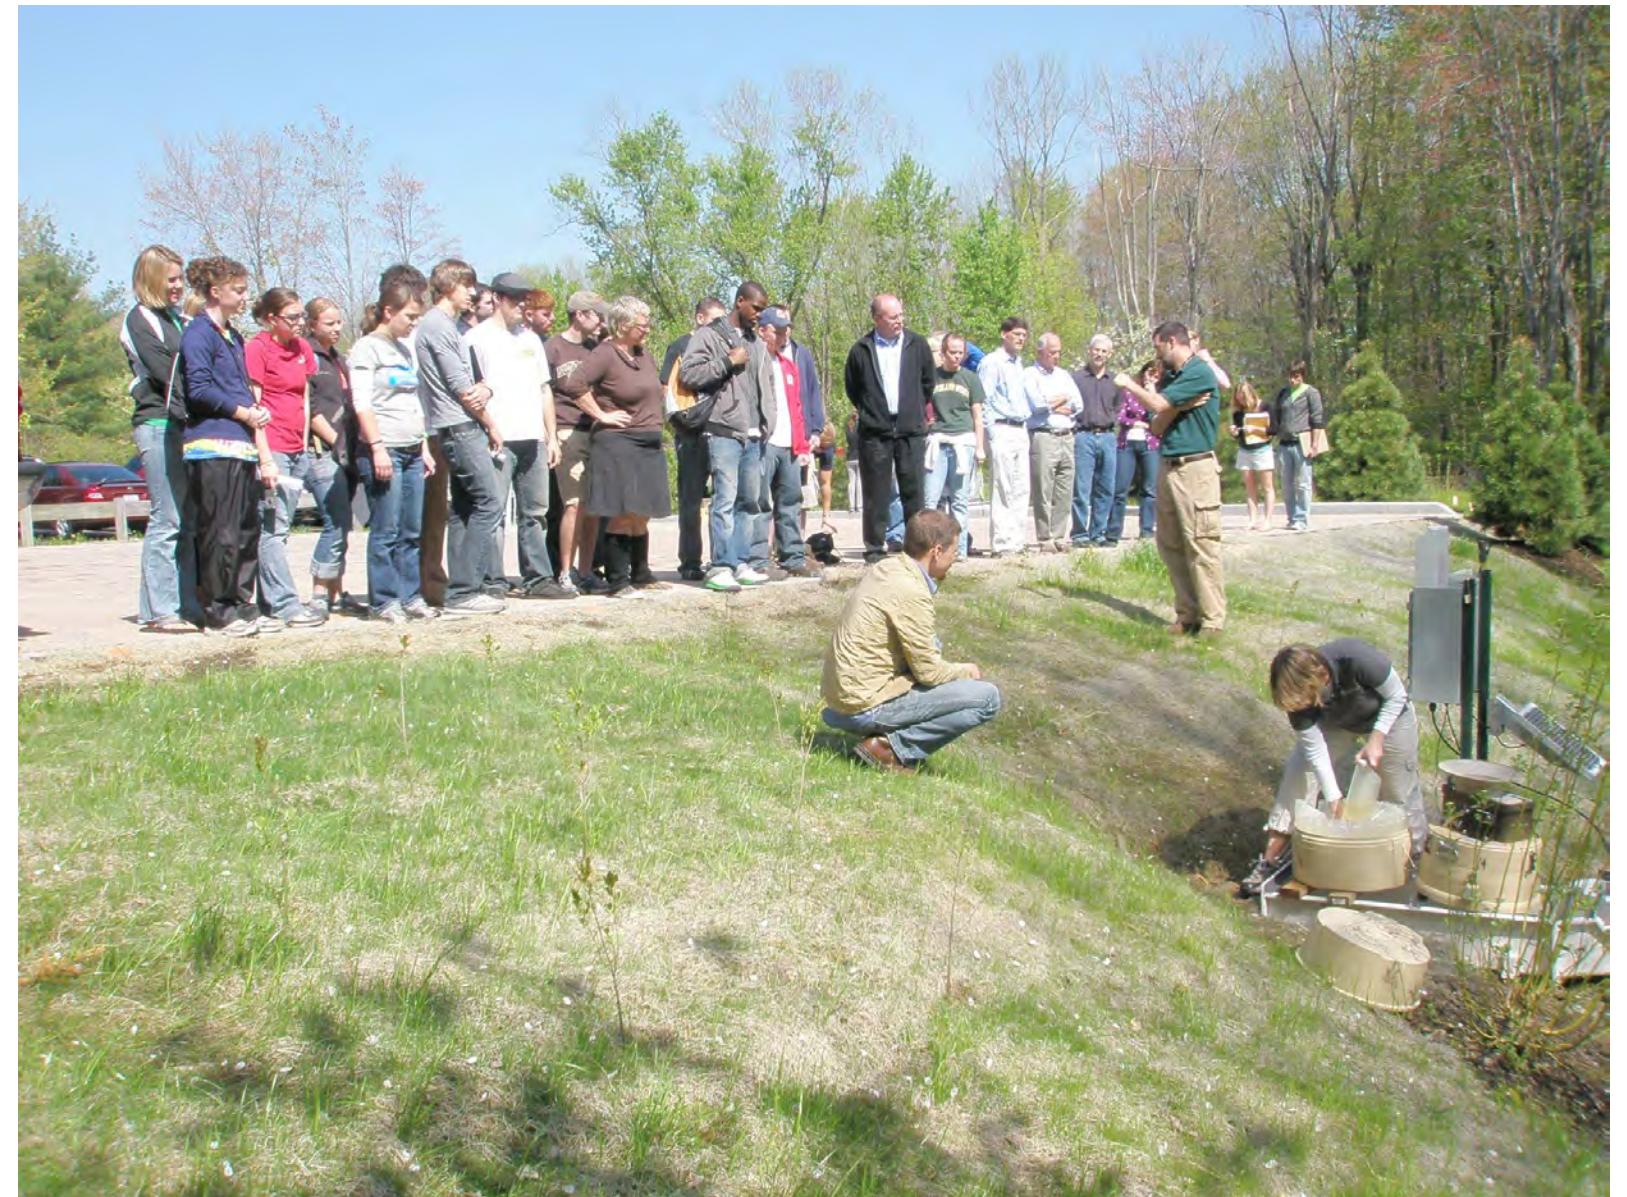
A Case Study – Data Summary

Water Quality Data Summary

- Phosphorus levels below threshold of 0.08 mg/L for Headwater Streams Dissolved nitrate and nitrate levels below threshold of 1.0 mg/L for Headwater Streams
- Low levels of chloride detected during winter, especially during the spring, most events below 30 mg/L
- Chloride concentrations of 230 mg/L may impair aquatic life over time in freshwater ecosystems
- Dissolved Heavy Metal Data TBA
