Office Building Green Infrastructure

Permeable Pavement, Rain Garden, Bio-Swales and Bio-Retention

The Sustainable Site

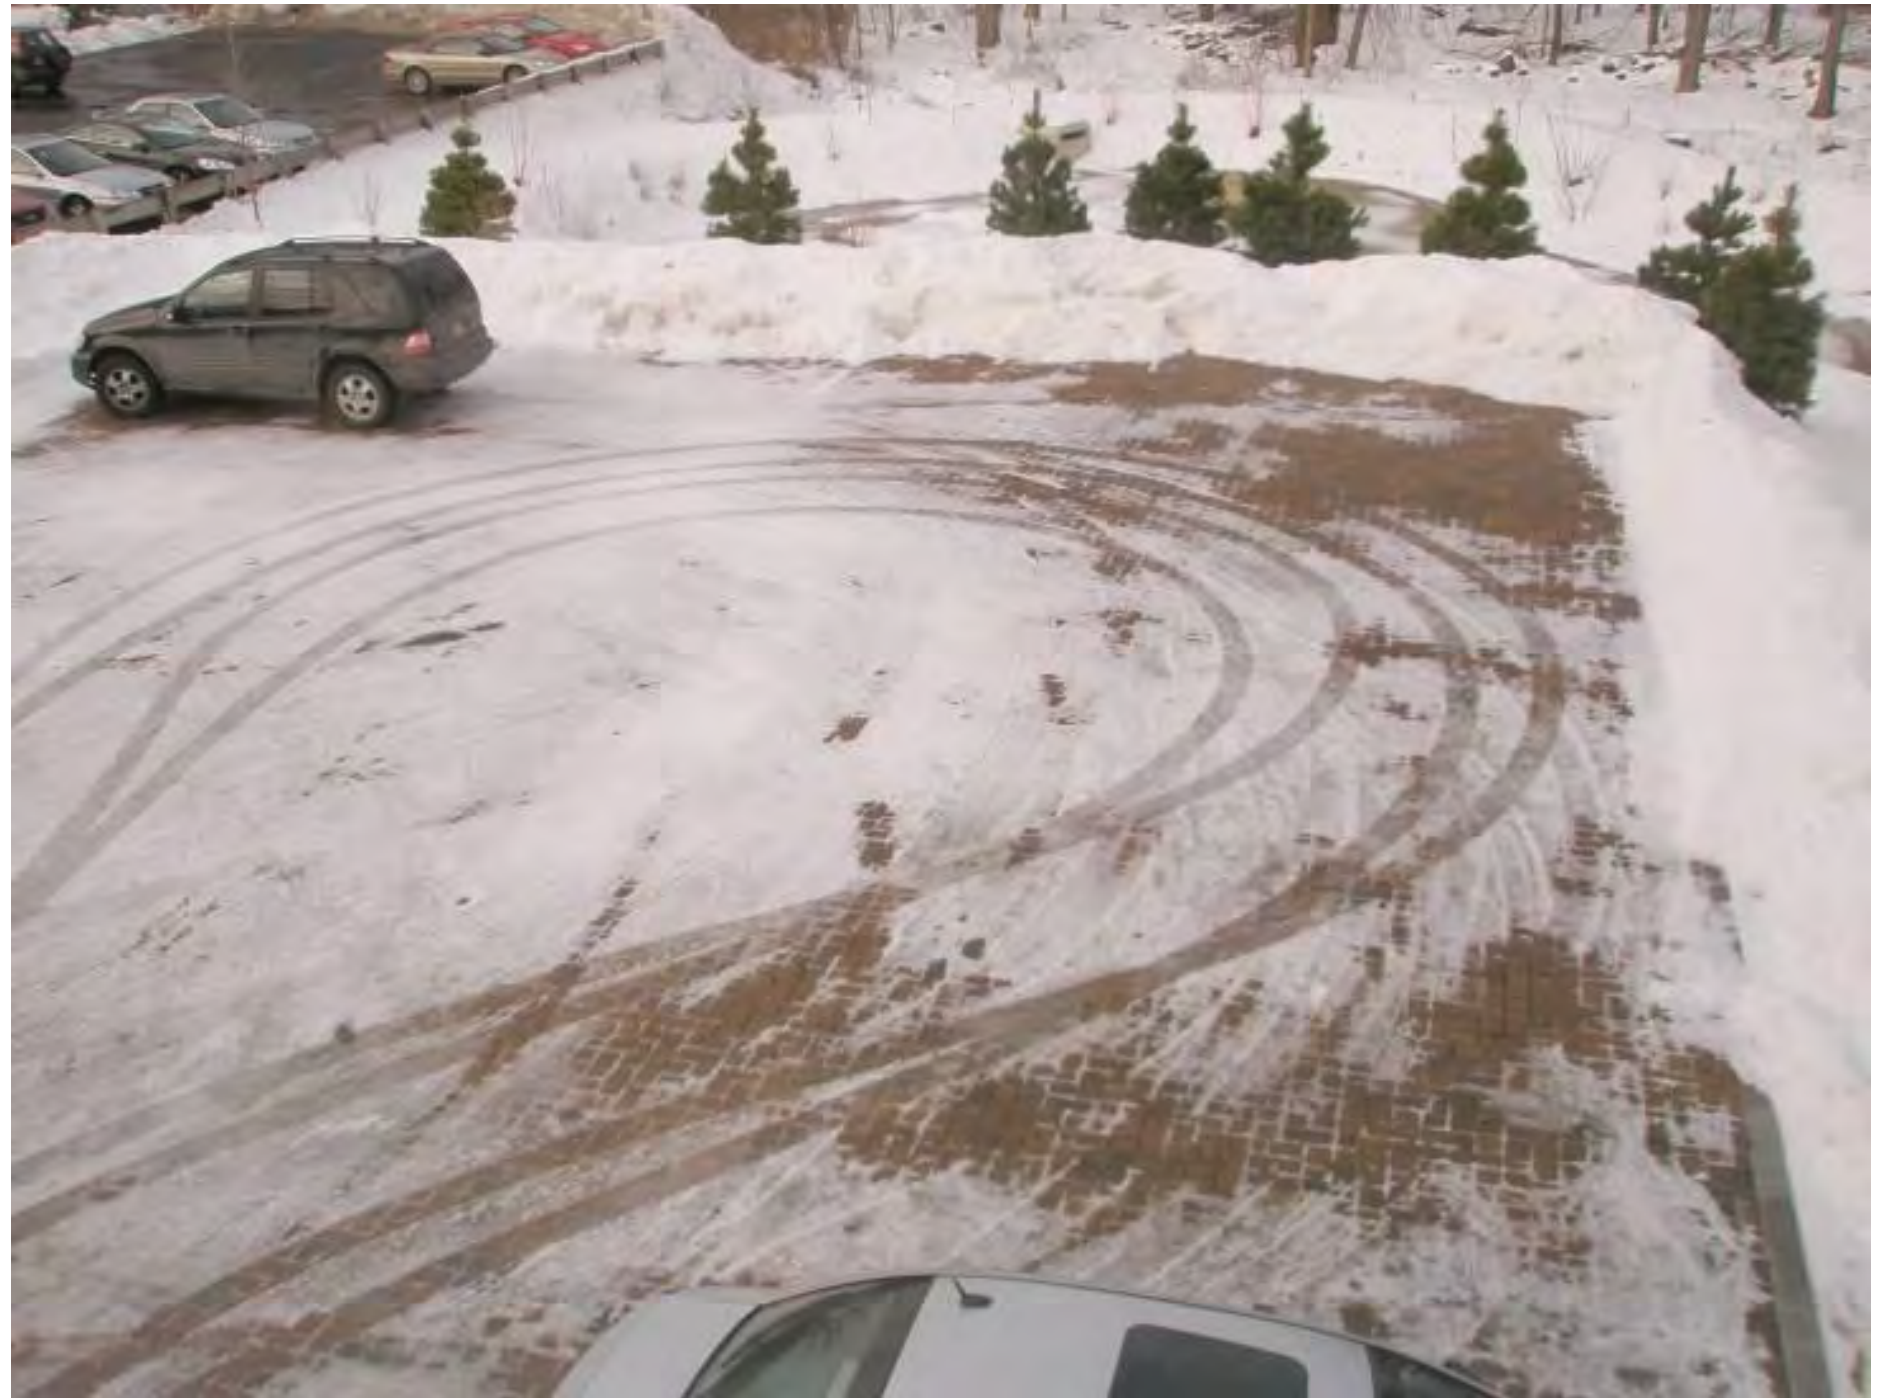
A Case Study – Conclusion

Permeable Pavement System

- Pavement System ability to self-de-ice and commitment to managing de-icing applications reduces the presence of increased levels of chloride in stormwater runoff.
- Permeable Pavers allow for normal snow plowing equipment which includes metal snow plowing blades.

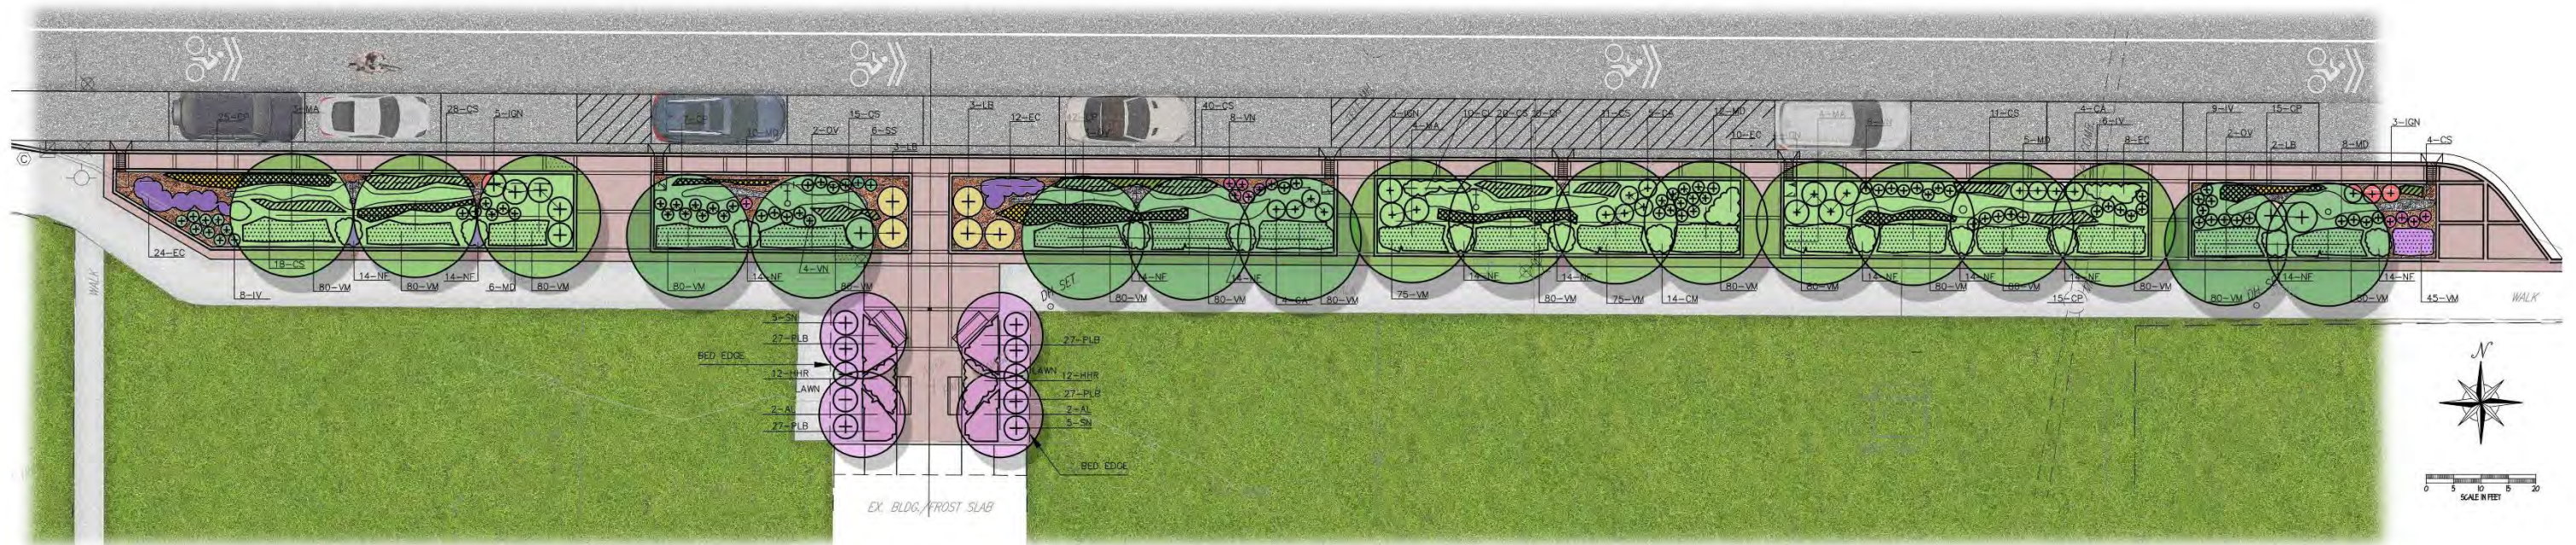
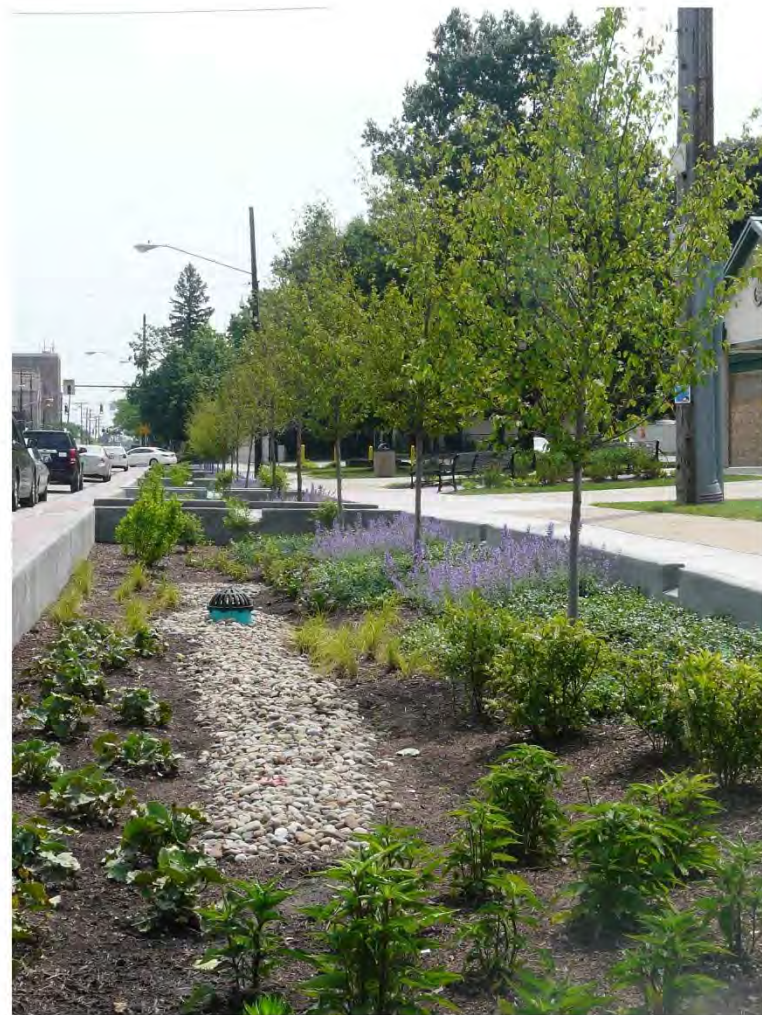
GRATE & FRAME DETAIL

PLANTER ADJACENT TO STREET

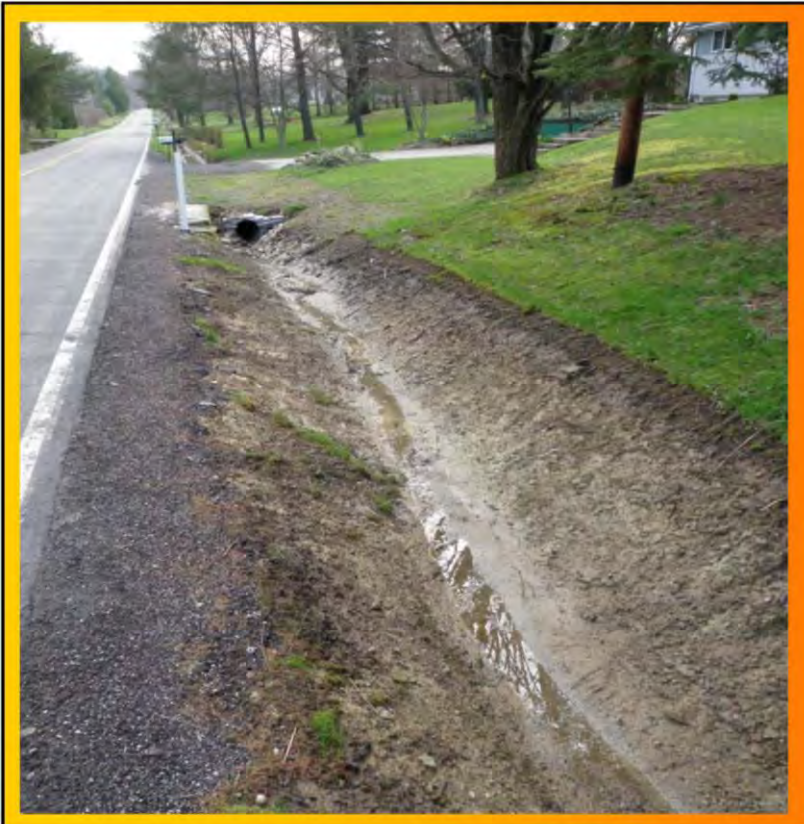
TRADITIONAL STORMWATER SYSTEMS...

*Composed of pipes and
roadside ditches*

*Designed to move stormwater
as fast as possible*

*Send large amounts of untreated
polluted stormwater and sediment
into unprotected waterways*

*Harm stream health and
lower water quality*
