## Engineered Log Complexes: It's the wood that makes it good.

Suzanne Hoehne, Biohabitats Josh Myers, CRWP Ohio Stormwater Conference May 8-10, 2019

## Marcourt Farms River Restoration

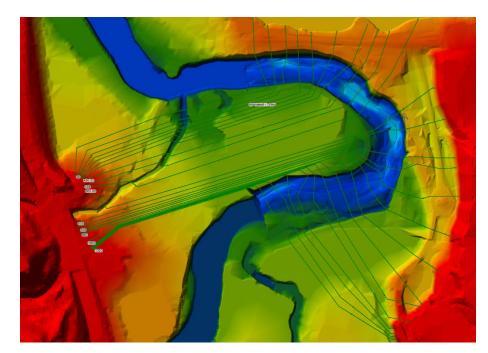
- Geomorphic Assessment
  - Watershed & reach scale
  - Sediment transport
  - Habitat features riffle/pool sequences
  - Bank stability soils
  - Historic indicators
- Discharge modeling
  - HEC-RAS
  - Scour predictions
  - Climate change impacts

- Topography
  - Lidar
  - GPS/Total station
  - Channel profiles and cross sections
  - Existing and downed trees
  - Site constraints/existing infrastructure

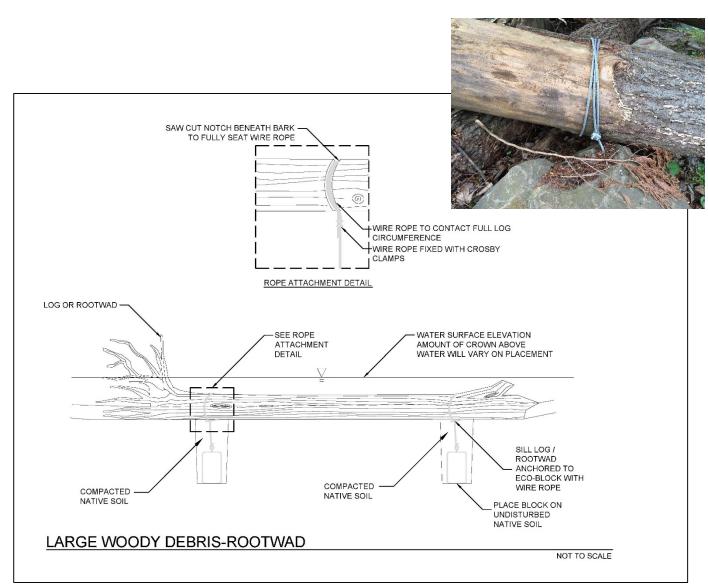
- Materials selection
  - Size, shape, decay rates
  - Local availability
  - Drag, buoyancy
- Calculations
  - Displacement (submerged volume) of wood
  - Buried surface area of wood and skin friction
  - Surcharge (gravitational load acting on wood)

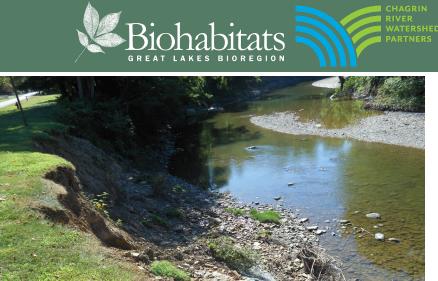
Downstream 7/30/2015

- Revisited site July 30, 2015
  - Bank downstream rapidly eroding, threatening road and bridge and impacting water quality
  - Landowners required immediate action on downstream section – riprapped slope
  - Erosion at project site increased from 2013 to 2015

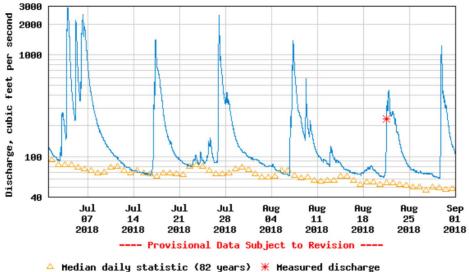
USGS 04209000 Chagrin River at Willoughby OH
