# Siting & Prioritizing Green Infrastructure for Phosphorus Reduction

Lower Stony Brook Green Infrastructure  
First Baptist Church Bioretention

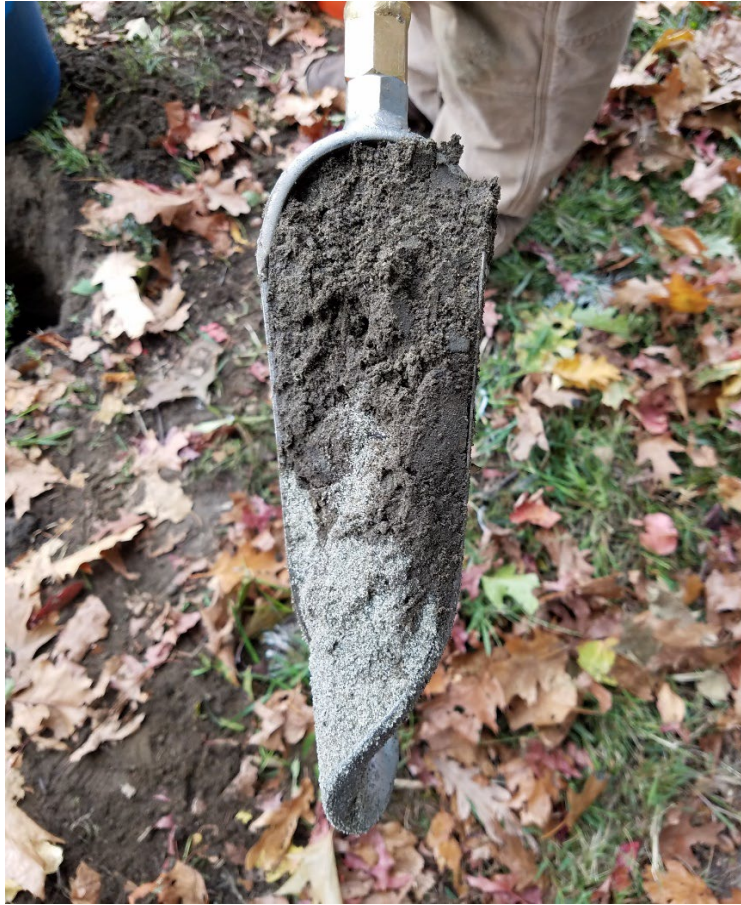
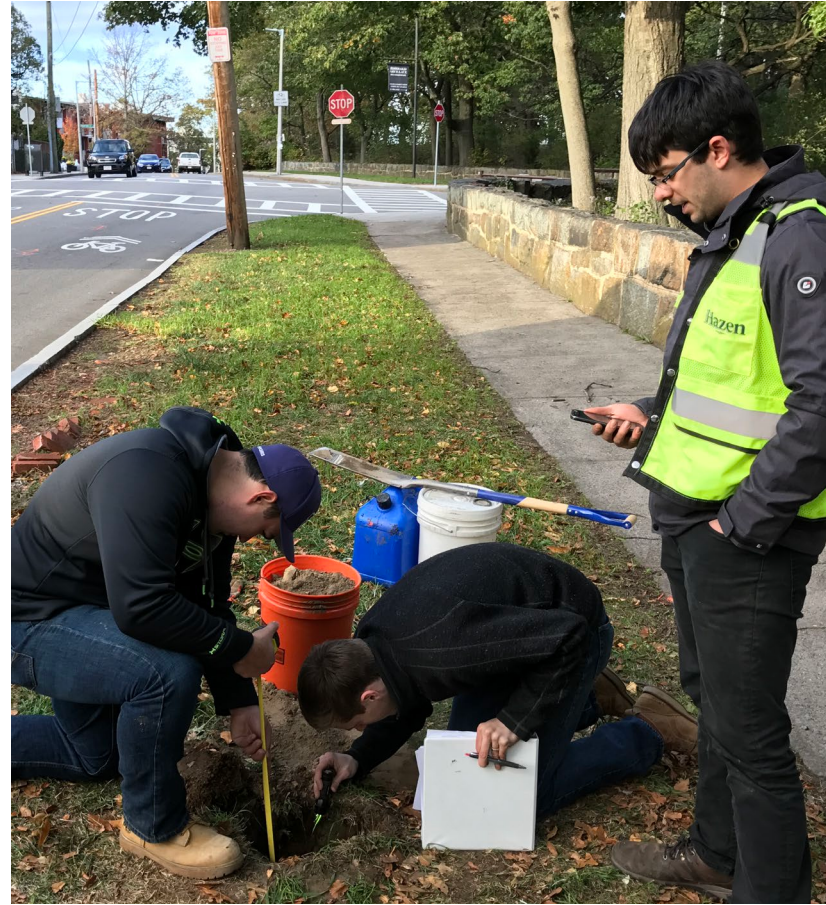
# Hand Auger Characterization and Infiltration Testing

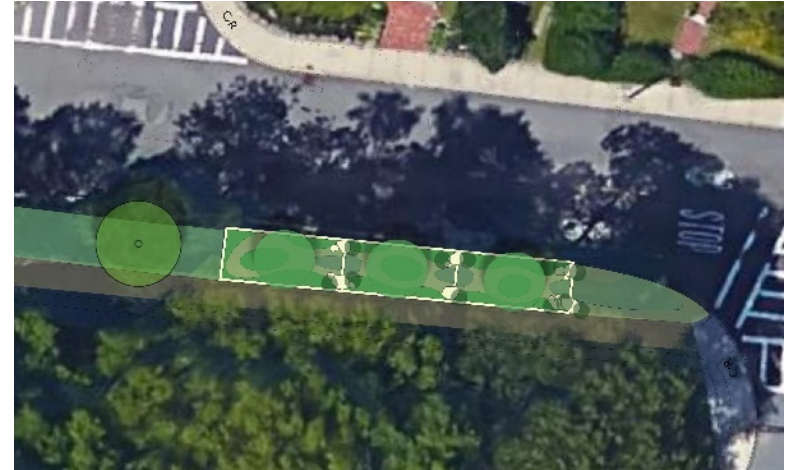
Example: Walnut Ave.

## Right-of-Way Bioretention

- Linear bioretention implemented within the ROW
- Treatment of adjacent ROW runoff through curb cuts and other diversions

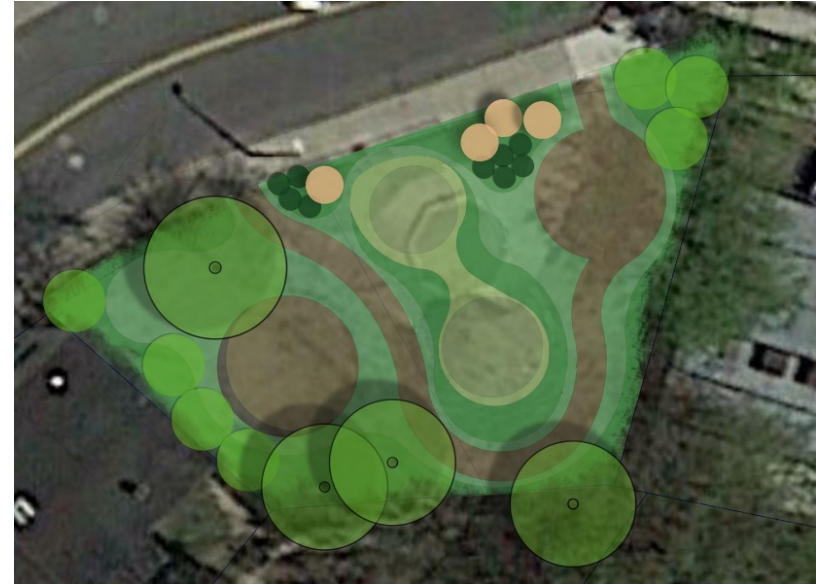
Example: Amory St. & Dimock St.

## Small Catchment Bioretention

- Bioretention on a public or private property
- Treatment of adjacent areas  $< 1$  ac
- Often sited in grassed areas, small parks, or other open spaces

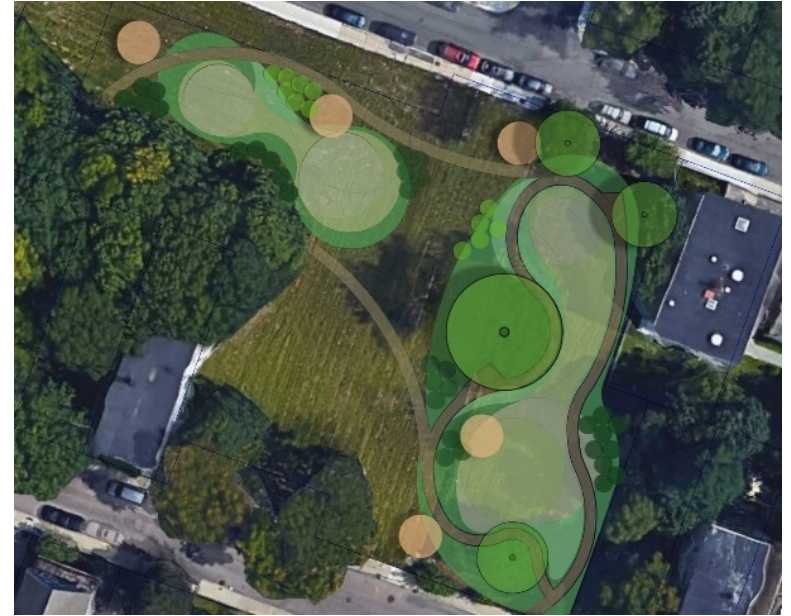
Example: Harold St. & Hollander St.

## Large Catchment Bioretention

- Bioretention on a public or private property
- Treatment of adjacent areas  $> 1$  ac
- Multiple drainage diversions, disconnections, and street crossings typical
- Often sited in vacant lots or other large open spaces

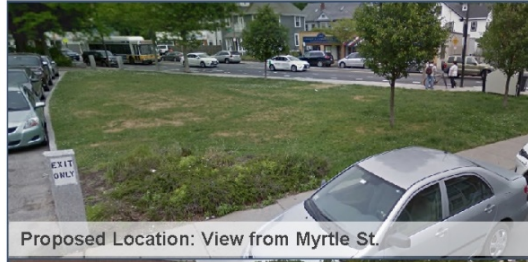
Proposed Location: View from Myrtle St.

The proposed site currently is a large grassed area located adjacent to, and owned by, the First Baptist Church. The proposed bioretention practice footprint was sited to avoid impacting several trees and a church entrance sign which are located around the perimeter.

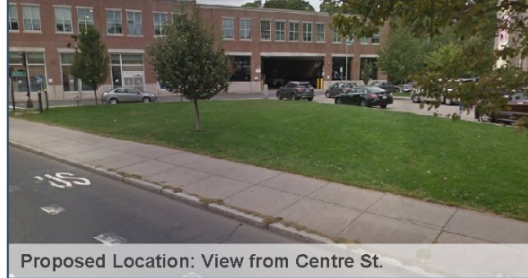
Proposed Location: View from Centre St.

A bioretention practice could be constructed in the grassed area adjacent to the church and the intersection of Centre St. and Myrtle St. Inlet routing may impact utilities within the sidewalk and may require utility relocation. This area could be a centerpiece of public demonstration due to its location next to a major thoroughfare (Centre St.), an adjacent bus stop, and bicycle lane.
