# Commercial GI Retrofits: Construction, Performance, and Maintenance

Ohio Stormwater Conference – Sharonville, OH

May 10, 2019

# Reynoldsburg Meijer

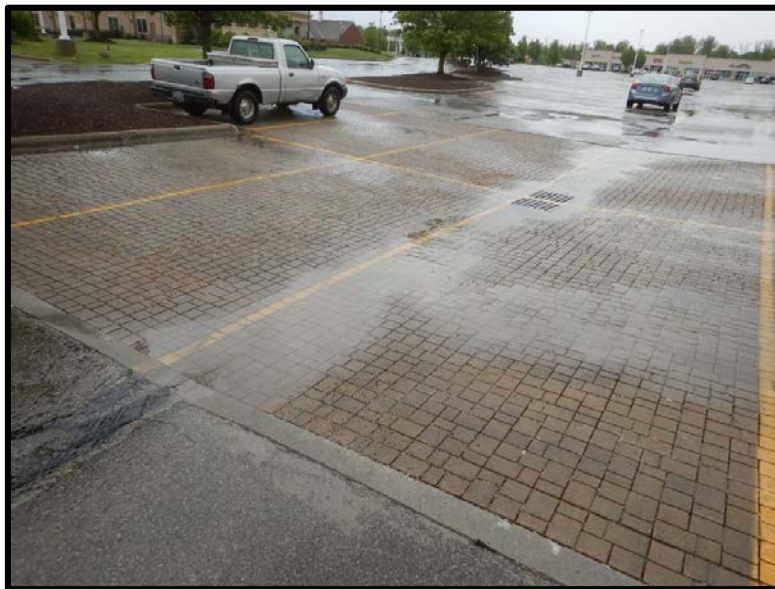
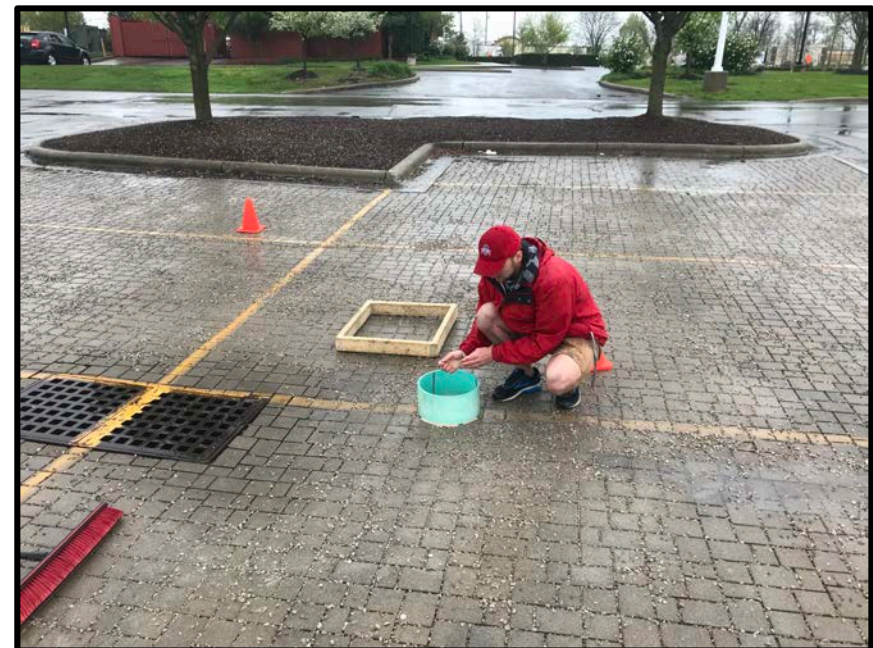
- Quarterly testing at 6 locations
  - Inform maintenance
  - Hot spots for clogging

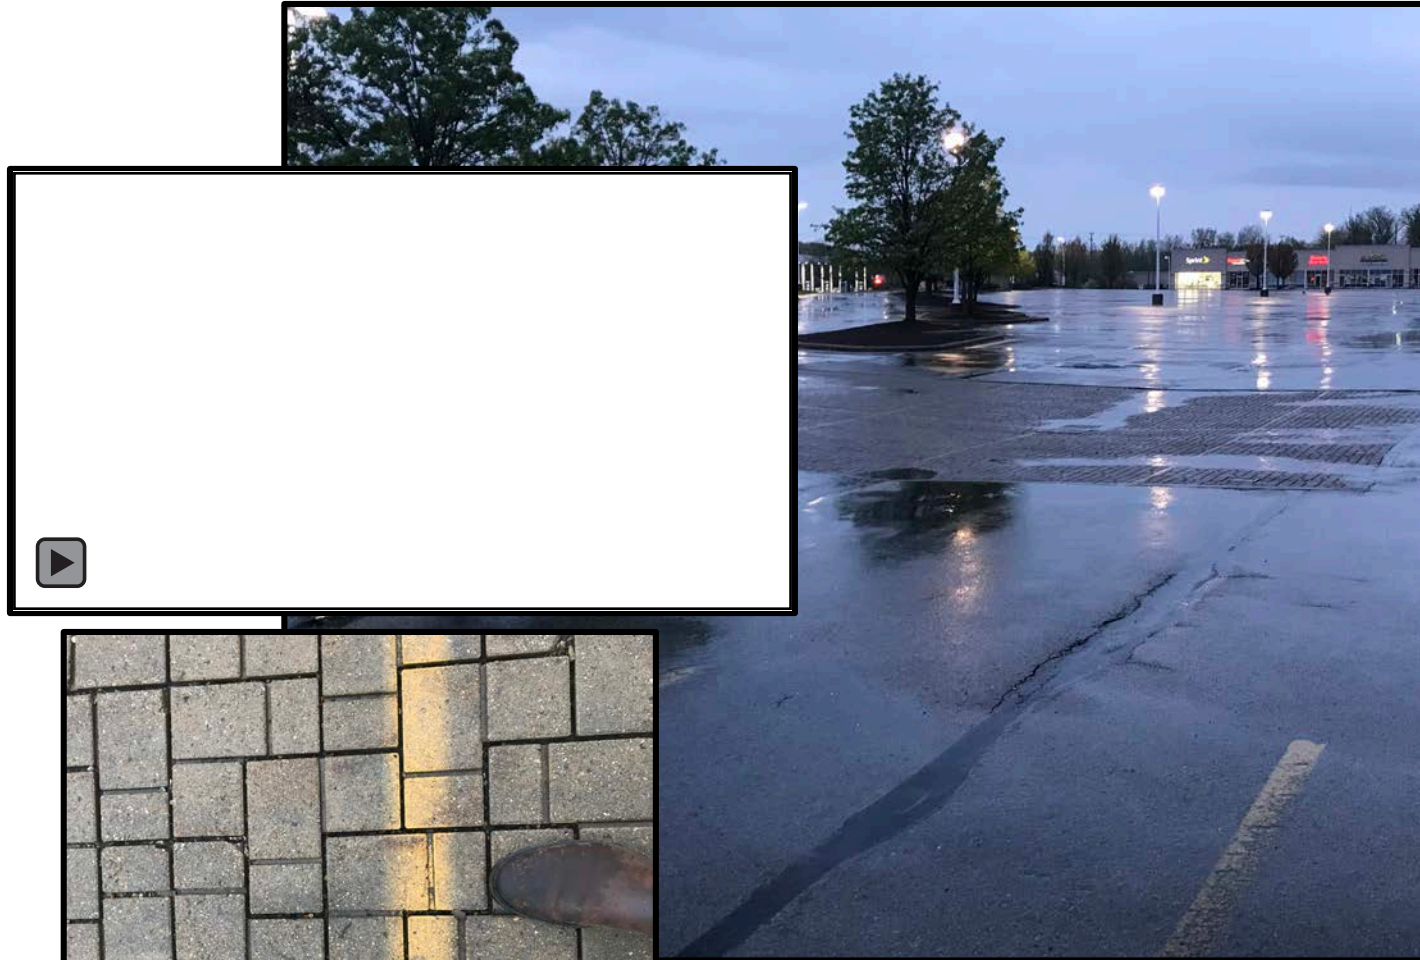
- Site was 17 months old at time of maintenance
  - No previous maintenance
  - Moderately clogged (5-150 in/hr)
  - Maintenance performed April 25, 2019
  - 5-15 passes with regenerative air street sweeper
  - Maintenance took 45 mins + 15 mins to add new chip stone

Clogged Area
