CASE STUDIES FOCUSED ON LONG TERM INSPECTION AND MAINTENANCE OF POST-CONSTRUCTION BMP'S IN HAMILTON COUNTY

Hamilton County Planning + Development
Stormwater + Infrastructure Division

Mohammad M Islam PE
Ben Poole EIT

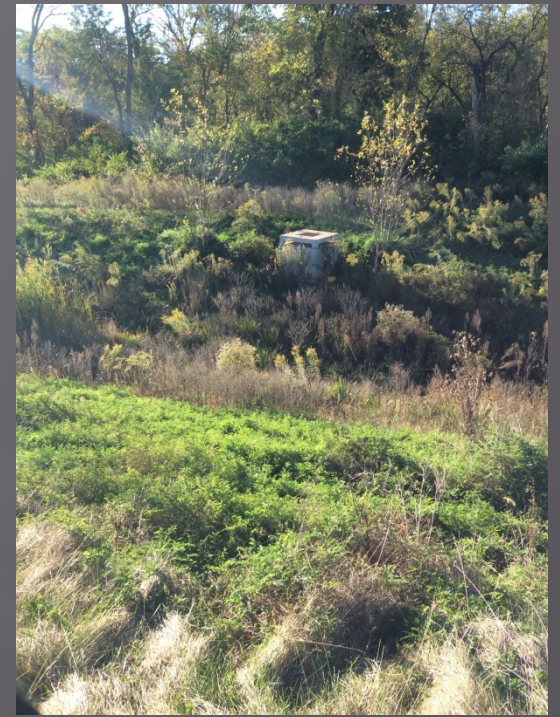
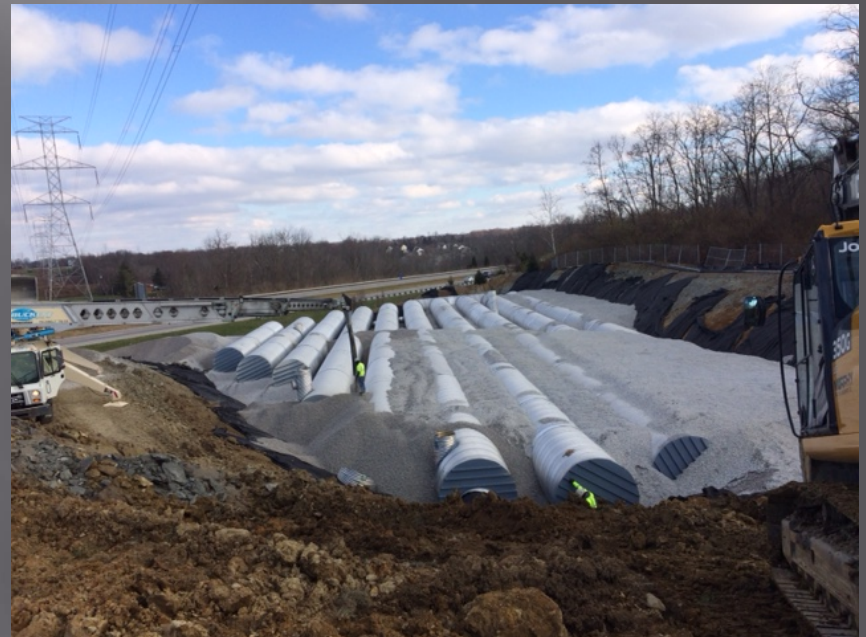
Mercy West Hospital – Dry Basin

- ▣ Total Volume = 49,400 cf
- ▣ $WQ_v = 19,453$ cf
- ▣ Inspection Scores:
 - 2015 – 6
 - 2017 – 6
 - 2018 – 12
- ▣ Inlet/Outlet clogging and sediment issues ongoing.
- ▣ Trash, erosion, and ground cover issues in 2017 & 2018.
- ▣ 2" orifice in face of Outlet Control Structure (OCS).

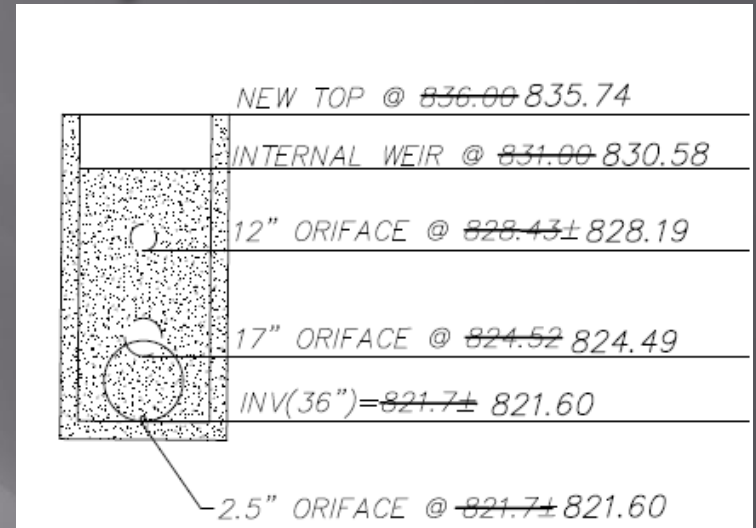
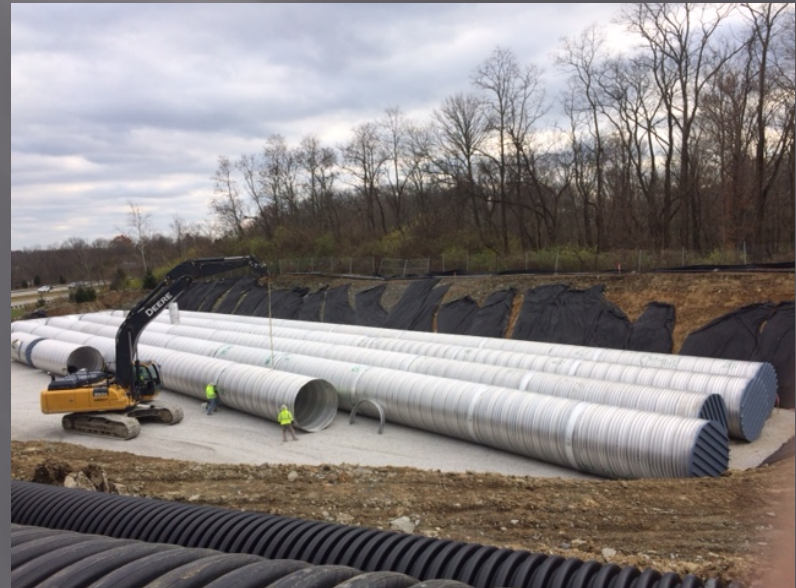
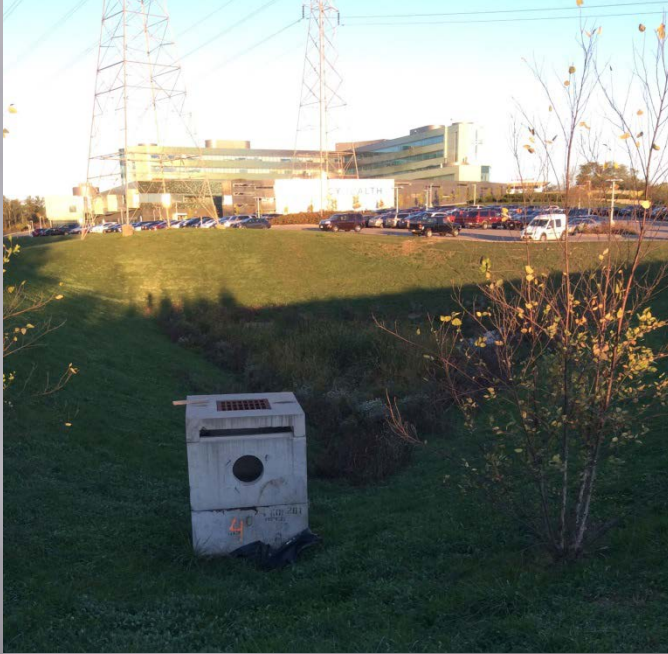
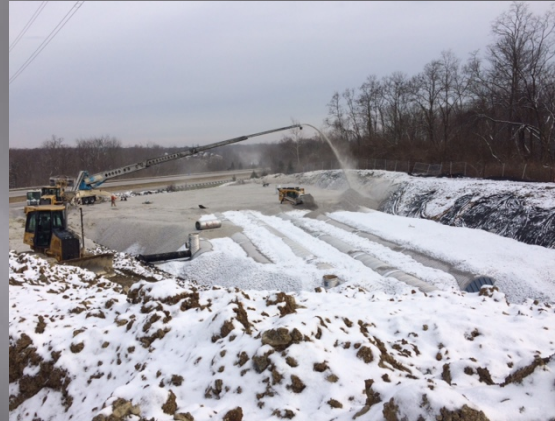
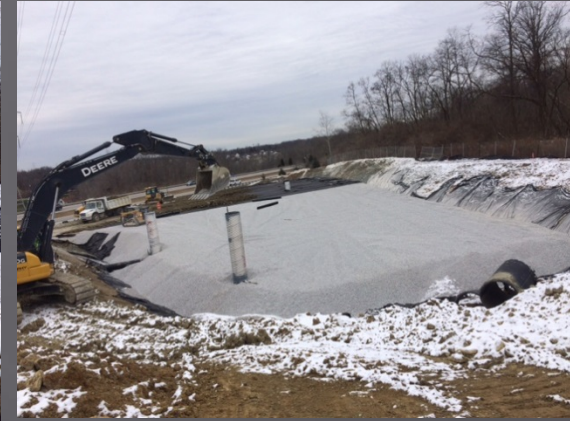
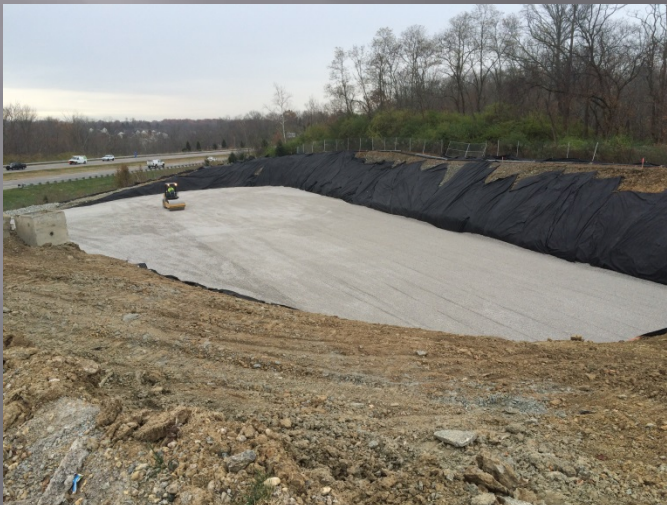
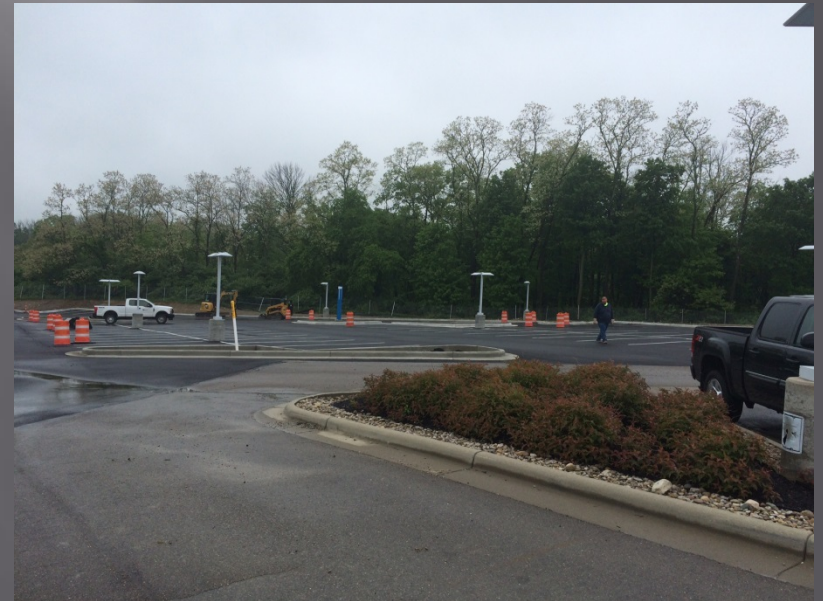
Mercy West Hospital – Underground System

- ▣ Converted from dry basin in 2016 to add additional parking
- ▣ Total Volume = 131,432 cf
- ▣ $WQ_v = 35,283$ cf
- ▣ Inspection Scores:
 - 2018 – 0
- ▣ Largest underground detention system in Hamilton County
- ▣ No maintenance issues.
- ▣ 2.5" orifice in internal weir wall of OCS.

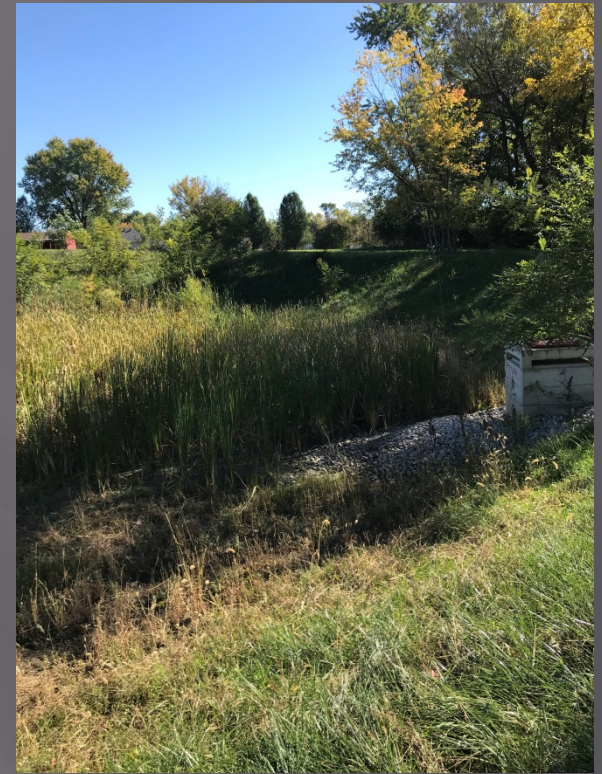
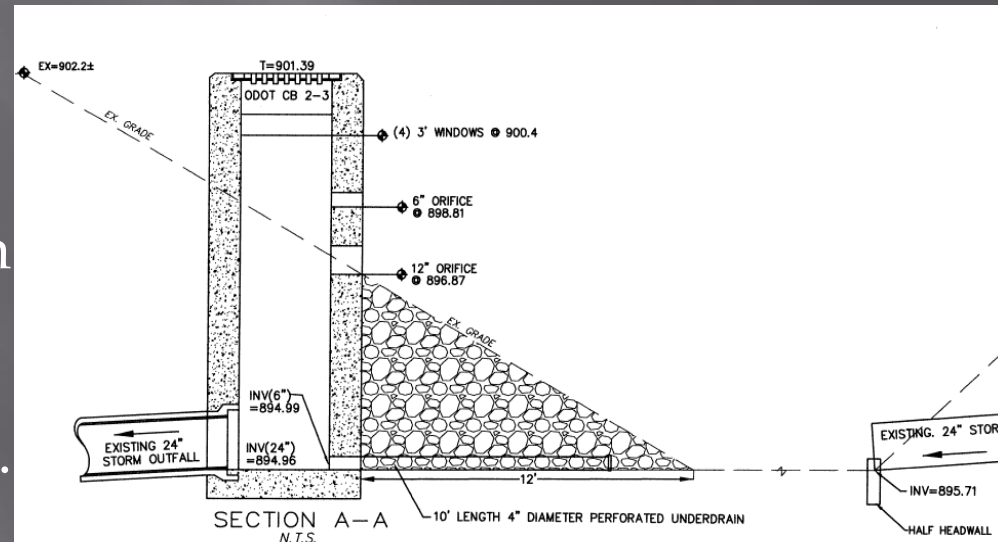
Artis Senior Living

- ❑ Dry detention basin installed in 2015.
- ❑ Total Volume = 24,113 cf
- ❑ $WQ_v = 8,471$ cf
- ❑ Inspection Scores:
 - 2017 – 12
 - 2018 – 6
- ❑ Erosion, overgrown vegetation, sedimentation, inlets & outlets clogged.
- ❑ Control structure condition improved 2017-2018.
- ❑ 4" perforated pipe under washed gravel WQ control.

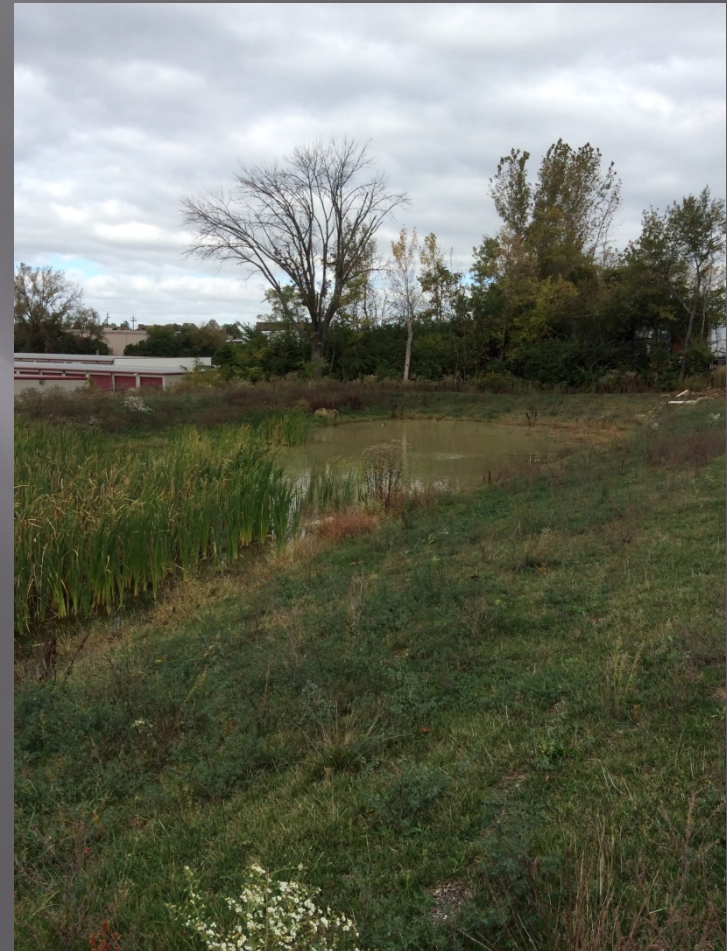
Blue Ash Storage – Dry Basin

- ❑ Total Volume = 25,591 cf
- ❑ $WQ_v = 6,400$ cf
- ❑ Inspection Scores:
 - 2015 – 8
 - 2017 – 25
 - 2019 – 23
- ❑ Sediment Basin standpipe was never switched to Post Construction Water Quality Control.
 - Prevented the basin from functioning as a dry basin
 - Oversight/miscommunication between agencies/inspectors.
- ❑ Inlets clogged, trash, and overgrown vegetation are ongoing issues.

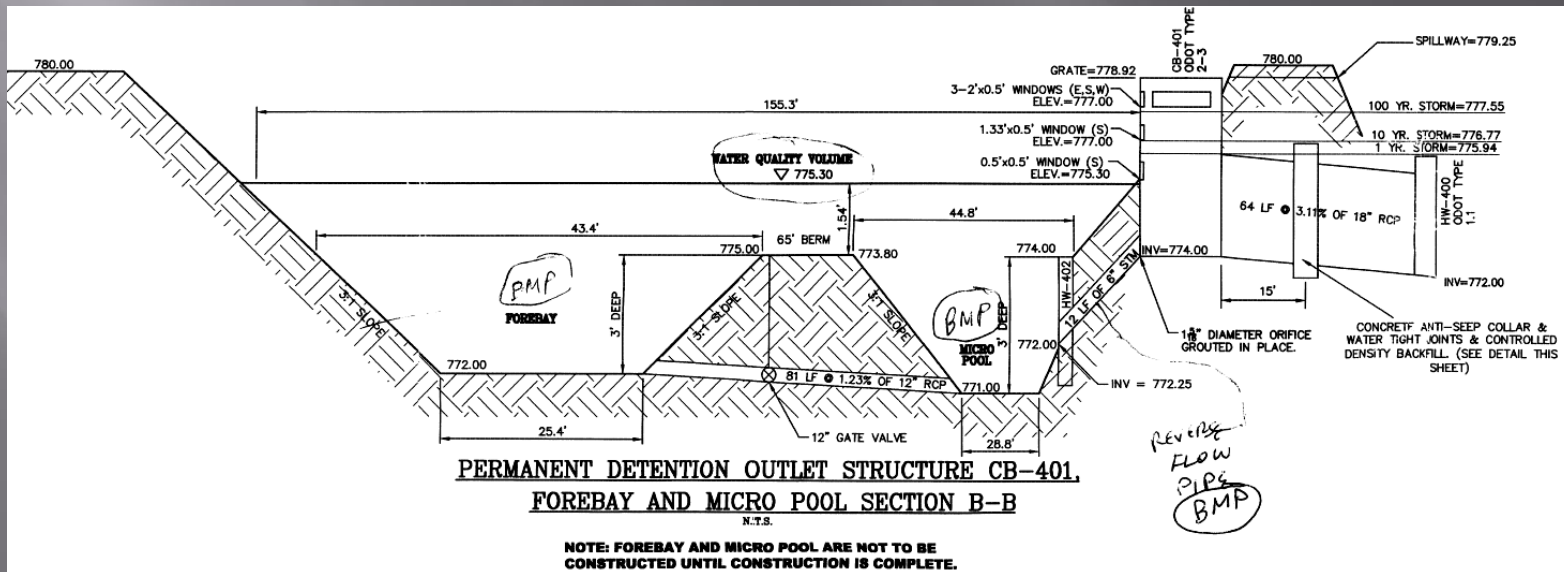
Alois Alzheimer Center

- ❑ 1 Dry Detention Basin installed in 2010.
- ❑ 8.11 ac drainage area
- ❑ Total Volume = 15,390
- ❑ $WQ_v = 4,792$
- ❑ Inspection Scores:
 - 2015 - 12
 - 2017 - 13
 - 2018 - 19
- ❑ Erosion, ground cover, WQ control and standing water are ongoing issues.

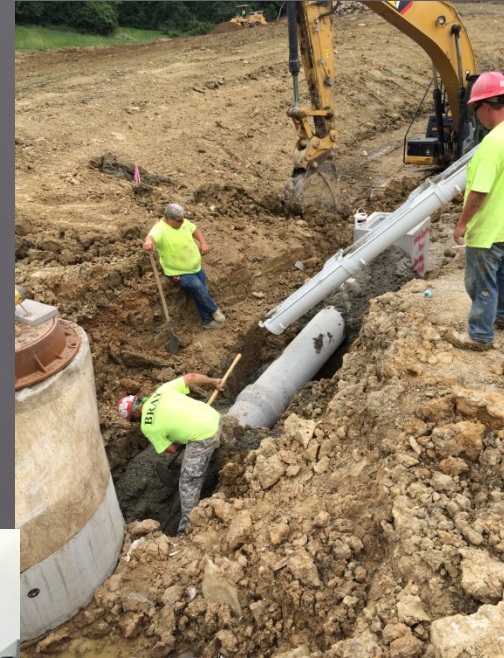
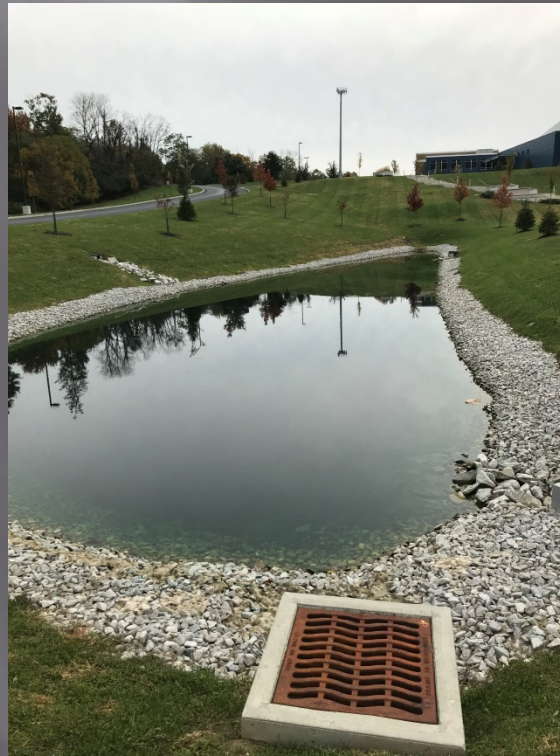
Crossroads Church – Wet Basin

- ▣ Inspection Score:
 - 2018 – 0
- ▣ No issues, in great condition.

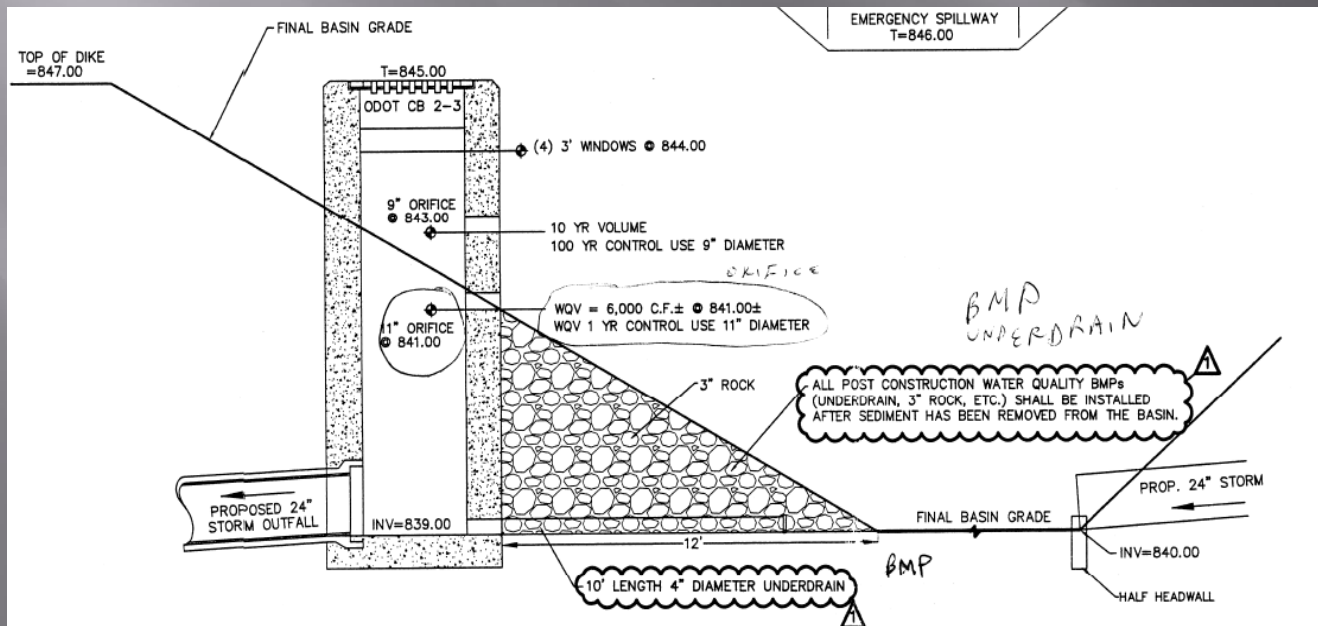
Liberty Nursing

- Dry Detention Basin installed in 2014
- 6.5 ac drainage area
- Total Volume = 15,000 cf
- $WQ_v = 5,875$ cf
- 4" perforated pipe under washed gravel
- Inlet/Outlet/WQ Control clogged, erosion, vegetation, sediment, and standing water issues all 3 years.

- 2015 – 12
- 2017 – 22
- 2018 – 23

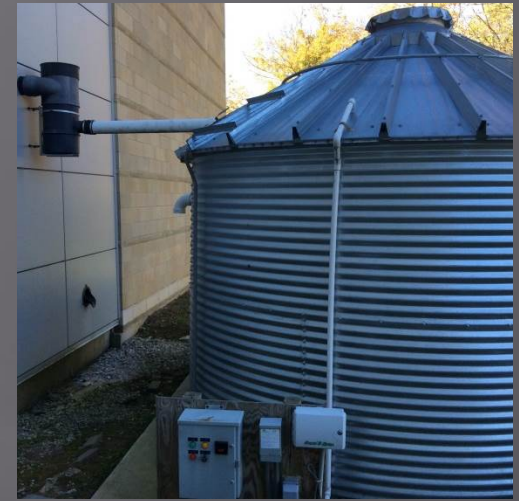
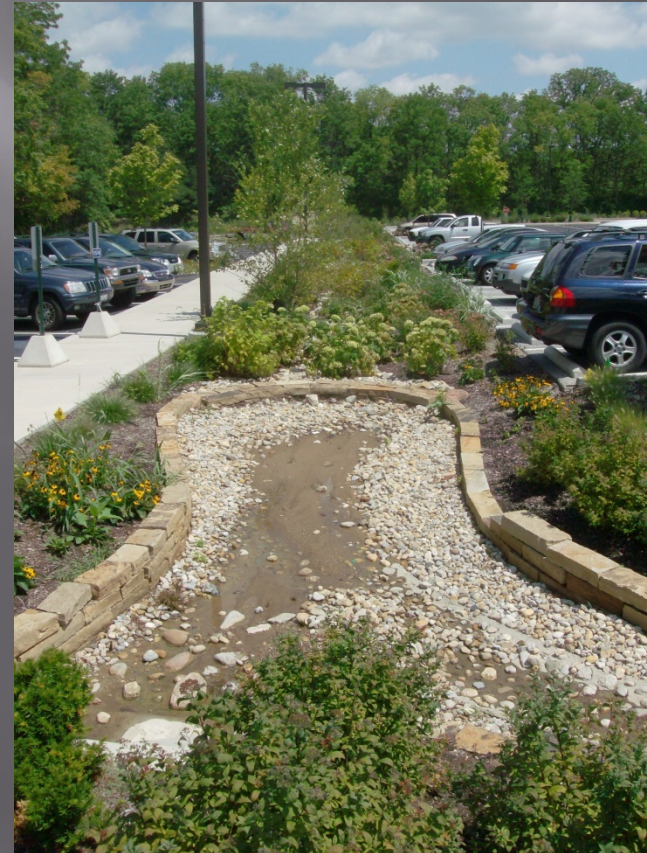
Diamond Oaks – Rain Garden

- Inspection Scores:
 - 2015 – 0
 - 2017 – 0
 - 2018 – 0
- Pervious pavement drains into rain garden.
- Rain garden drains through underdrain and catch basin 6" above grade.

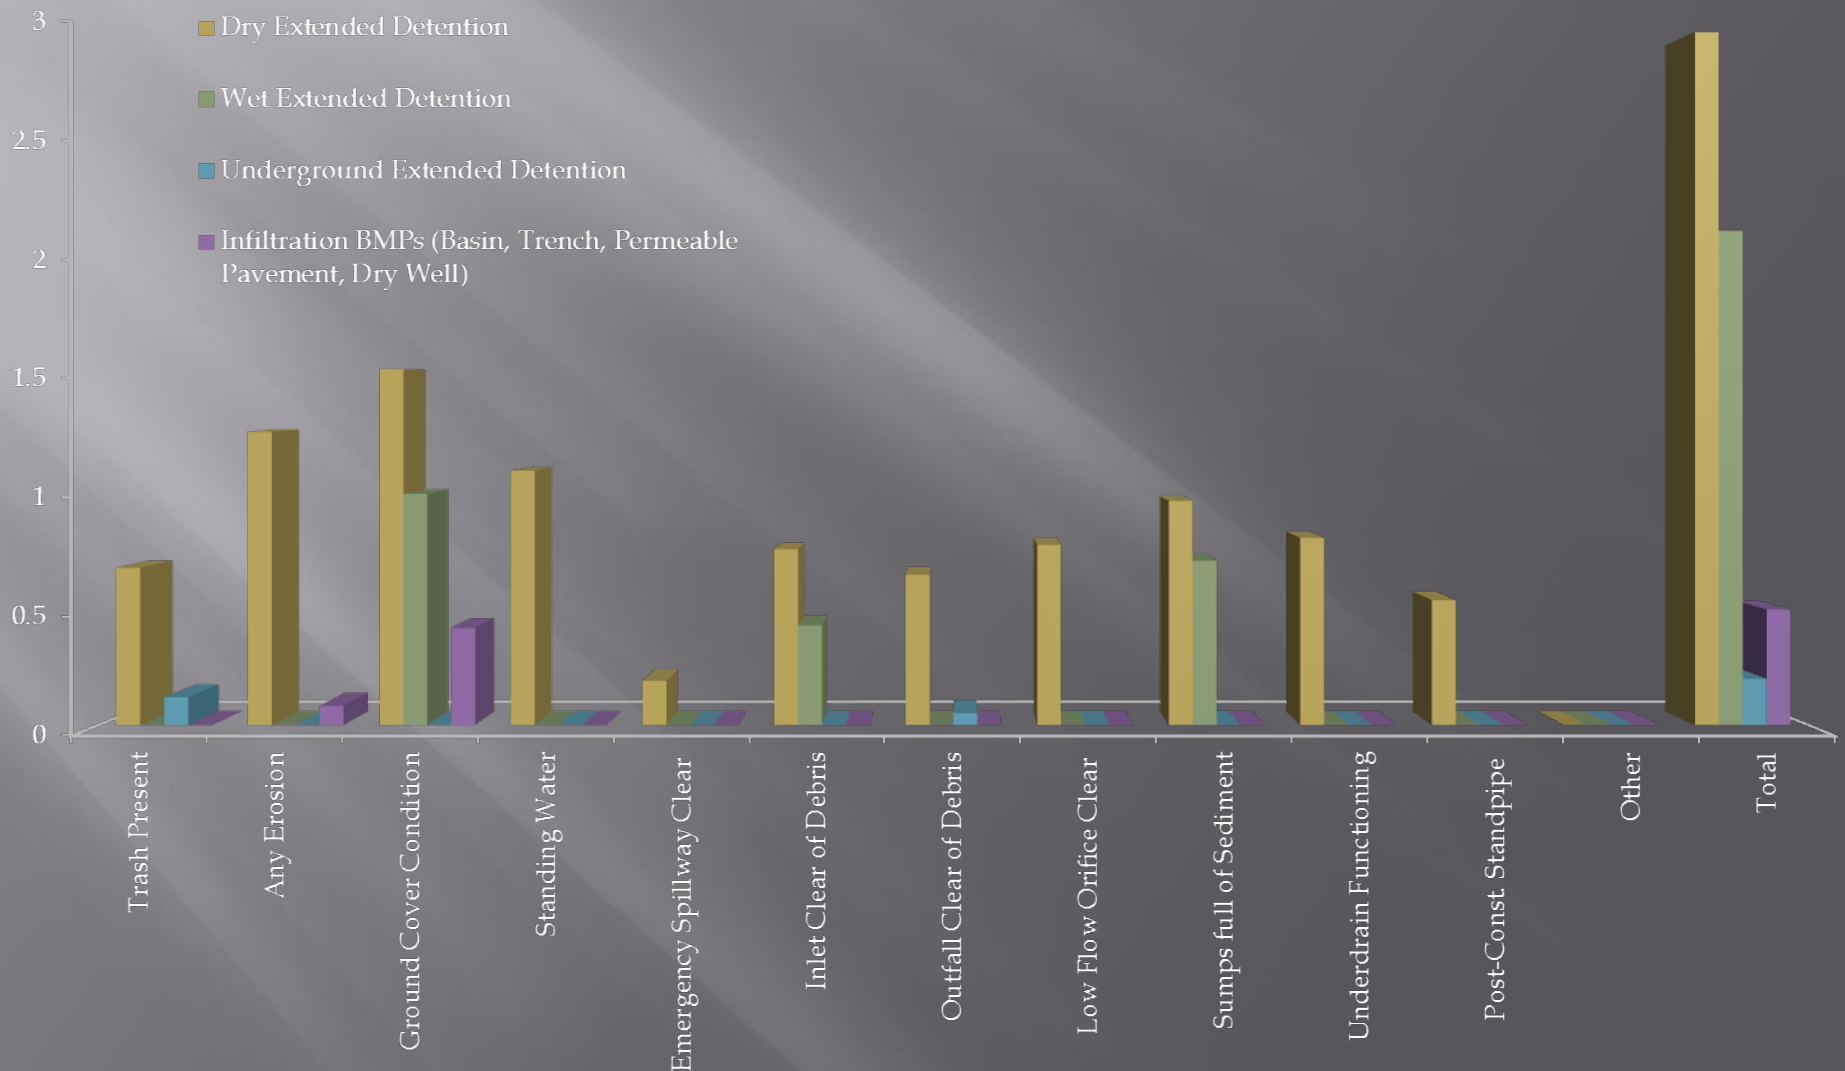
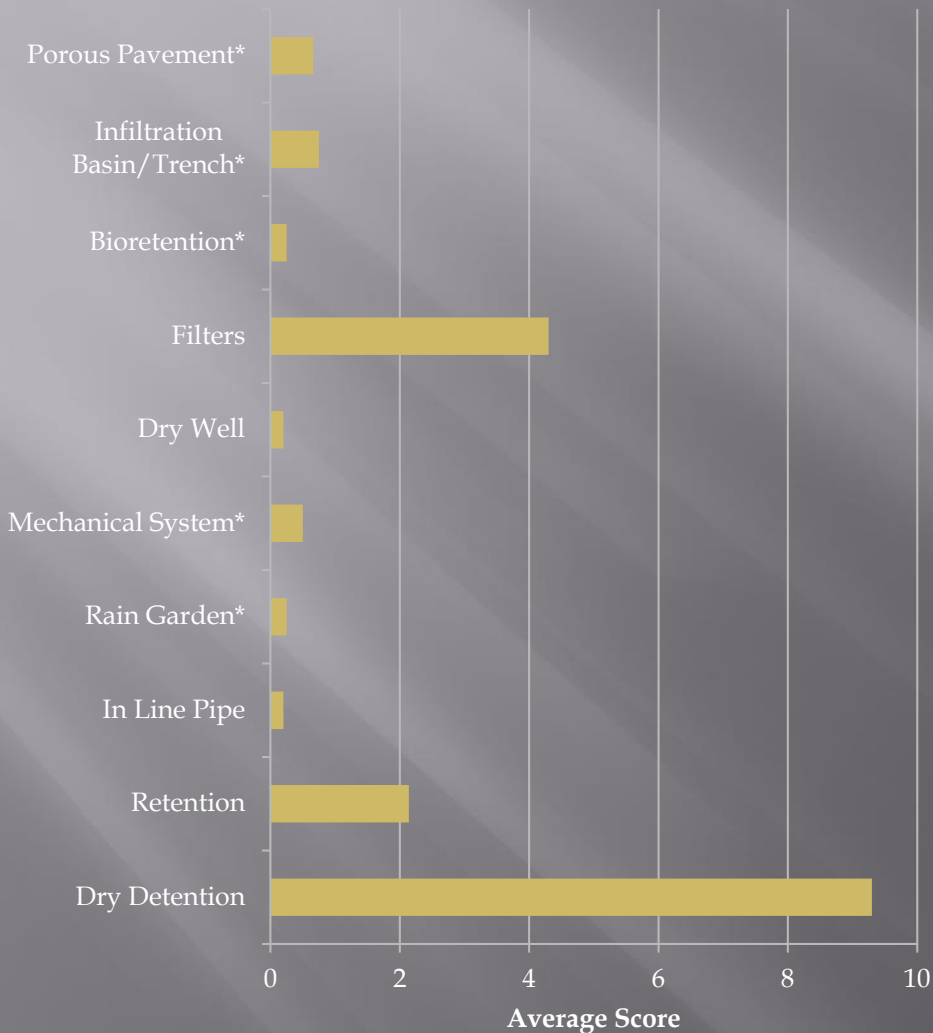
2018 Inspection Results

- Dry detention problems generally caused my lack of basic maintenance and small WQ/Low-flow orifices.
- Wet detention basins fare much better than dry basins.
- Inlet filters (no longer acceptable with 2018 CGP) were all removed or completely clogged.
