Streambank Failure Mechanisms and Streambank Stabilization on Pistol Creek at McCammon Drive

Patrick McMahon, S&ME Senior Engineer

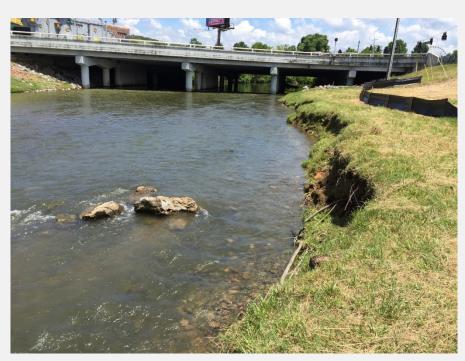
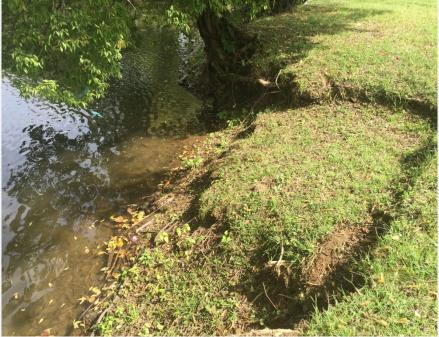
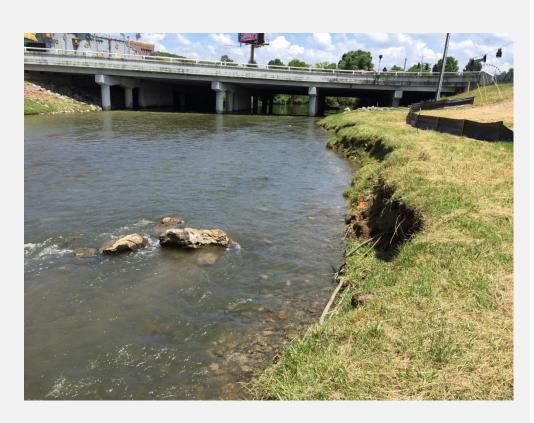
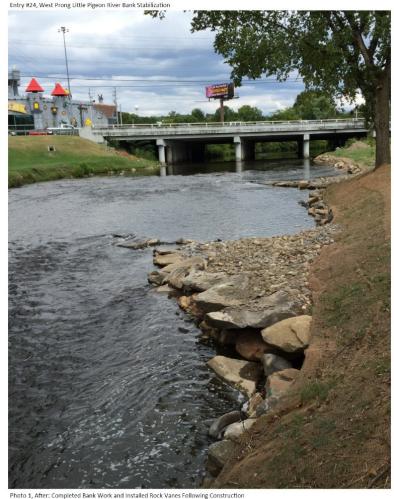
Most Streambank failures are a combination of hydraulic and geotechnical failure.

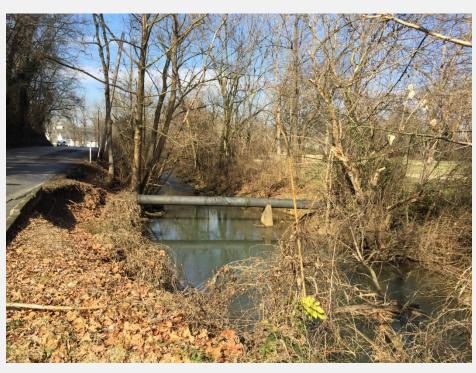
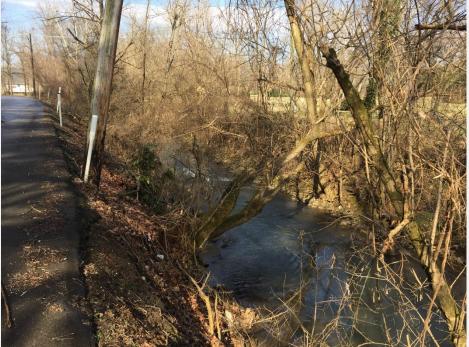
Louisville Rd. 400' North of Library

West bank Pistol Creek too eroding Eastern edge Louisville Rd.

Install guardrail on Eastern edge Louisville Rd.

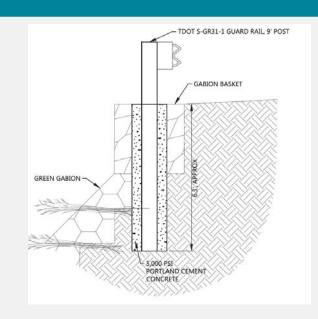
Utilities

Confined Work Space

Traffic

Floodway

Failure Mechanisms

Space for Guardrail

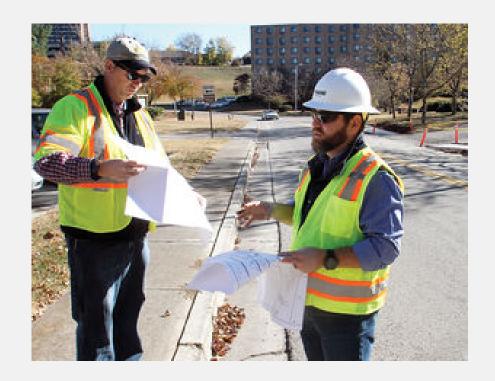
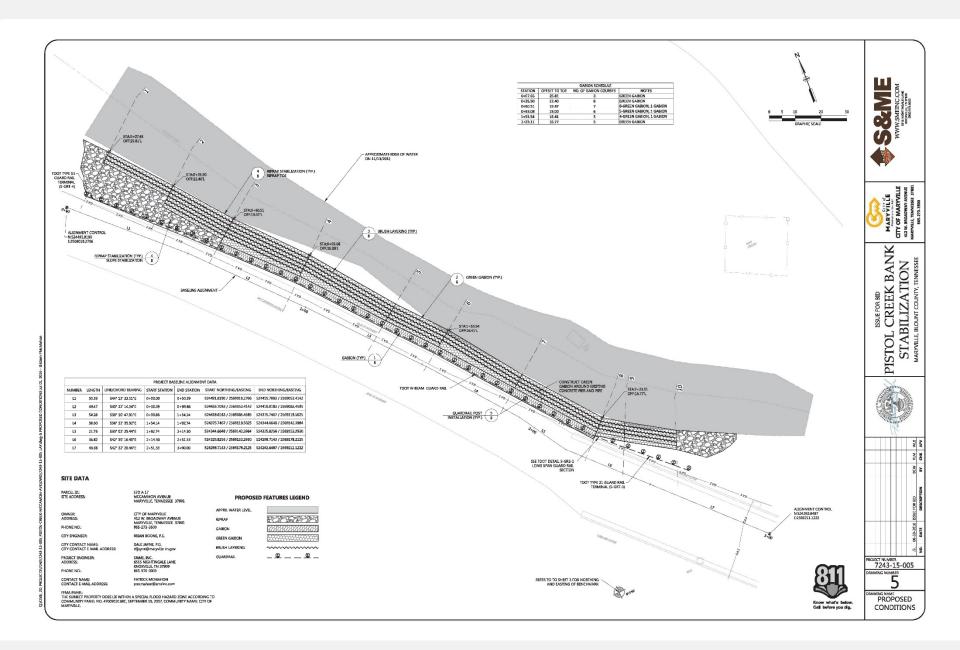
More Utilities

Stubborn Drivers

Surprise Spring

Construction Loading / Geotechnical Hazards

Wick Drains Beneath the Road French Drain at Spring
