An Urban Stream Manager's Guide to Field-Based Master Planning

George Remias, PE

**Northeast Ohio
Regional Sewer District**

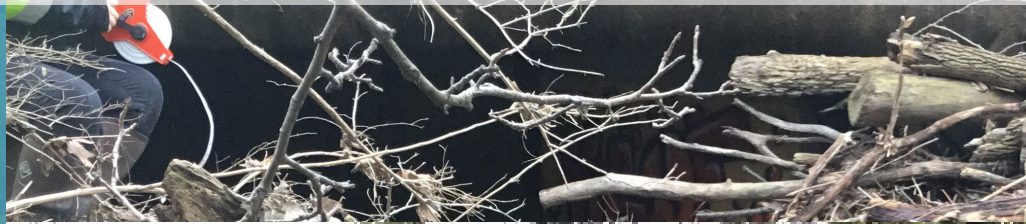
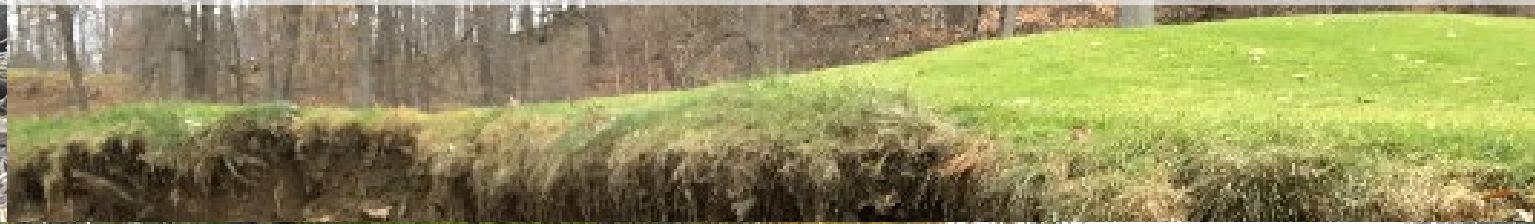
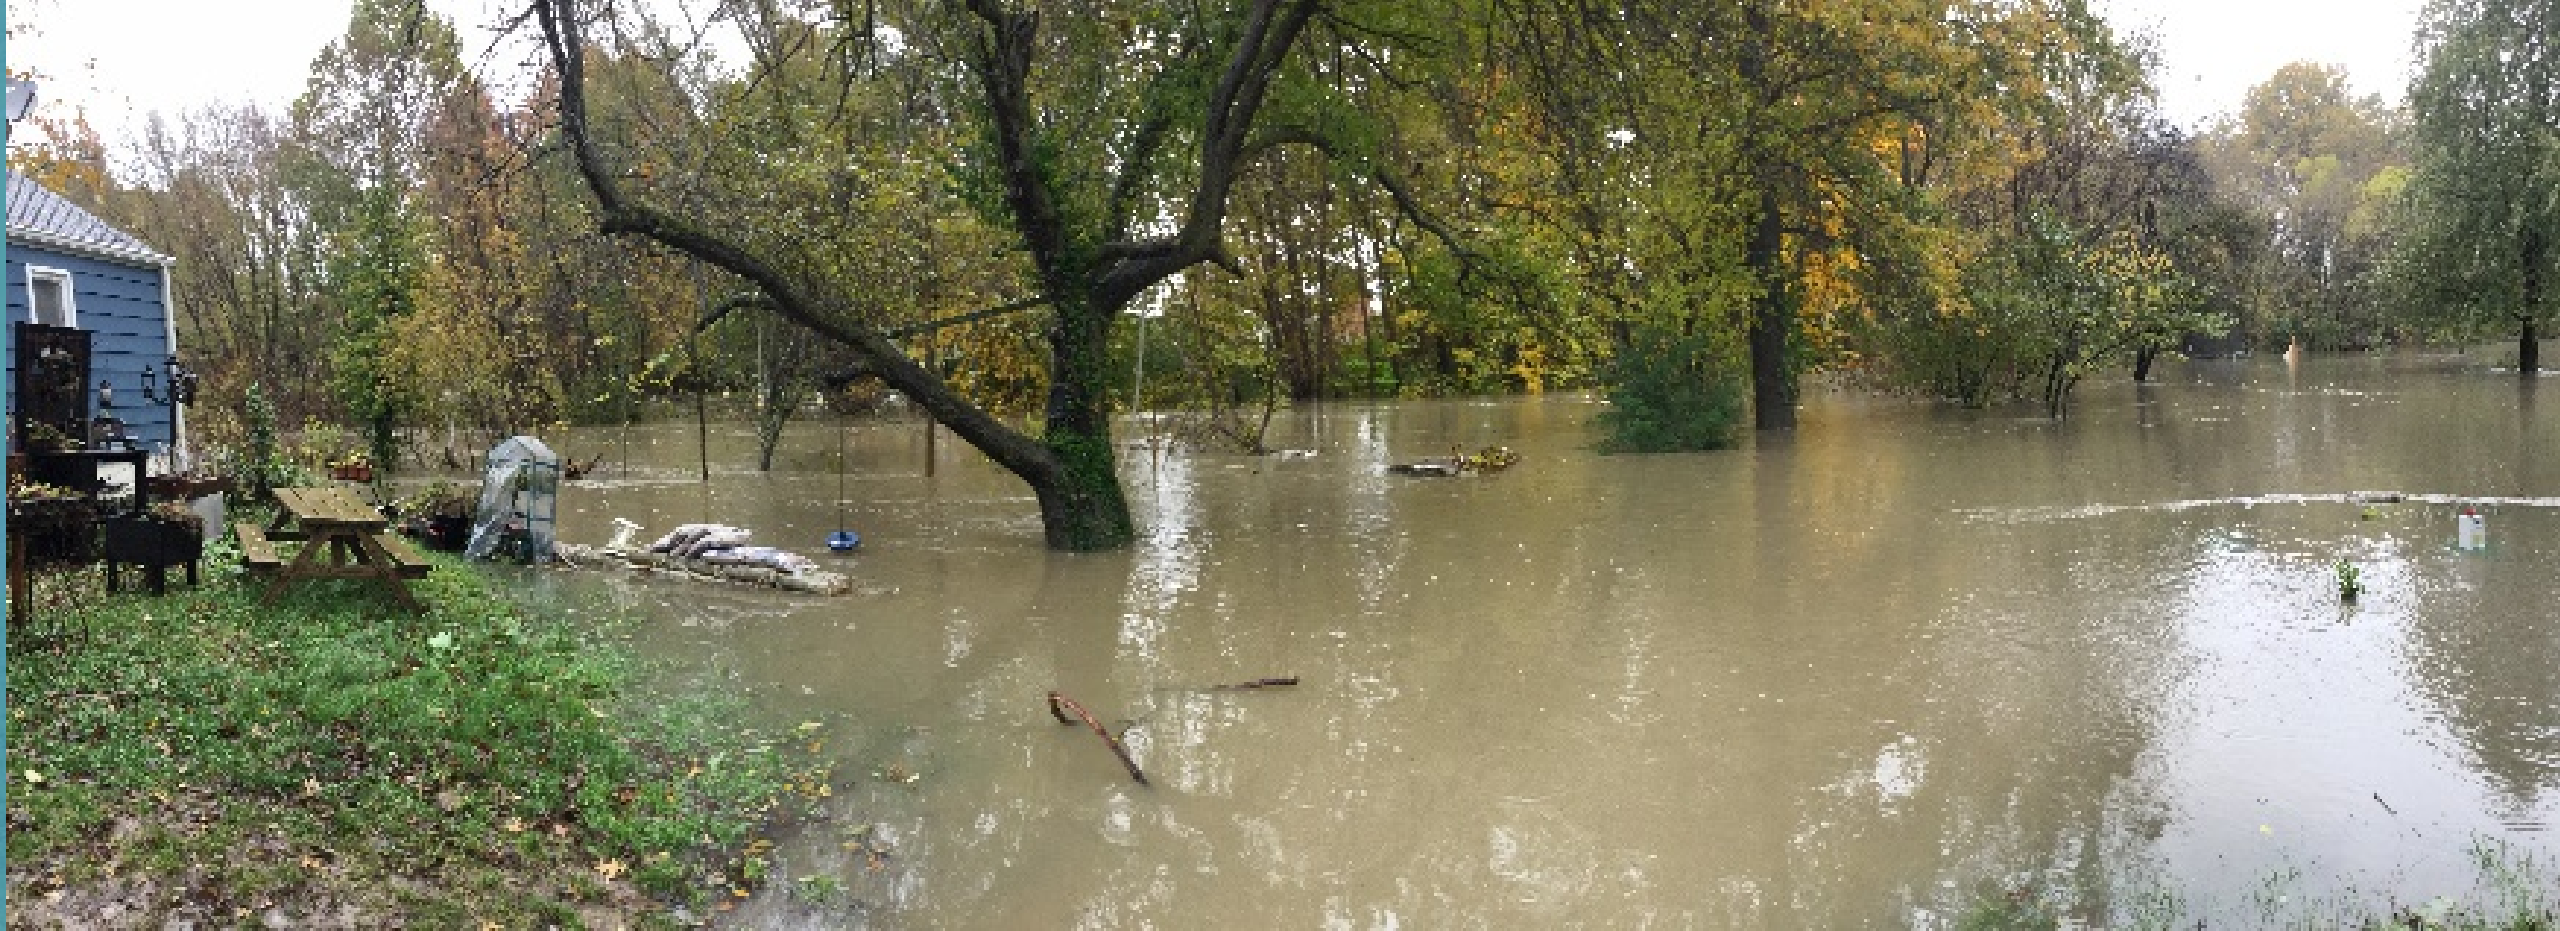
Stormwater Inspection: Condition Scores

SWIM Standard for Assigning Condition Ratings					
Condition Rating	Sediment & Debris Accumulation (Crossings)	Sediment & Debris Accumulation (Basins)	Structural Integrity (Crossings)	Structural Integrity (Streams)	Hydraulic Performance (Crossings)
	[% Blocked]	[% Active Storage Lost]	[ODOT Culvert Rating]	[BEHI/NBS]	[Peak Water Level]
1	0 - 10%	<=5%	8 or 9	Low/Low	<50% flow area
2	10 - 25%	<=10%	6 or 7	Moderate/Low	>50% flow area
3	25 - 50%	<=20%	5	High/Moderate	Surcharged
4	50 – 75%	<=30%	3 or 4	High/High	Road Overtopped
5	>75 %	>30%	0, 1, or 2	Very High/ Very High	Road Impassable (D > 9-inches)

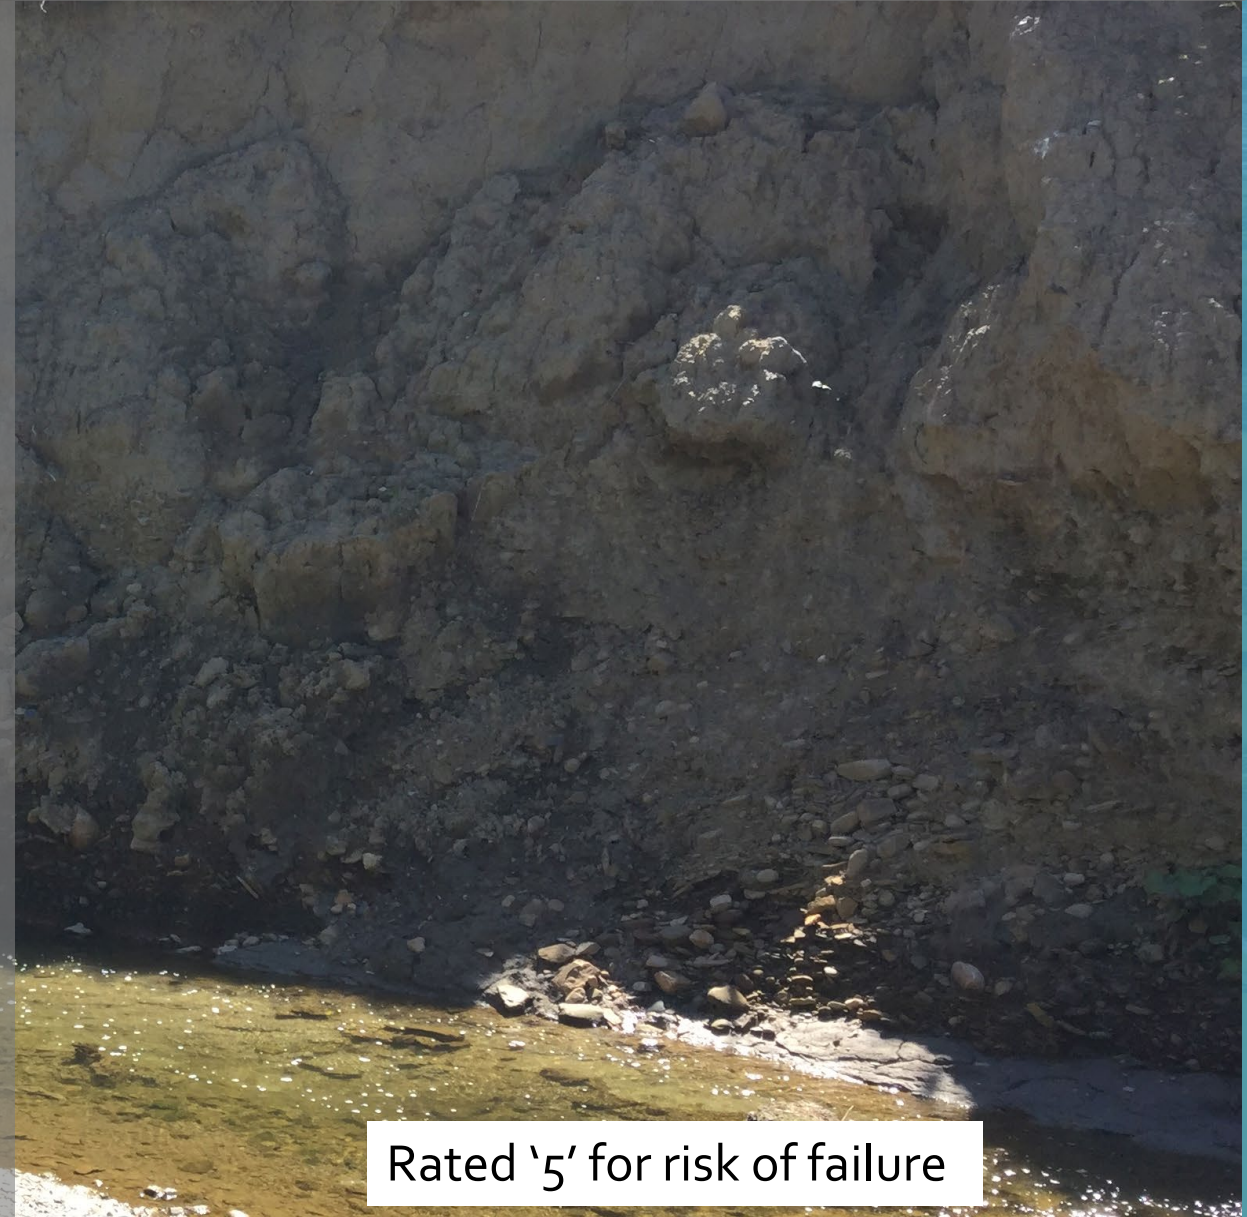
- ❑ Building, Transportation, Utility (BTU)
EX: Assigning Structural Condition Rating (1-5) to a BTU along a stream:
 - Condition Score #1: Assign BEHI/NBS condition rating to stream
 - Condition Score #2: Infrastructure slope = Top of bank distance to infrastructure/bank height, where:
 - $[1 > 5:1; 3 > 2:1 \text{ but } \leq 3:1; 5 \leq 1:1]$
 - Worst condition score assigned to BTU

Rated '5' for risk of failure

Assigning Structural Condition scores to BTUs

1. Condition Rating #1: stream lateral erosion following BEHI/NBS approach
2. Condition Rating # 2: Measure infrastructure slope (TOB distance to infrastructure/Bank Height)
3. Assign highest condition rating to BTU

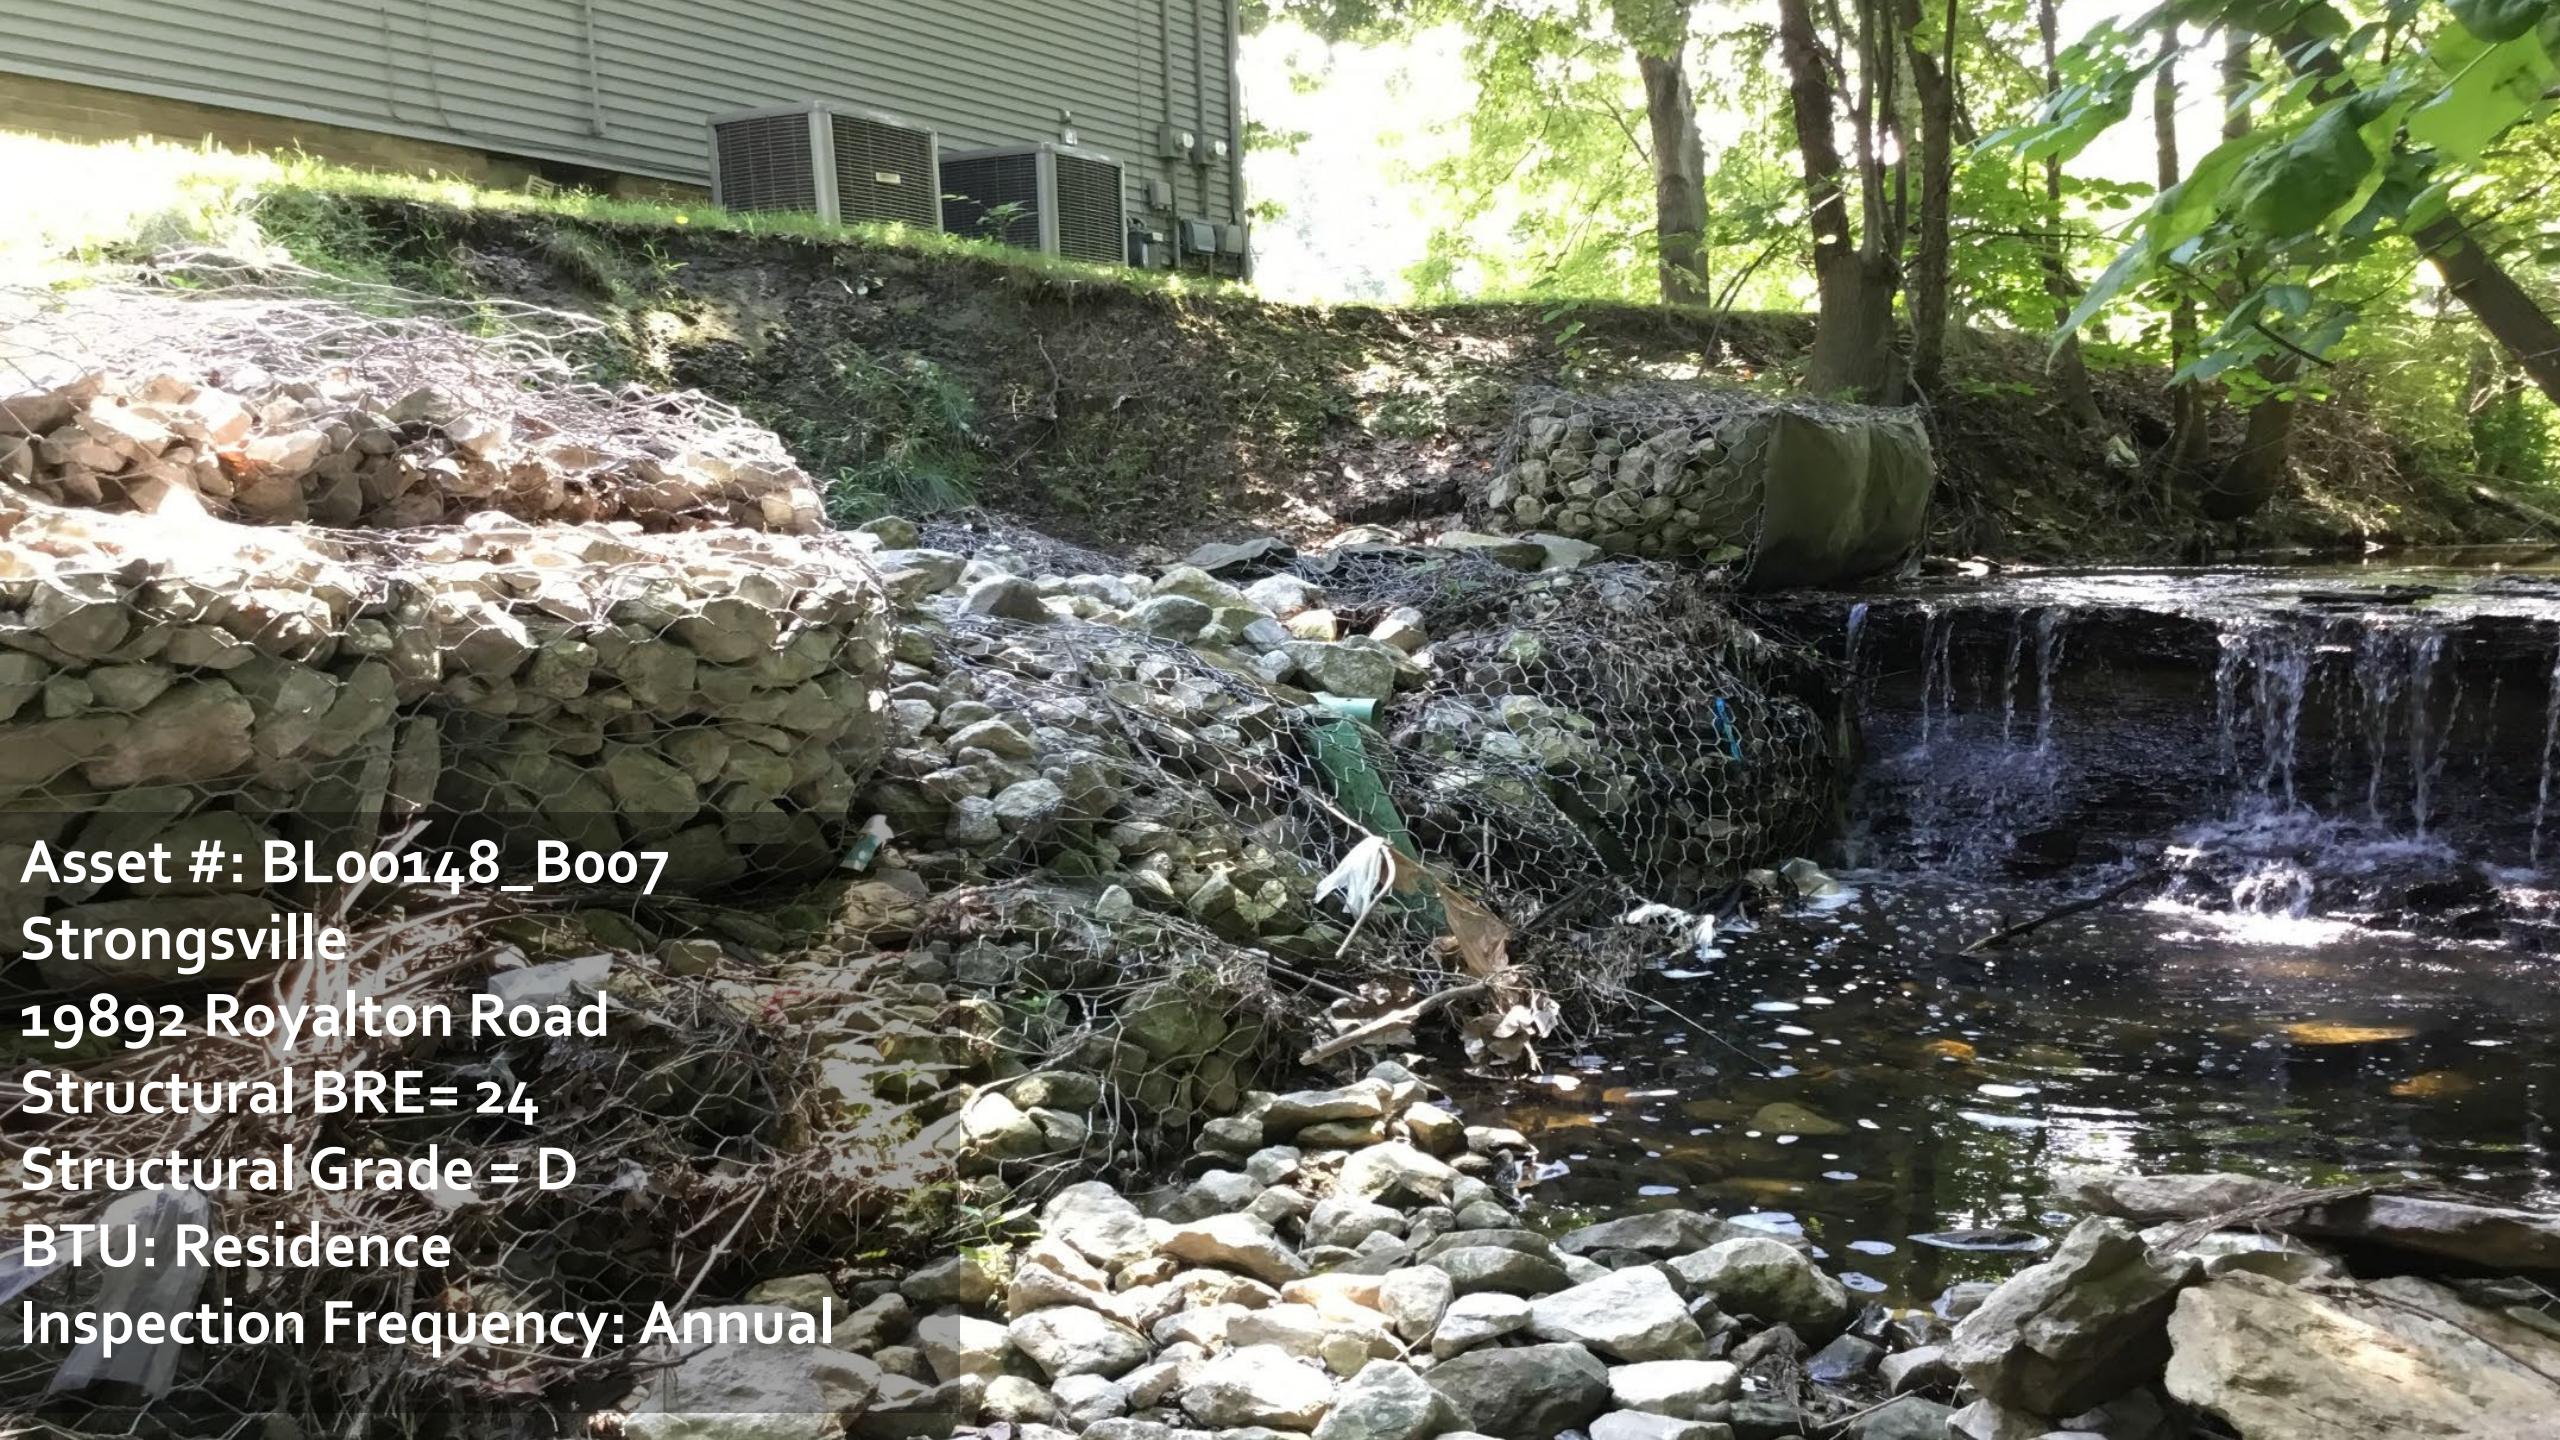
Asset #: BL00148_Boo7
Strongsville
19892 Royalton Road
Structural BRE= 24
Structural Grade = D
BTU: Residence
Inspection Frequency: Annual

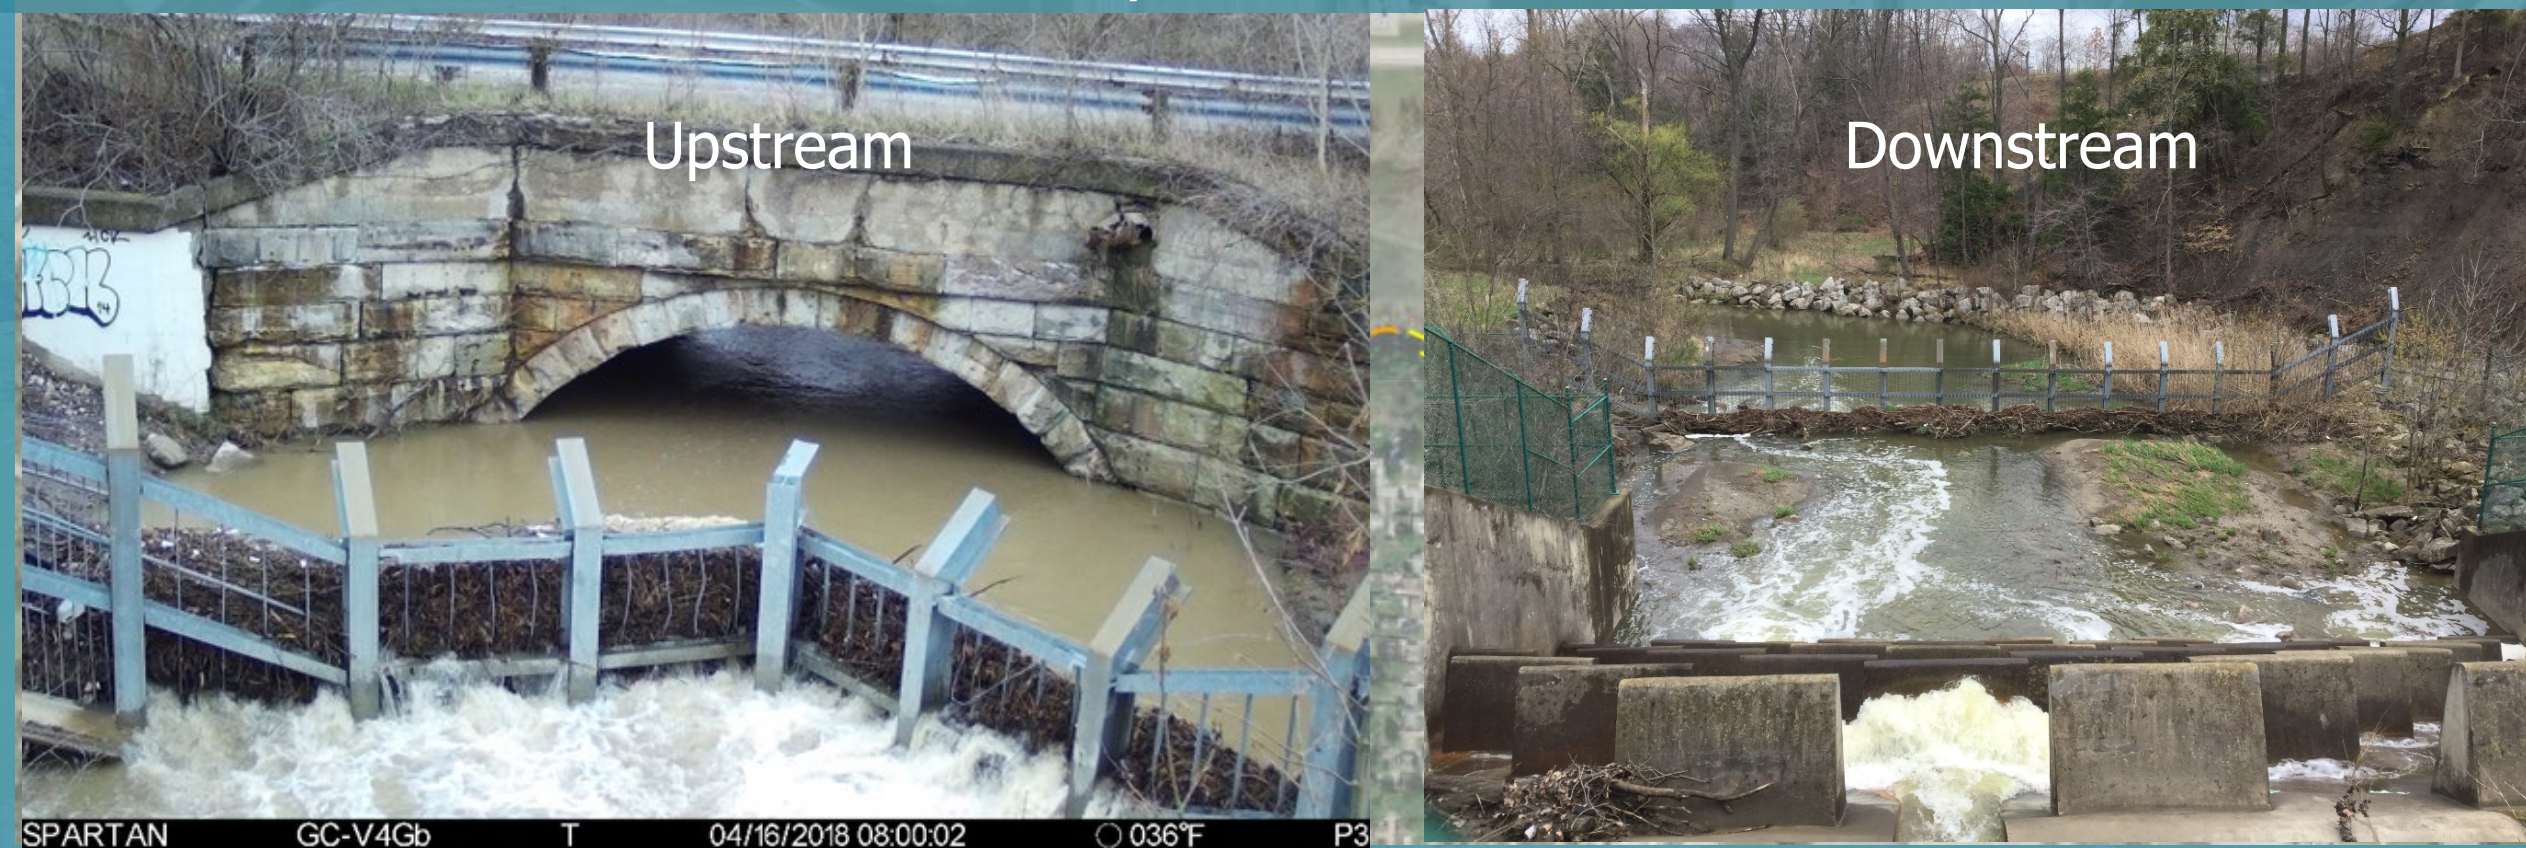
Estimating Bank Erosion Rates along Stream Reaches: "Cheesy Poof" Method

CLE Airport Debris Rack

Following the BEHI/NBS "cheesy poof" method, high percentage of the Abram Creek sediment load is estimated to be generated between the CLE debris rack and SR 237

The same stream reach is the primary source of LWD at the CLE debris rack and sediment at the outlet structure

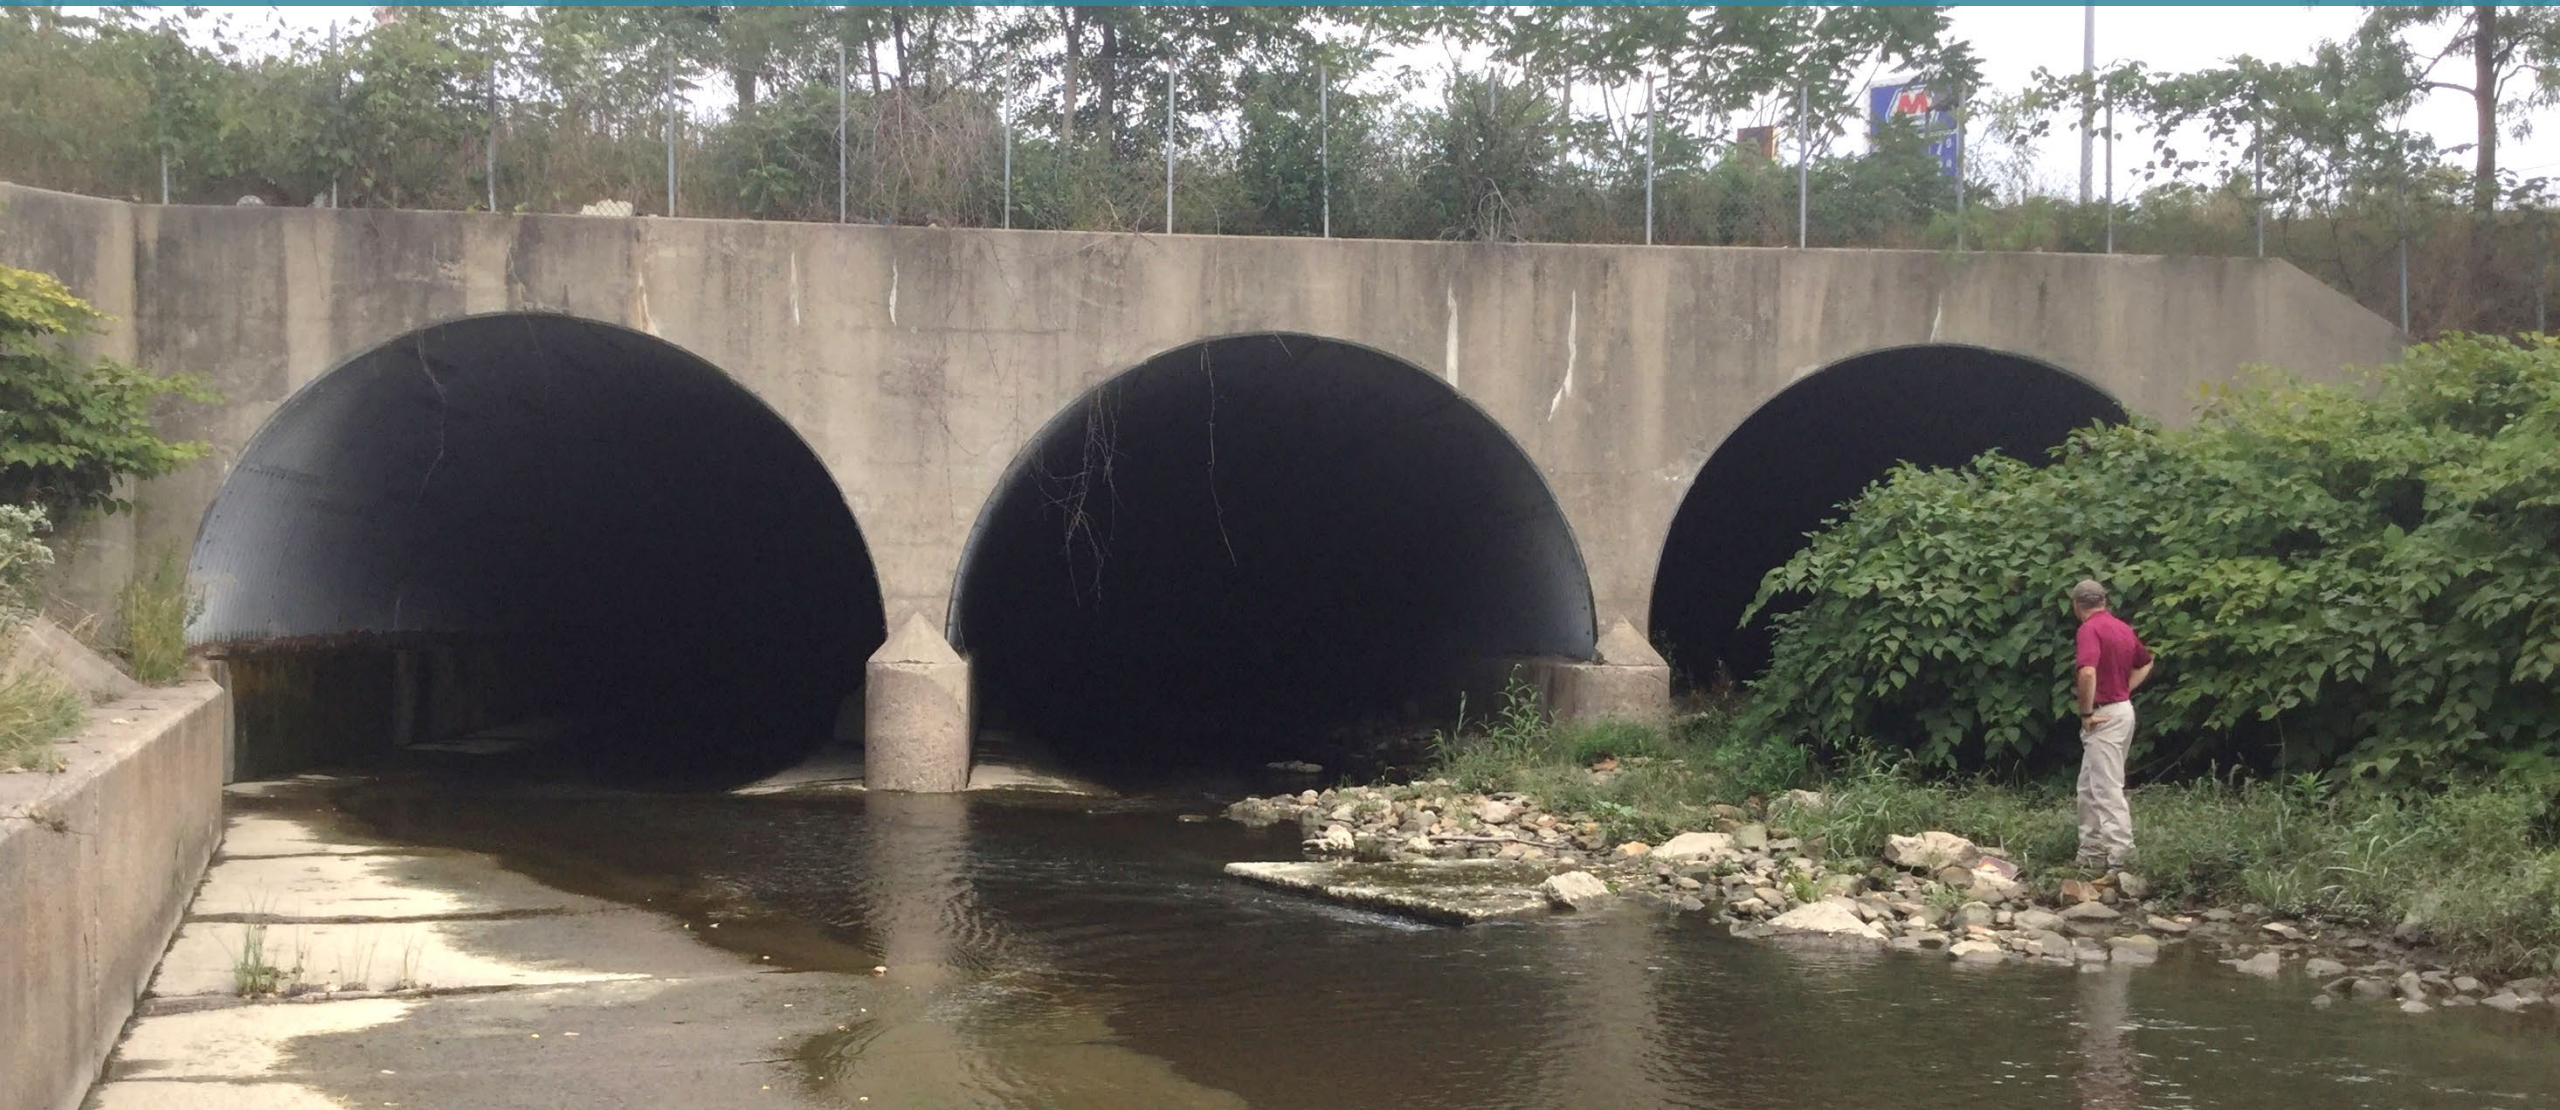
Consider Stream Function when Assessing Hydraulic Performance

Model culverts with sediment buildup under baseline conditions
where stream function is stable

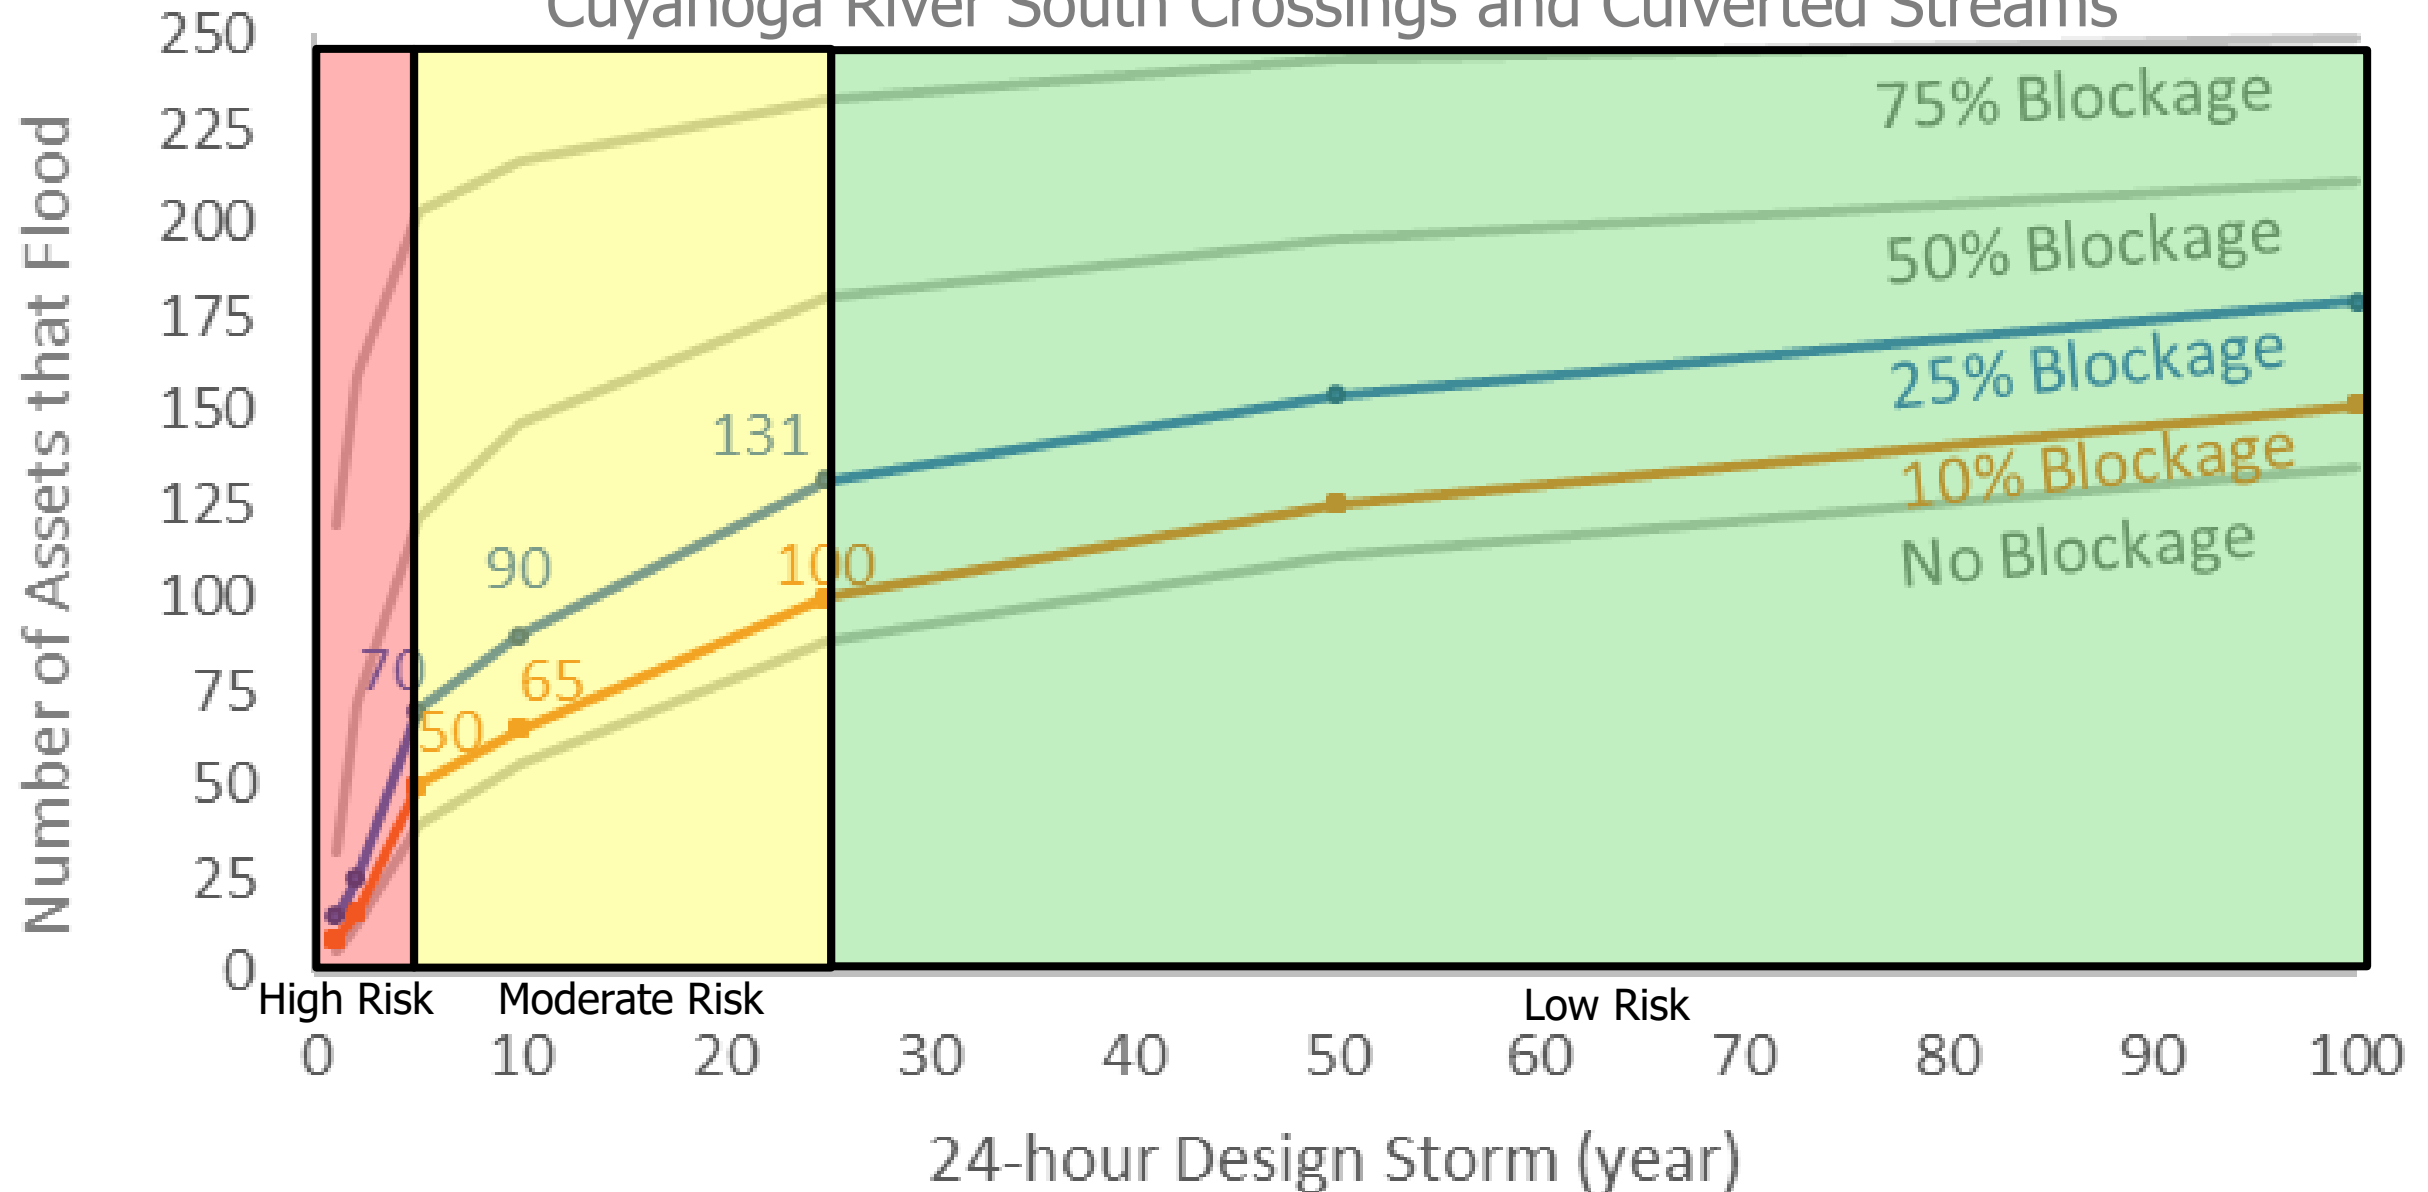
Projected Flooding Due to Debris Blockage

Cuyahoga River South Crossings and Culverted Streams

RSS Asset ID	First BTU Flooded		Design Storm						
	BTU Type	BTU Asset ID	1- year	2- year	5- year	10- year	25- year	50- year	100- year
CC00069_001	Local_Road	CC00069_T001	47%	30%	4%	-53%	-113%	-162%	-217%
CC00071_001	Local_Road	CC00071_T001	81%	72%	60%	46%	26%	10%	-9%
CC00077_001	Local_Road	CC00077_T001	86%	78%	66%	56%	48%	42%	38%
CC00087_001	Driveway	CC00087_T001	66%	52%	24%	2%	-31%	-59%	-86%
CC00089_001	Local_Road	CC00089_T001	86%	79%	66%	56%	42%	29%	15%
CC00091_001	Local_Road	CC00091_T001	90%	85%	77%	70%	65%	62%	58%
CC00109_001	Local_Road	CC00109_T001	80%	67%	48%	36%	22%	15%	8%
CC00111_001	Arterial_Road	CC00111_T001	79%	65%	45%	33%	19%	11%	4%
CC00123_001	Local_Road	CC00123_T001	89%	85%	75%	66%	51%	30%	12%
CC00127_001	Local_Road	CC00127_T001	83%	77%	64%	51%	29%	-1%	-27%
CC00135_001	Local_Road	CC00135_T001	91%	82%	68%	49%	27%	4%	-24%
CC00137_001	Local_Road	CC00137_T001	81%	73%	55%	31%	-3%	-42%	-75%
CC00155_001	Local_Road	CC00155_T001	59%	44%	36%	25%	-12%	-64%	-113%

CC00161_010M	Local_Road	CC00161_T001	68%	50%	30%	25%	23%	20%	21%
CC00169_001	Local_Road	CC00169_T001	69%	62%	51%	41%	24%	9%	-8%
CC00171_001	Non_Res. Road	CC00171_T001	24%	-5%	-52%	-93%	-143%	-181%	-213%
CC00173_001	Local_Road	CC00173_T001	53%	35%	9%	-16%	-46%	-69%	-88%
CC00175_001	Driveway	CC00175_T001	78%	68%	53%	38%	15%	-12%	-47%
CC00179_001	Non_Res. Road	CC00179_T001	81%	70%	65%	51%	33%	15%	-5%
CC00081_001	Highway	CC00081_T001	60%	38%	3%	-24%	-52%	-70%	-82%
CC00093_001	Highway	CC00093_T001	66%	49%	19%	-6%	-23%	-37%	-50%

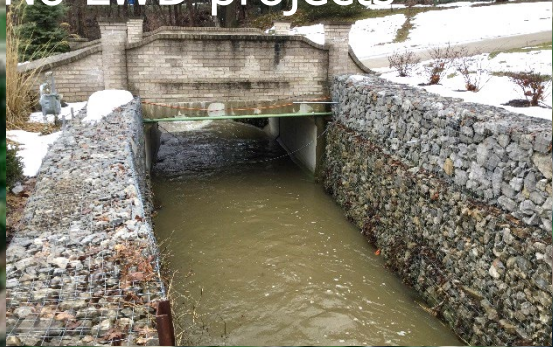
CC00175

Understanding Where LWD collects and Why Consider Culvert Width compared to Stream Channel Width

6x12-ft Box Culvert
No LWD projects

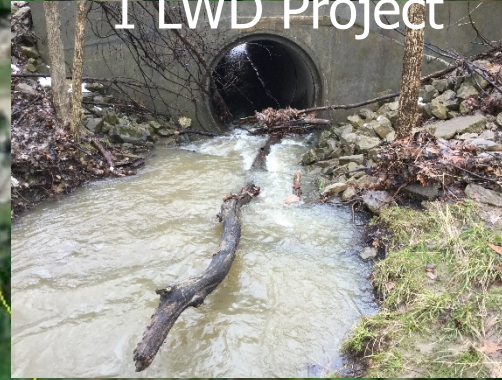
CC00173

7-ft Circular Culvert
1 LWD Project

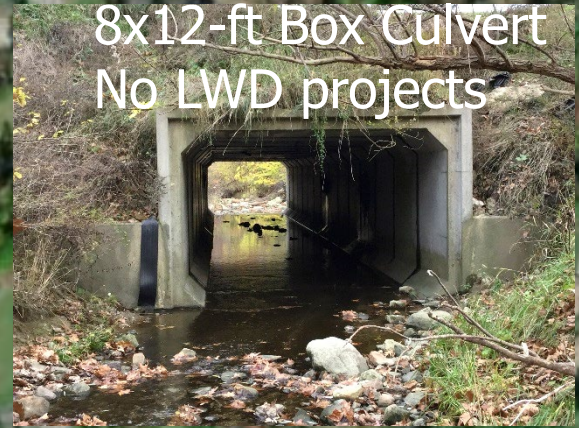
CC00169

8x12-ft Box Culvert
No LWD projects

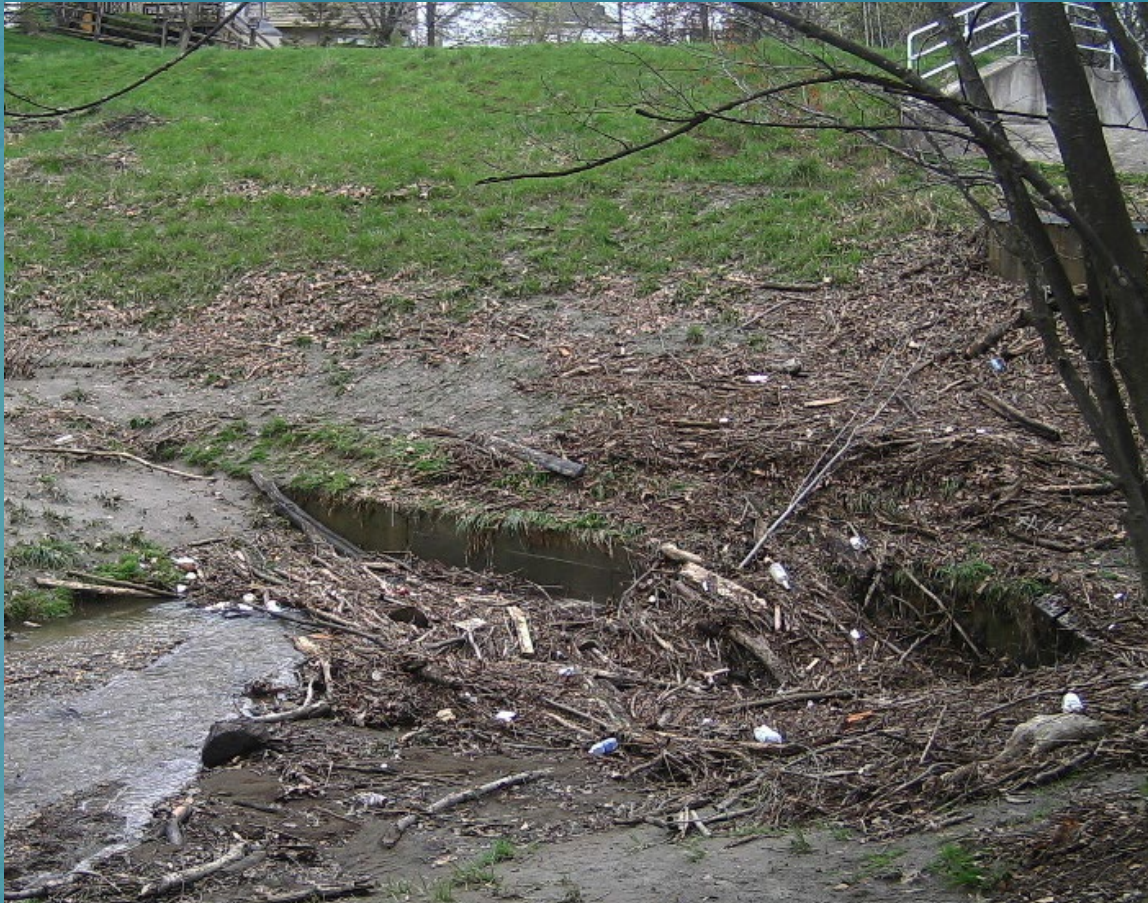
Preventative Maintenance Example

4/9/17: 1.62-inch Rain Event

April 18: Debris rack is clear pre-storm event

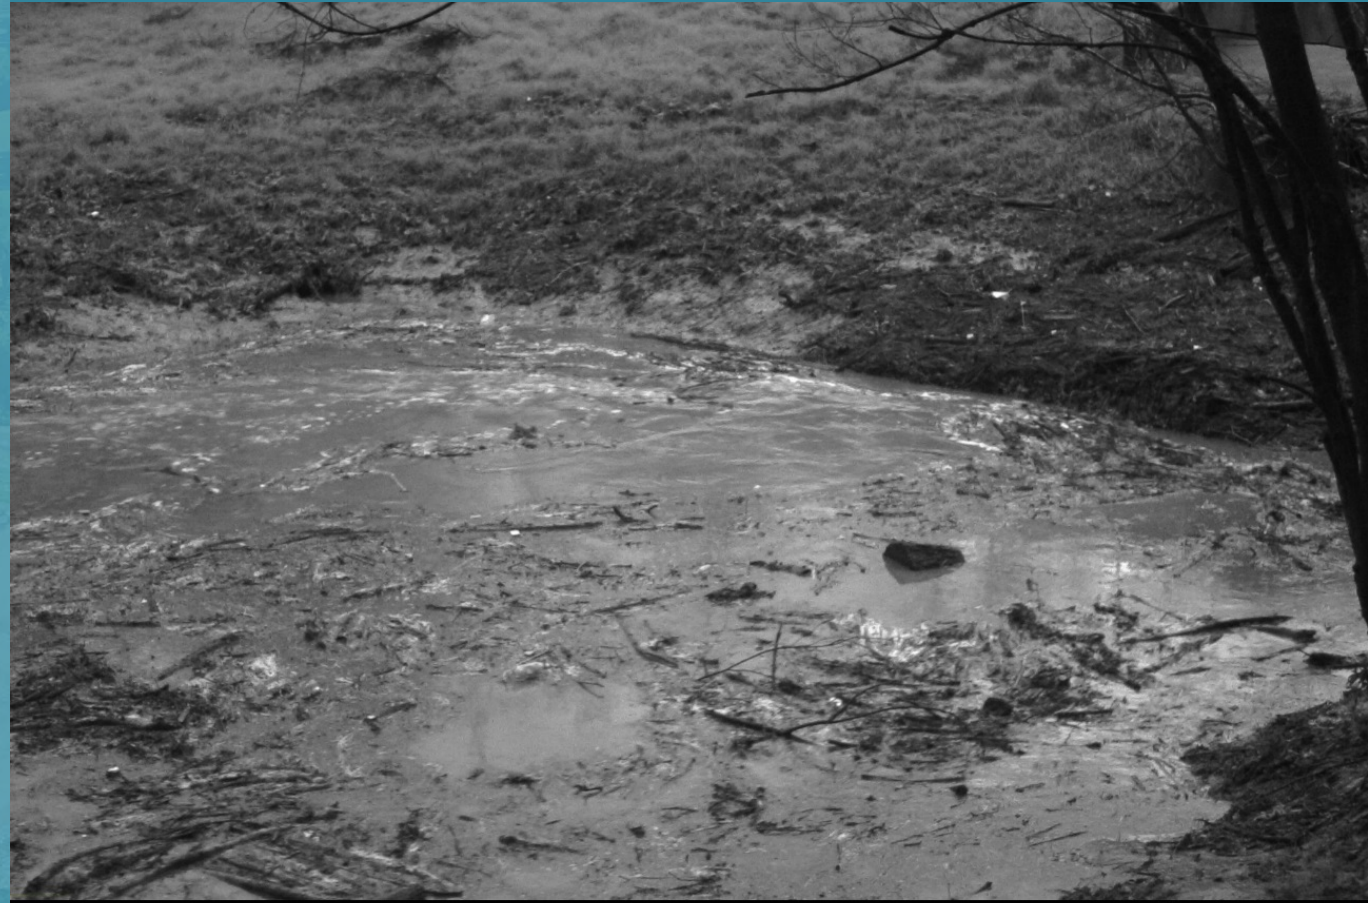
4/19/17: Peak of storm at 8:15 pm

4/20/17: LWD nearly 100% blocking debris rack post storm; Generated 80 CY of LWD

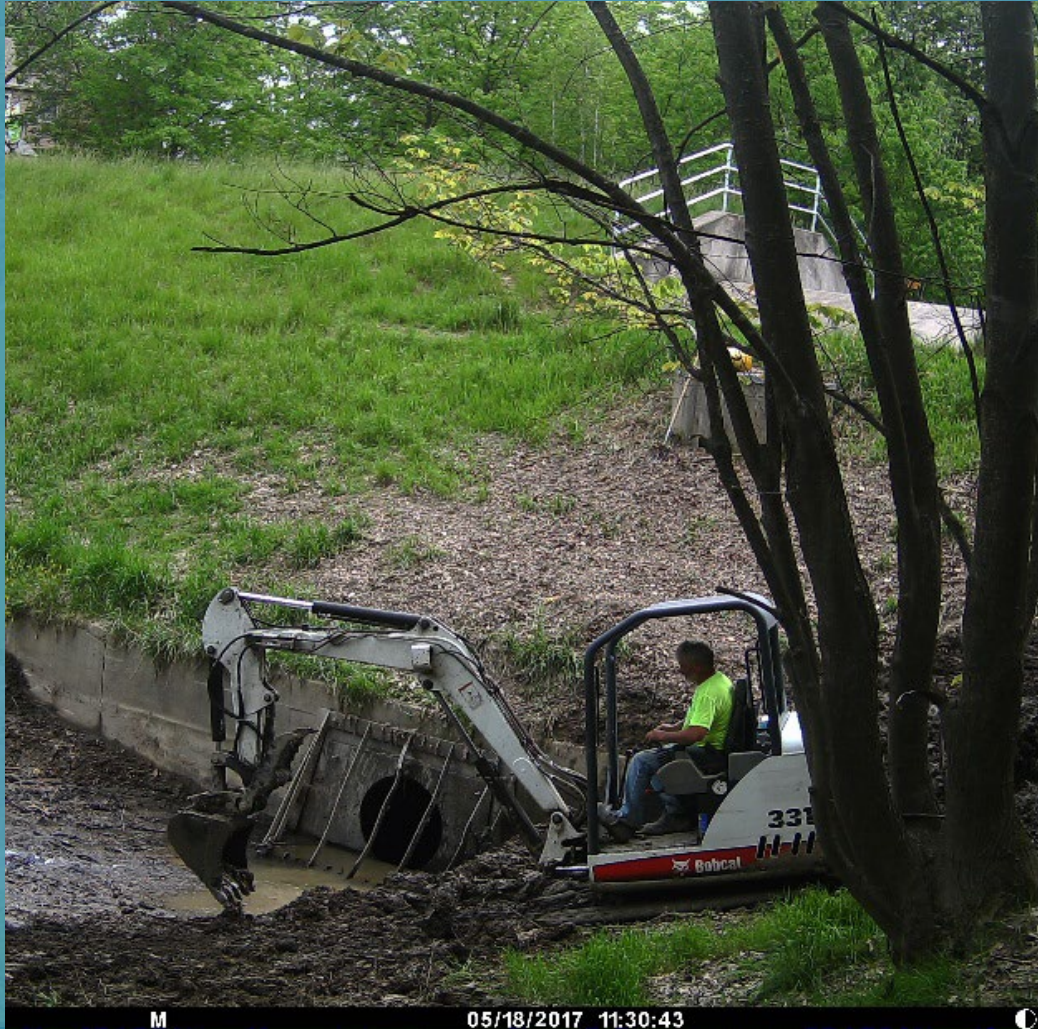
5/18/17: 1.52-inch Rain Event

Basin was cleaned prior to an equivalent storm event, which prevented the emergency spillway from activating

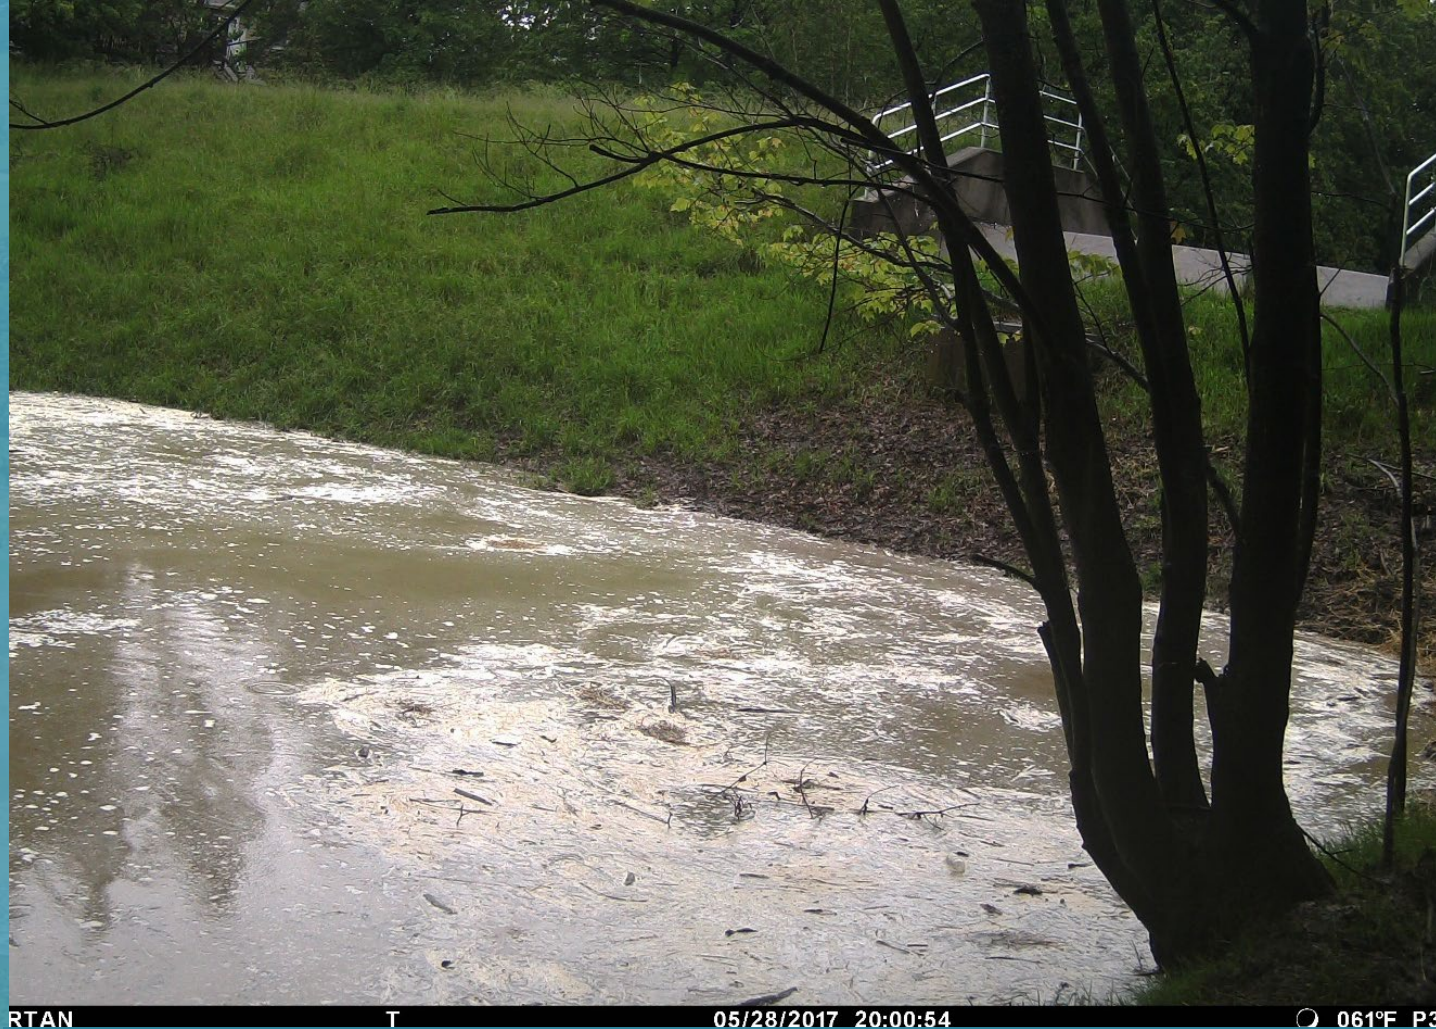
May 18, 2017: Maintenance removed LWD

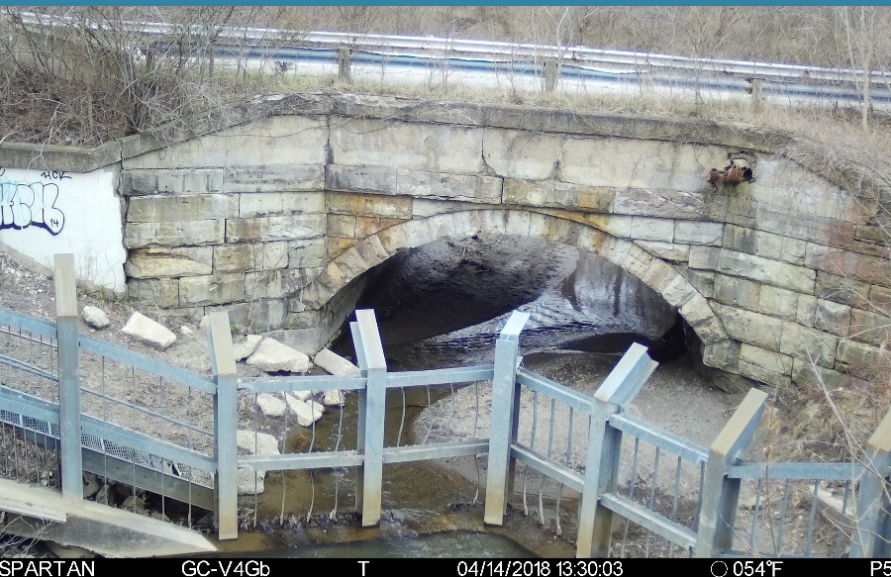
April 14, 2018: Debris rack is clear prior to storm event
