An Urban Stream Manager's Guide to Field-Based Master Planning

George Remias, PE

**Northeast Ohio
Regional Sewer District**

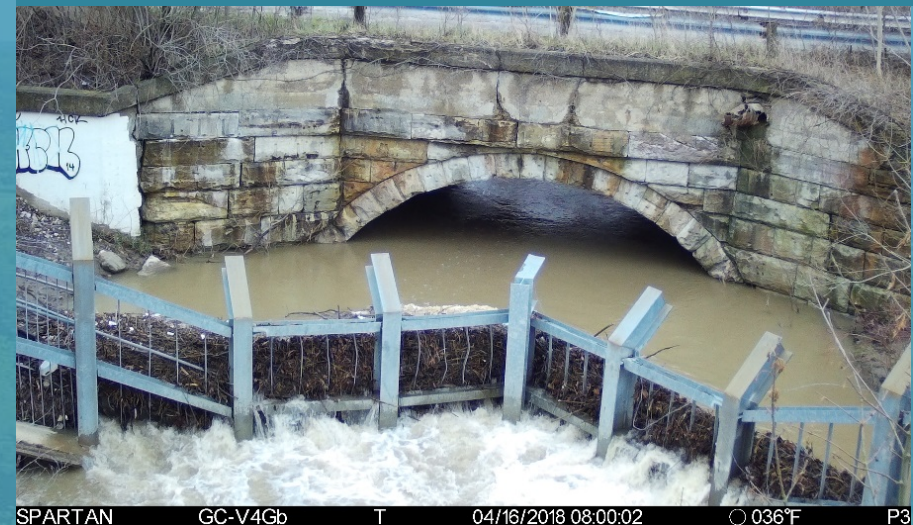
- April 16 2018 storm (2.91-inches) generated 48 CY of LWD

April 16: Peak storm and debris accumulated on debris rack

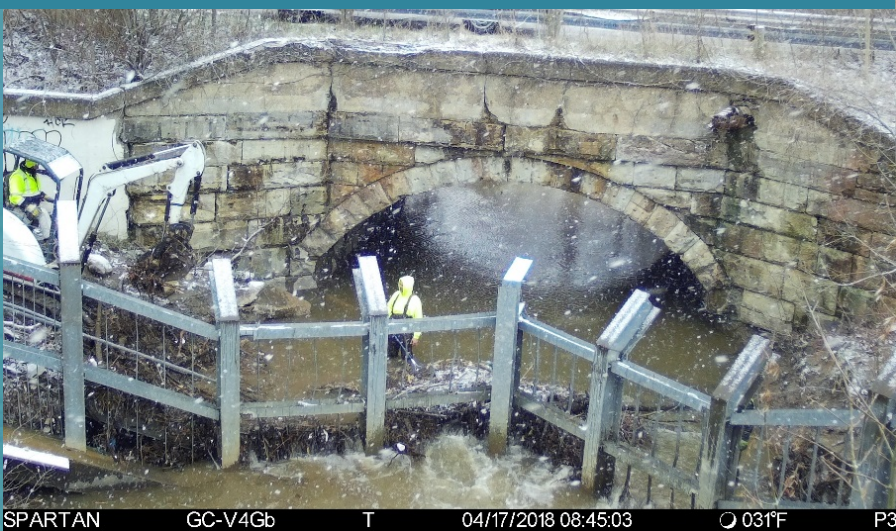
April 17: Maintenance performed next day to remove 48 CY LWD

- Used a trail camera to identify and quantify maintenance projects without a field visit

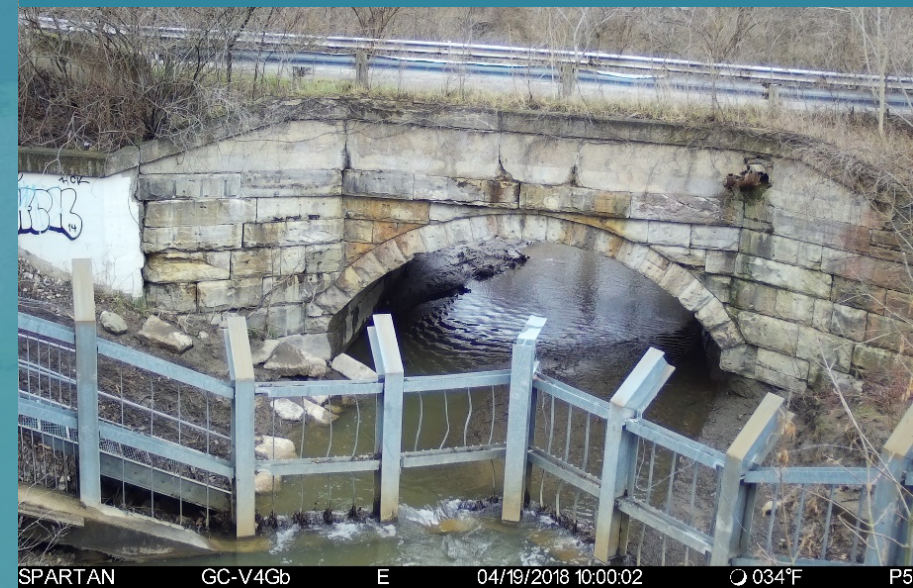
Debris rack is clear post April 17 maintenance project
