# **ODOT Research**

# **Soil Amendment for Stormwater Volume Reduction**

ms consultants | USGS | 2019

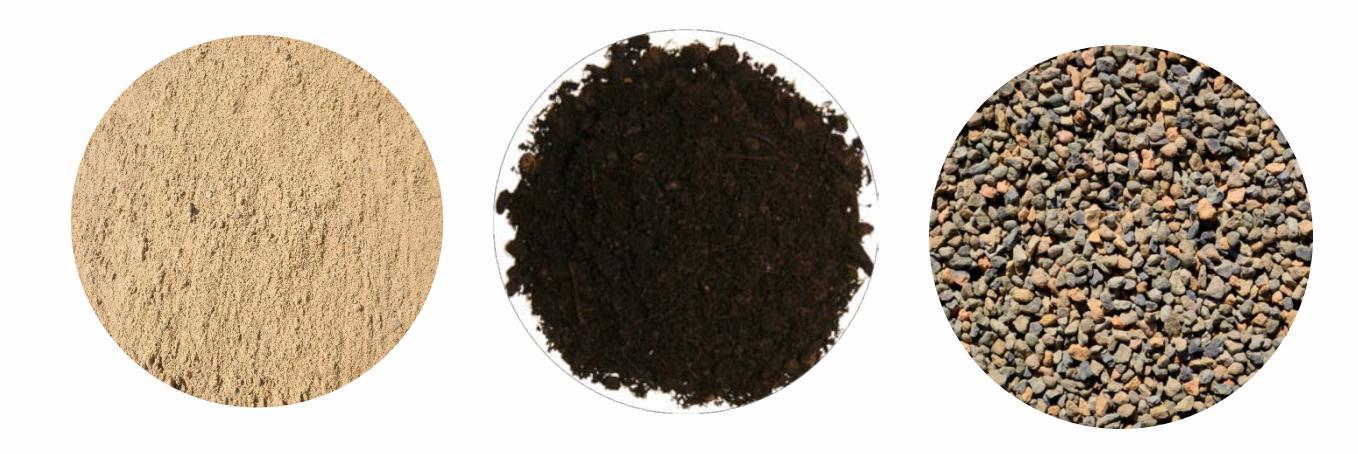
FINAL RECOMMENDED SOIL AMENDMENT DESIGN										
Mix Design	Number of Sites	Incorporation Depth (in.)	Native Soil (%)	Compost (%)	Sand (%)	Expanded Shale (%)				
Α	2	4	54	29	17	0				
В	B 2		54	29	0	17				
С	3	6	54	29	17	0				
D	3	6	54	29	0	17

- 1) Compost & Sand (4-inch)
- 2) Compost & Sand (6-inch)
- 3) Compost & Expanded Shale (4-inch)
- 4) Compost & Expanded Shale (6-inch)

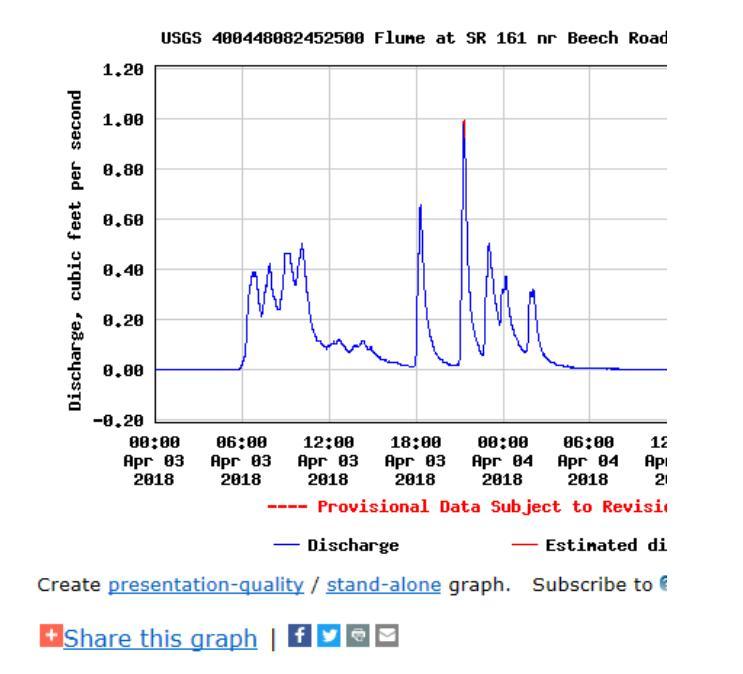
### Gage Data - flumes

#### Discharge, cubic feet per second

#### Gage height, feet

#### USGS 400448082452500 Flume at SR 161 nr Beech Road nr New Albany OH

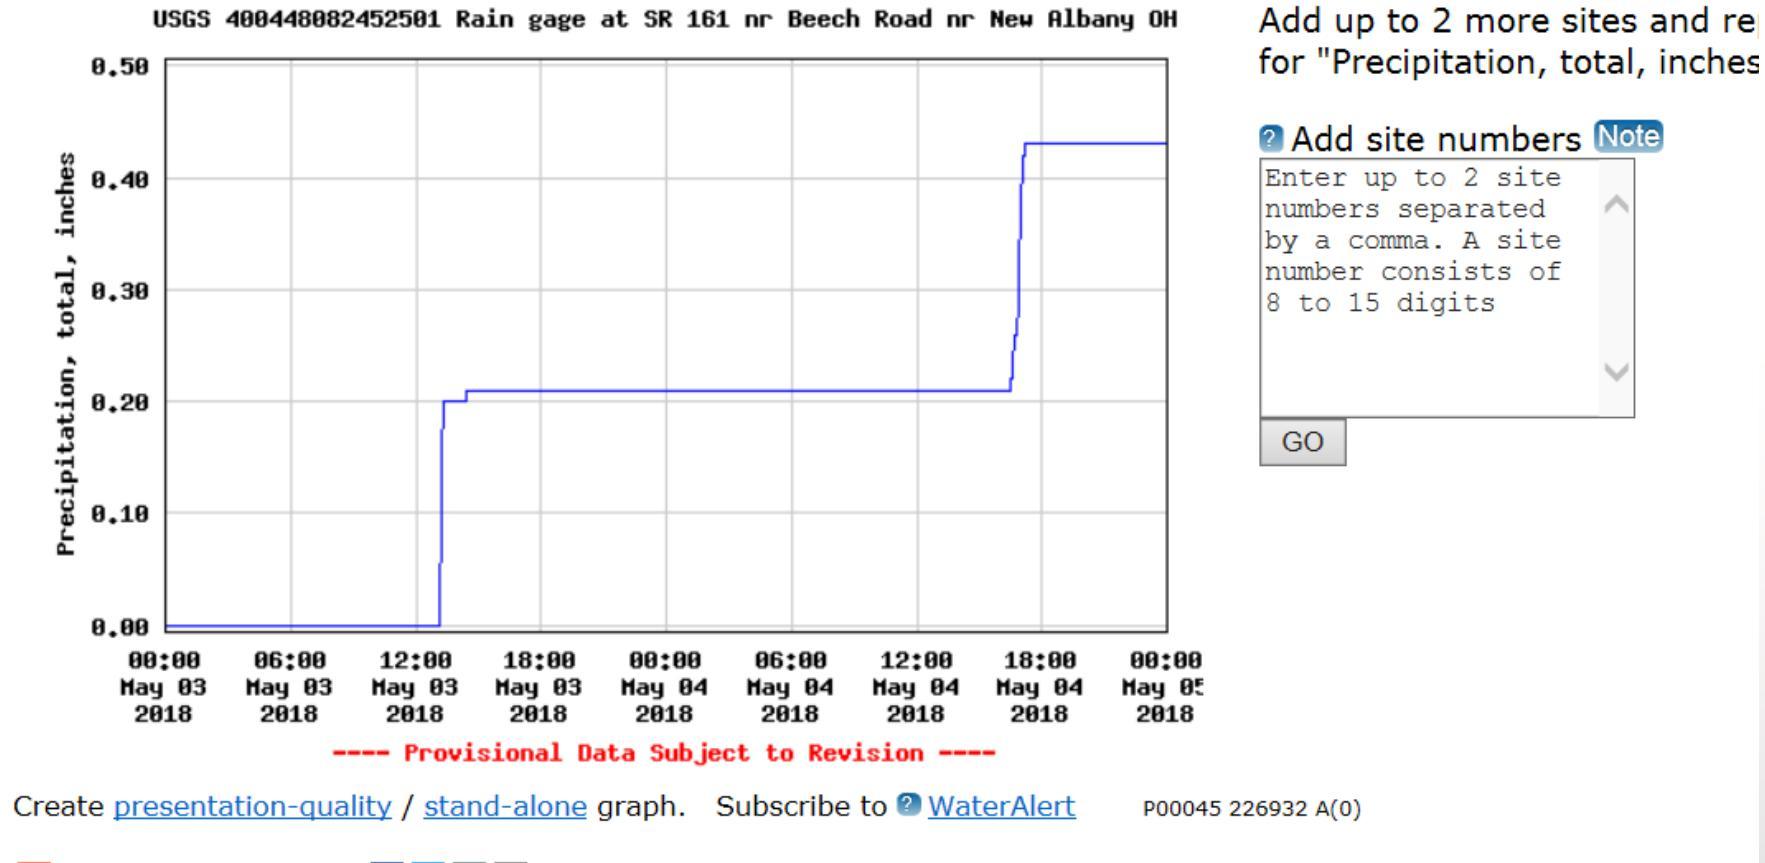
### Gage Data - rain

#### Precipitation, total, inches

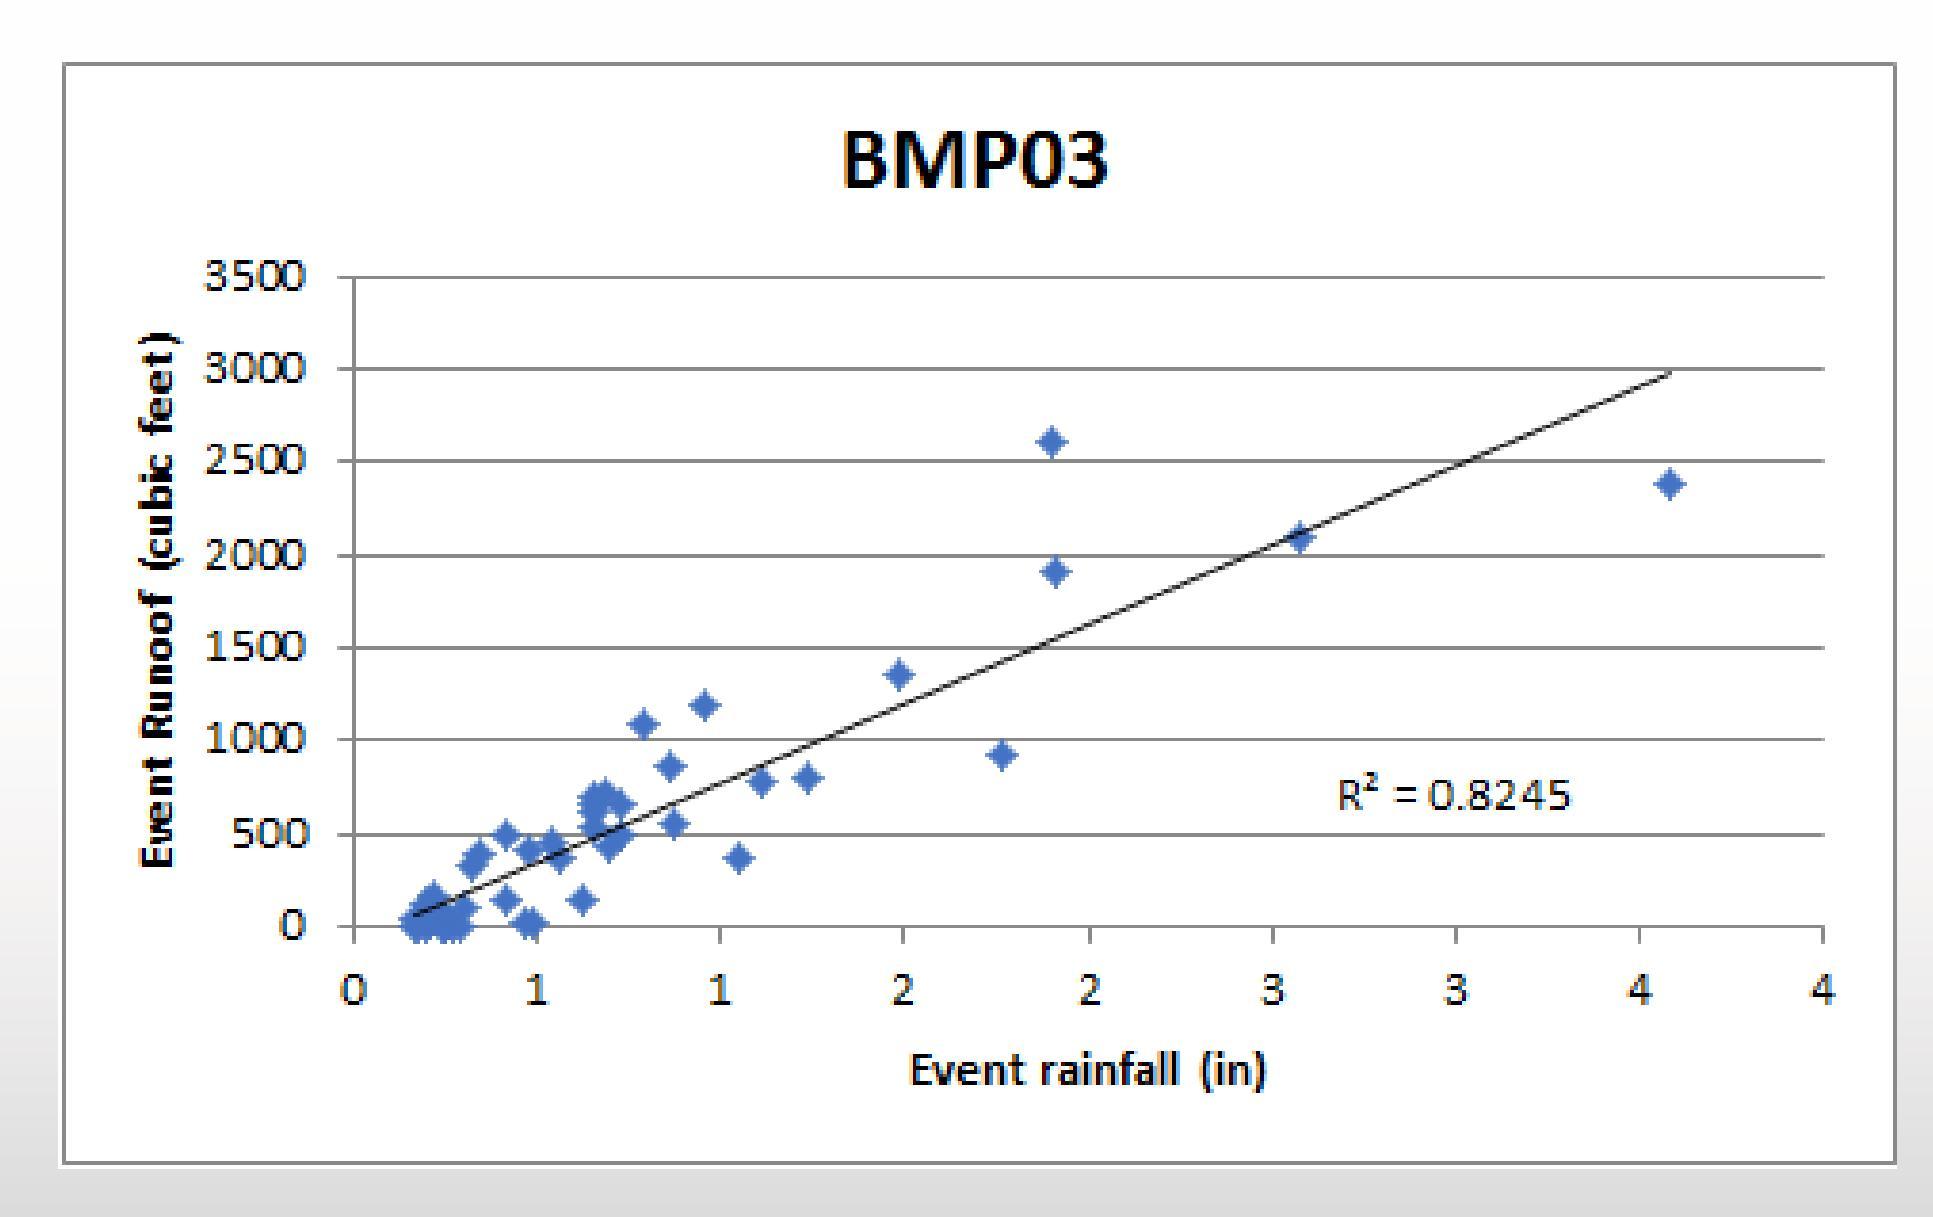
# **Event Pre-BMP results**

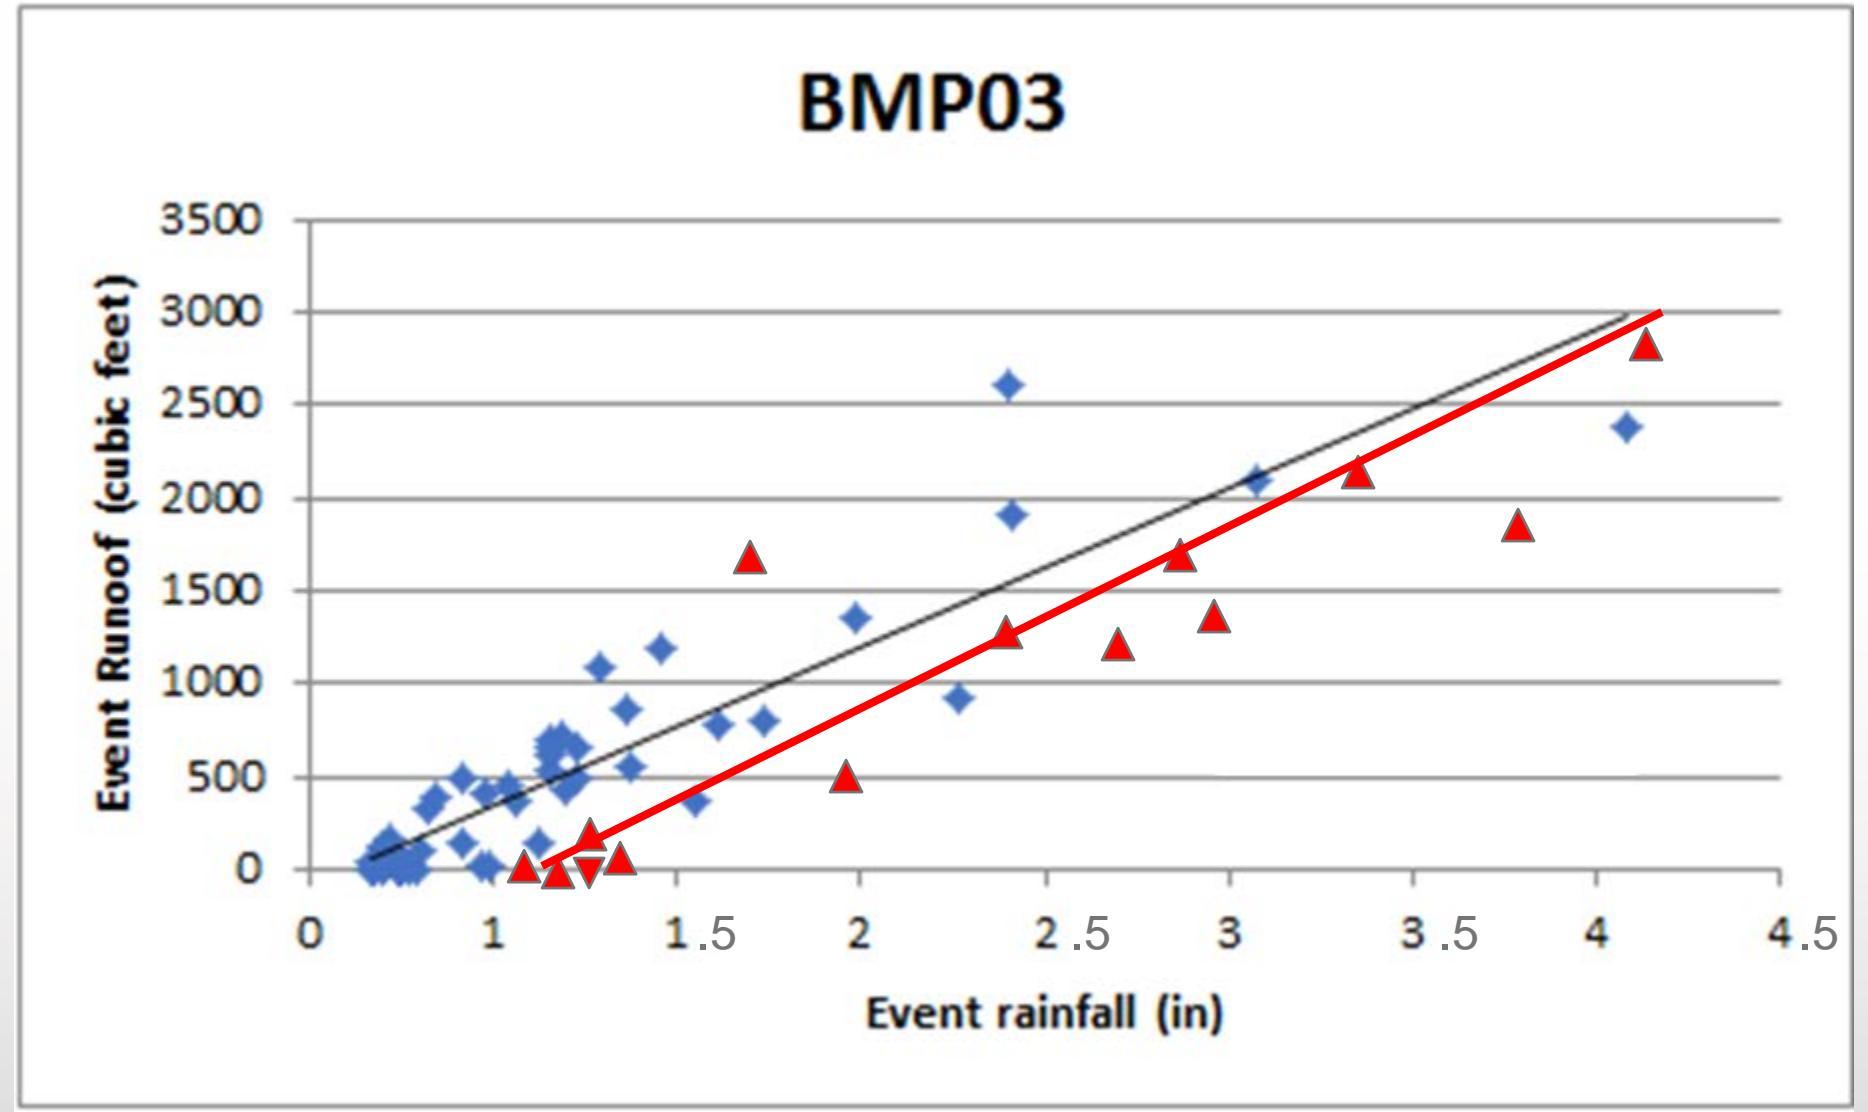
# Hypothetical Event Pre vs Post results

# Pre-Post BMP Results comparison factors

- Drainage area size
- Drainage area slope
- Percentage of drainage area that is impervious
- Event total rainfall
- Event total rainfall intensity
- Event max 1-minute rainfall intensity
- Event max 10-minute rainfall intensity
- Event timeframe of maximum rainfall intensity
- Total rainfall in previous 24 hours
- Total rainfall in previous 48 hours
